***Exxon Valdez* Oil Spill  
Restoration Project Annual Report**

**Archaeological Site Restoration, Index Site Monitoring, 1995**

**Restoration Project 95007A  
Annual Report**

**April, 1996**

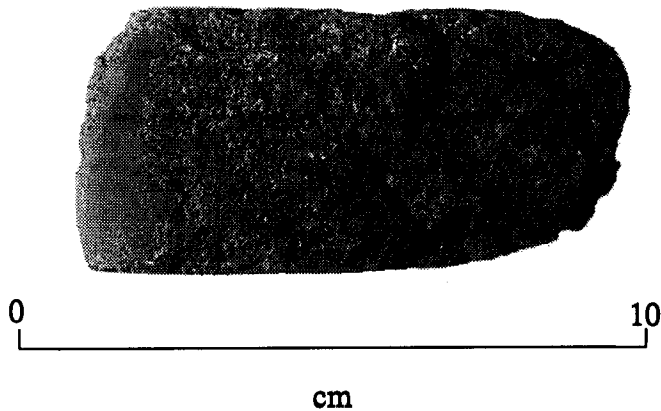
A planing adze bit of hard, coarse grained stone was found on the beach surface near the northern limits of the exposed fire cracked rocks (Figure 2). It is 8.9cm long, 4.2cm wide, and

**Figure 2.** Planing adze bit collected from beach, AFG-098. Photo: DNR, Office of History and Archaeology.

1.5cm thick. The adze bit was collected and will be curated with the other artifacts.

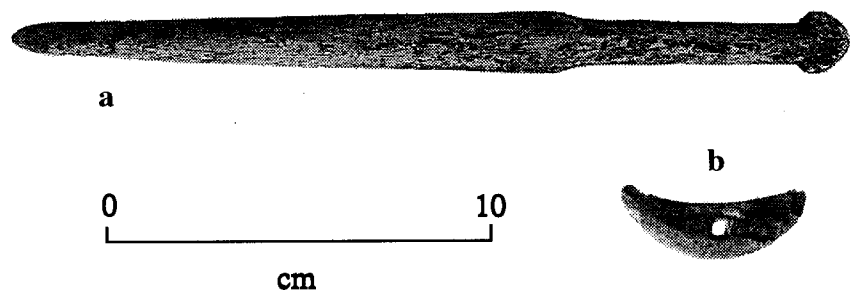
A bone dagger found on the beach near the center of the

**Figure 3.** Artifacts collected from beach, Perevalnie Passage Site, AFG-046. Photo: DNR, Office of History and Archaeology.

site and in danger of disappearing into the surf was collected (Figure 3a). The dagger is carved from sea mammal bone and measures 21.8cm long. It is 1.7cm wide and 1.0cm thick. The dagger will be curated with an ivory pendant collected during 1994 (Figure 3b).

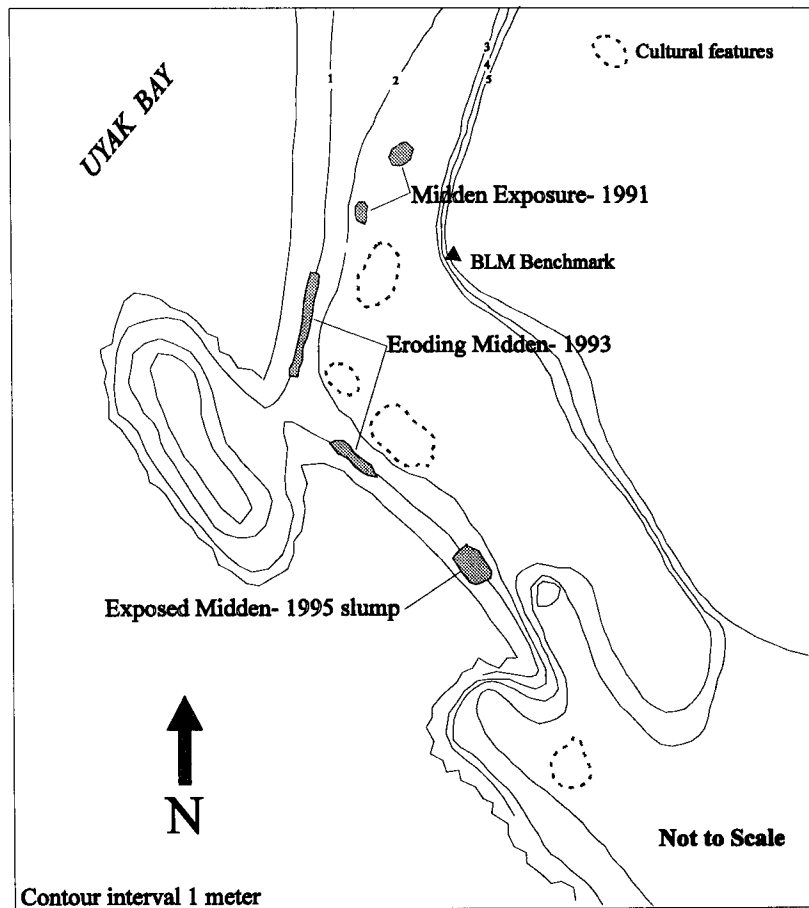
In 1989 Exxon Archaeologists reported two excavations in the eroding southern face of the midden. A 1990 visit confirmed the damage but found no new holes (Haggarty et al. 1991). The site was revisited in 1991 (Dekin et al. 1993) and two additional exposures on the bluff near the east end of the site showed clear signs of illegal excavation. Two further excavations inside features at the western end of the bluff were of apparent human origin and recent, probably from that summer. A monitoring visit by U.S. Fish and Wildlife Service archaeologists in 1993 discovered three additional potholes in the bluffs. Erosion continues, primarily at the southwestern end of the site.

On September 12, 1995 U.S. Fish and Wildlife Service Archaeologists Charles Diters and Debra Corbett examined the beach fronts where the majority of past damage had occurred (Figure 4). One area on the southern midden face has a significant slump in the vicinity of several old holes which may have contributed to the slump. However, no new excavations were evident; the old holes are revegetating. Minor erosion at the southwest edge of the site continues.

**Figure 4.** Cultural features and injury locations at the Chief Cove Site, KOD-171.

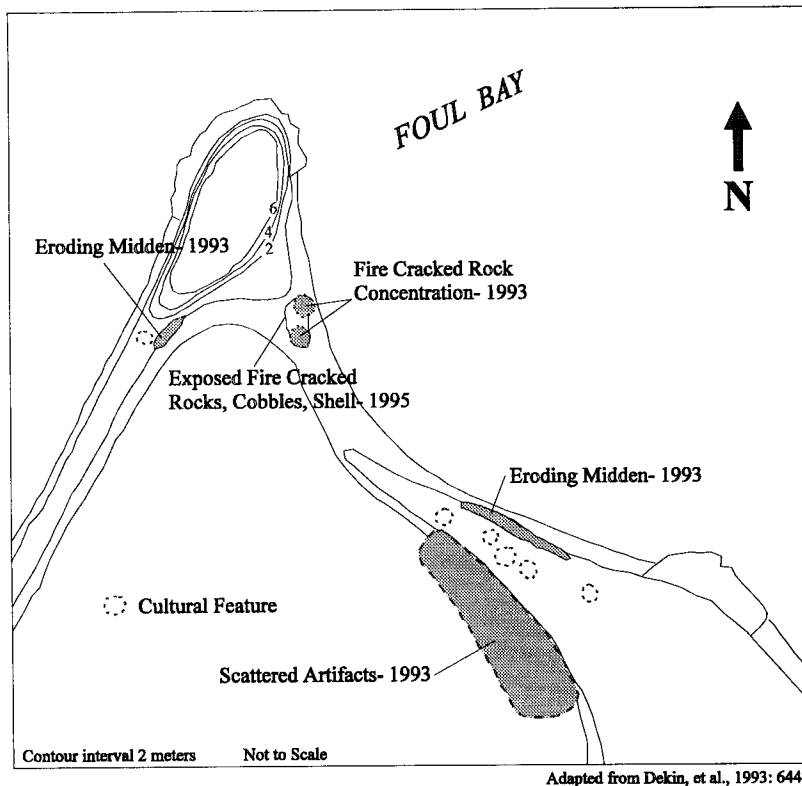
**Figure 5.** Cultural features and injury at the Ban Island Housepit Site, AFG-129.

Debra Corbett, accompanied by a contract video crew (Stefan and Clare Dobert) flew to Ban Island. The site was thoroughly examined to locate all past reported disturbance. A thick mat of decaying seaweed on the lagoon side of the southern site area precluded inspection of the intertidal zone but all other areas were examined. Additional concentrations of fire cracked rock and a possible hearth were noted in the intertidal zone. All reported vandal holes were relocated and were revegetating. No new excavations were evident. Erosion continues on the edges of both the north and south upland areas, and in the intertidal zone.

ends of the site, in upended tree roots in the drowned forest, and in the eroded intertidal area. Artifacts were found in the intertidal zone (Figure 5).

During the initial survey in mid-July, recorders noted four vandal holes in the seaward edge of the southern midden and holes inside two housepits. Most of the excavations were old but one was recently disturbed. Two weeks later a cleanup vessel crew in Foul Bay was briefed on archaeological procedures. The next day a freshly excavated vandal hole was discovered on the site. Investigation failed to produce a suspect and no further damage was noted in the next several months (Mobley et al. 1990). The site was not monitored in 1993.

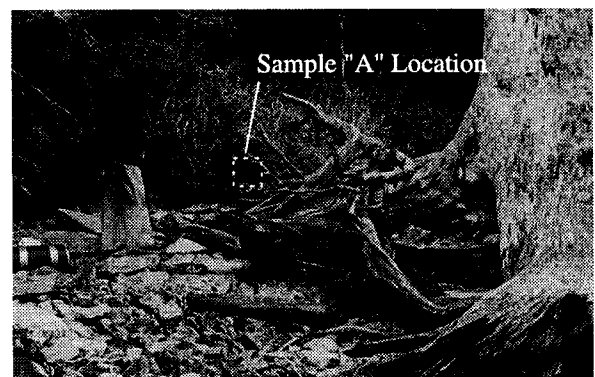
**Figure 6.** Sample "A" location, McArthur Pass Site, SEL-188. Photo: National Park Service.

Sediment samples were collected from two localities at the McArthur Pass Site. The samples were recovered from previously sampled areas to maintain continuity of monitoring. The sample from Unit A was a column of turf and sediments taken from the eroded bank face (Figure 6). The column measured 4cm x 4cm x 12cm. The sandy gravel sample was tested for petroleum hydrocarbons with the HNU- Hanby test kit and provided negative findings.

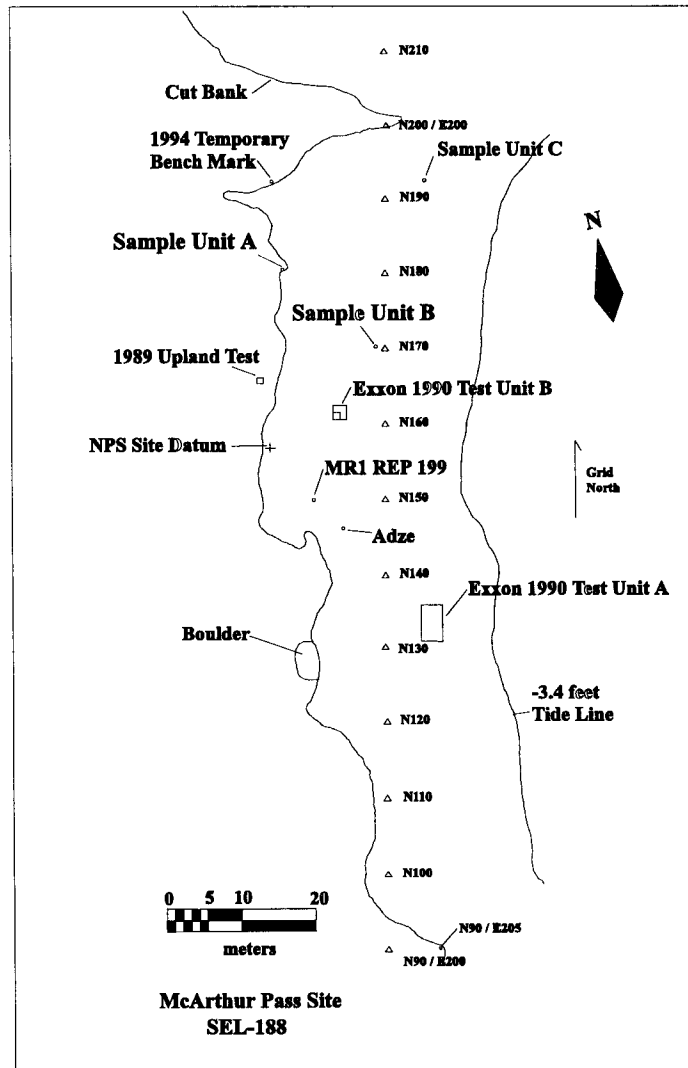
The inter-tidal gravel from locality B smells strongly of crude oil and because of the obvious presence of oil, was not tested. Samples collected from the beach in 1993 were identified as originating from the *Exxon Valdez* (personal communication, J. Short to T. Birkedal, July 5, 1995)(Figure 7). Oil still remains in the intertidal sediments at the site. A tar mat was found which measured 50cm x 20cm and was 10cm thick. The mat, which was left in place, contained flakes of slate, some of which were culturally modified. A water worn cobble which is not the same lithology as local bedrock and possibly culturally

**Figure 7.** Cultural remains and sampling locations, McArthur Pass Site, SEL-188.

introduced, was also embedded in the tar mat. The unit selected as sample location C was covered by water during the visit and was not sampled.
