*Exxon Valdez* Oil Spill  
Restoration Project Annual Report

Archaeological Restoration, Index Site Monitoring, 1998

Restoration Project 98007A  
Annual Report

April, 1999

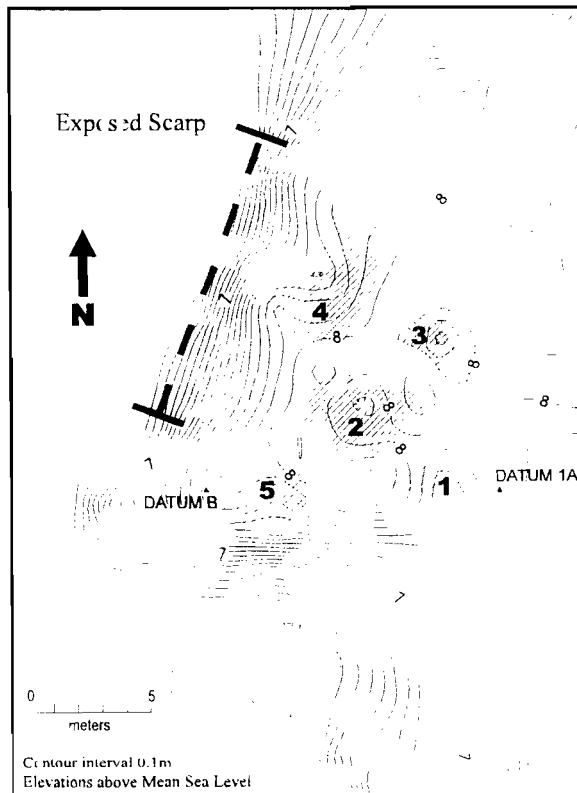
**Figure 2.** Exposed scarp at area of erosion, AFG-082.

The AFG-082 Site was first noted during 1983 and tested during 1991. The site consists of five subdued depressions in a grassy knoll overlooking a rocky beach (Figure 2). Adjacent to the site is a pond created by drift logs and other storm deposited debris, damming a small drainage. The knoll is comprised of organic rich soil midden, poor in shell or other organic remains. The bone fragments recovered were calcined fragments. A single fragment of clam shell was recovered from the limited tests excavated. The midden is positioned on a bedrock knob. The front of the midden is exposed by tidal erosion. Artifacts are found on the beach gravel at the base of the exposure.

The visit to the site during 1998 revealed continued erosion due to storm waves but no evidence of vandal activity (Figure 2). No tar balls or mousse like that seen in 1991 were found in 1998. No artifacts were collected from the beach. A few fragments of ground slate, boulder chips, and fire cracked rocks were present among the gravels.

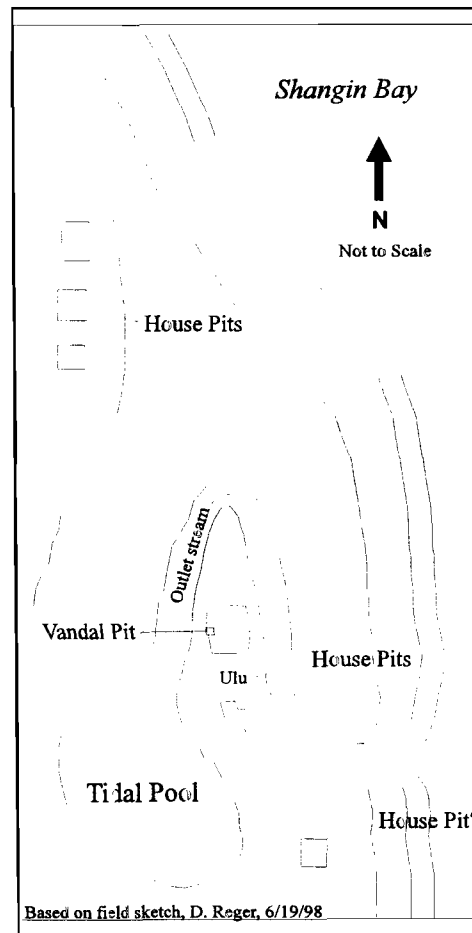
**Figure 3.** AFG-084 site area.

This site was located during 1983 and was described as two house depressions with midden on a low gravel spit (Klingler 1983). The spit, located near the head of Shangin Bay, lays between a tidal pond and the bay shore (Figure 3). The outlet stream of the pond is eroding the site both behind and in front of the house depressions.

Artifacts were found in both areas of erosion. Vandalism was noted at the site in 1983 but location of the damage was not specified. Archaeological testing at the site documented culturally stained soil, fire cracked rocks, bone, a few shells, and artifacts beneath a deposit of Katmai Ash. The artifacts were attributed to Koniag affiliation in a later report (McMahan 1993). A hole was dug into the west wall of the northermost house pit on the spit. It is near the center of the back wall and is now enlarging due to natural slumping of the beach gravel matrix. The square shape of the pit and the condition of the pit walls suggest it was excavated within the past year or two. No grass or other vegetation has invaded the open pit walls.

Another, nearby, site area was found during the 1998 visit to the head of Shangin Bay. The two house pits on the low gravel spit were again located and overlooking the spit from a higher terrace to the south was a large rectangular depression. It may represent a house depression but was not tested. West of the documented site on the spit, at the base of the hillside were two more square depressions and perhaps a third depression. The northernmost depression is indistinct in the tall beach grass cover. The depressions are arranged in a line parallel to the base of the slope about 15m to the west. No testing was attempted around the apparent house pits. The distinct pit outlines suggest a recent or historic age.

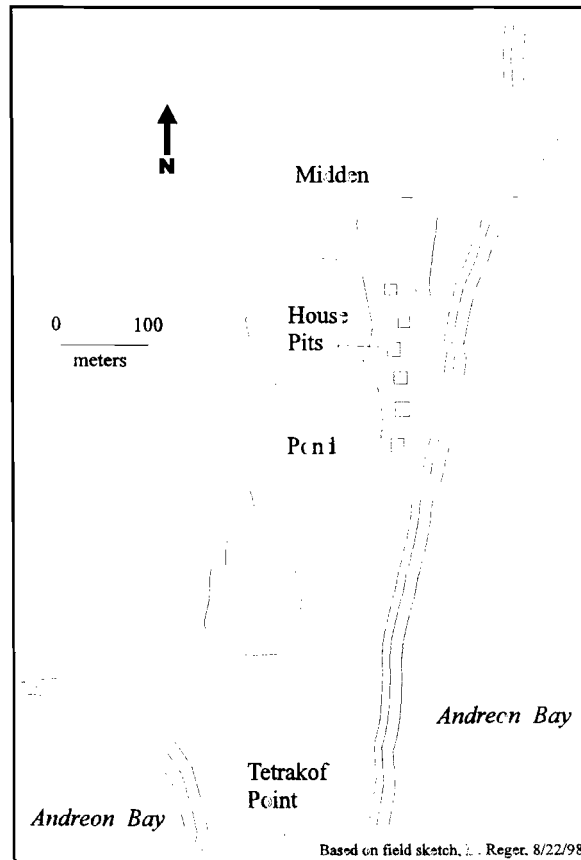
Figure 4. Tetrakof Housepit Site area map.

During the 1998 field season, the Tetrakof Housepit Site, AFG-160 was identified for examination for damage from vandal activity. The site was identified by Exxon archaeologist Don Abbott during July 1989. He noted that there were six distinct house depressions with a possible additional pit at the north end of the site. The house pits appear to be single room pits situated on a narrow, low, ridge between a fresh water pond and the active ocean beach (Figure 4). The alignment of the pits is staggered generally along a south-north line. The house pits are situated on the inland side of the ridge and the distance between the beach and house pits is about 20m. The pits range from 5m to 9m in diameter. Most pits have small spruce trees growing within the circumference of the pit.

Midden is evident between the northern most pits and the eroding ocean beach scarp and is exposed at the north end of the site in tree roots and beneath a thin sod cover. The scarp measures 0.5m to 1.0m in height. Broken clam and crushed mussel shells are exposed through the sod. No test excavation was attempted. During the 1998 visit, no midden was found exposed at the beach. In 1989 midden, composed of clam and mussel shell, fire cracked rock, charcoal and fish bone, was eroding along the scarp in an area 0.2m high and 0.3m wide. Beach grass has grown over any previously exposed midden. No evidence was seen for vandal activities at the site. The shores of Tetrakof Point were examined for additional sites. Root wads and erosional exposures were checked for cultural remains. The ridge west of the freshwater pond was also surveyed. No midden or house pits were found.

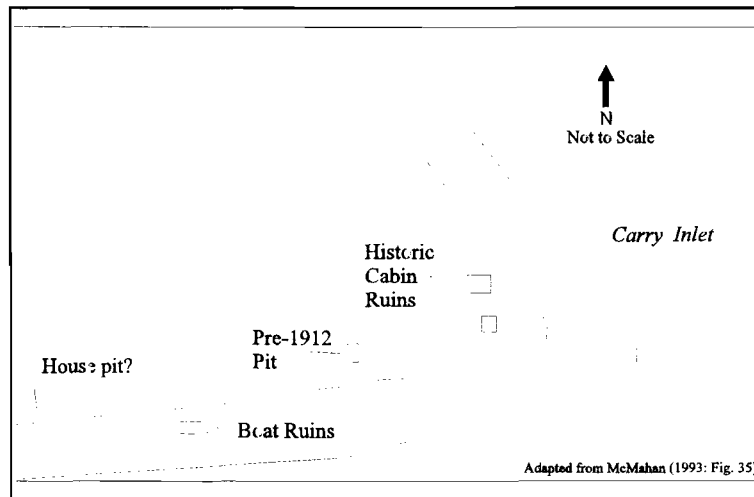
**Figure 5.** Site area map, AFG-156, showing surface features.

When high winds prohibited travel on Shelikof Strait to visit index sites to be monitored, we walked to Carrie Inlet to check on known sites located there. The AFG-156 Site was mapped and archaeologically tested during 1990. Presence of Katmai Ash in some features and not in others suggested occupation in the early 20<sup>th</sup> Century. Artifacts

and structural remains are still exposed at the site eight years after initial mapping. West of the apparent mining remains, about 100m, is a newly discovered, rectangular depression oriented parallel to the beach scarp (Figure 5). It lays about 1m from the bluff edge and is very indistinct. The trail along the bluff edge traverses the depression which is disguised by irregular clumps of moss cover and trees. It has the appearance of an old house depression but was not tested.

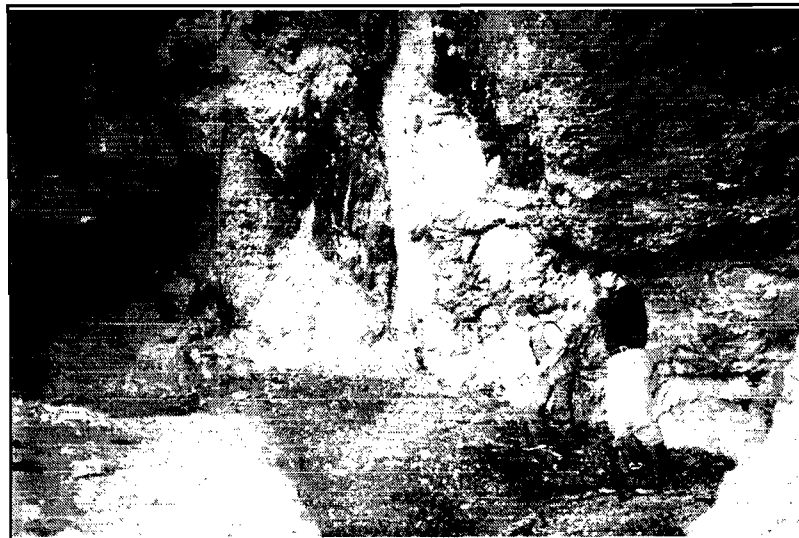
**Figure 9.** Interior of Crafton Island Cave, view to the northwest (Chugach National Forest photo, 7/10/98).

The site visit was conducted on July 10, 1998 (Figure 7). Comparisons were made with fieldnotes and a scaled map produced from previous fieldwork (Dekin, et al. 1993). The cave opening is oriented to the southeast and measures 9m wide by 22m high. The interior is 16m wide by 14m deep. The midden covers a 4m x 10m area and is over a meter deep. The prominent rock slab at the entrance is covered by a thin layer of midden, large mammal bones, slate debitage, and otter or fox scat.

A Forest Service sign placed inside the entrance in the northeast corner of the cave is still present. A mound of dense midden behind the sign contains large vertebrae and a concentration of shell in a small nook of the rock wall. The matrix is blackish-brown, dry and loosely compacted. The midden extends along the northwest wall and consists of dark gray, loosely compacted sediment with mussel and clam shell, sea mammal, fish and bird bones, slate debitage, and fire-cracked rock. The disturbances originally reported by Exxon contract archaeologists (Mobley et al. 1990), are still evident along the back wall in the northwest corner as indicated on the 1991 map (Dekin 1993). They consist of shallow excavations and small backfill mounds and may be from continued animal disturbance. There is a trench-like depression (1.54m long x 0.35m deep) along the west wall in a small nook in the rockshelter wall. Stratigraphy in the trench reveals bone and shell midden throughout and several slate artifacts. The midden does not extend into the southwest corner of the rockshelter. The rock lined pit in the south corner of the the cave, shown on the 1991 map (Dekin 1993), is currently obscured by additional rock fall. The only feature not illustrated on the 1991 map is a hearth-like depression 5.3m southwest of the USFS sign. The depression is 0.12m deep and 0.42m in diameter. There were no additional signs of disturbance other than noted in previous monitoring visits by Dekin's crew in 1991 and Yarborough in 1992. This was the final year that SEW-004 was monitored by the Forest Service because of its conveyance to the Chugach Alaska Corporation.

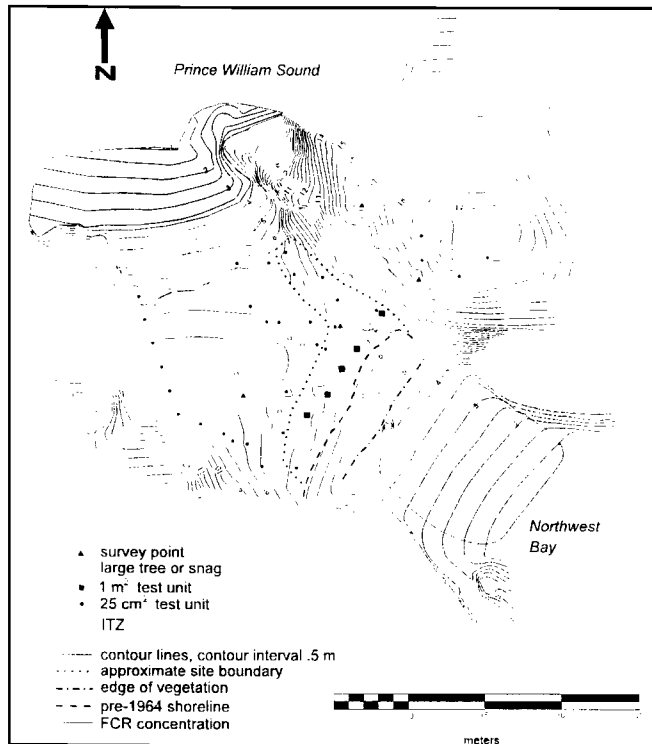
Figure 10. SEW-440 area map.

The midden exposure and fire cracked rocks are visible but the bank at the head of the beach looks stable with no evidence of erosion or looting. Weathered dimensional lumber is present at the head of the beach. Investigation of the beach at low tide revealed fire cracked rock and unmodified greenstone but no artifacts. The crew relocated the east/west and north/south lines of survey posts and test pits from the 1994 excavation. The test pits are re-vegetating well and their outlines are barely visible. Remains of a collapsed cabin are still visible. No vandalism or erosion was observed during 1998.

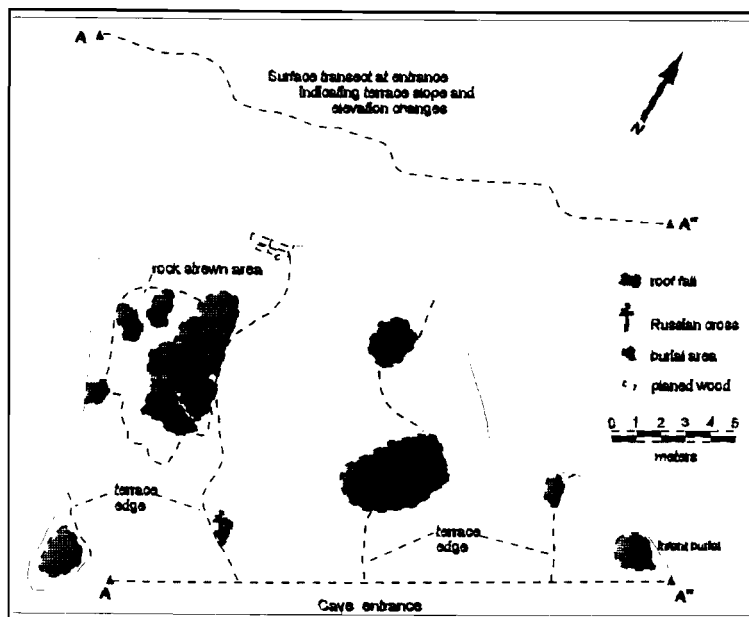
Figure 11. SEW-469 surface feature map.

The infant burial noted on the 1997 map (Yarborough and Barthold 1997) in the east corner at the lowermost end of the rockshelter appears intact. Material found on the surface in the vicinity of the burial includes woven mat fragments, planed wood, bird and sea mammal bone and clam shells. Cut bark planks are still present along the north wall of the uppermost level. Numerous pieces of shaped wood and wood points are scattered throughout the upper area. Modern trash was noted in the northwest corner of the rock shelter. The southwest corner of the rock shelter contains human bone fragments including carpals, metacarpals, and a sternum covered by sphagnum moss as indicated on the 1997 map. The Russian Orthodox cross remains standing, undisturbed except for decaying kiwi fruit "offering" (?) at its base.

The smaller overhang is located approximately 50m uphill (to the south) and is about 1.5m across. The overhang contains two wood slab planks and smaller pieces of planed wood along the north wall. A human vertebrae is wedged between the north wall and a small boulder on the floor of the overhang. The floor is covered by small to large rocks and loose reddish dry soil on the floor of the shelter.

There is one discrepancy between earlier observations and those made in 1998. No woven mat fragments were noted with the human remains in the southwestern corner of the main shelter as there were when SEW-469 was initially recorded in 1989 (Lora Johnson 1989 fieldnotes and photos; Linda Yarborough 1989 fieldnotes). However, no mention has been made of the mat fragments in any of the monitoring reports since 1989.

The 1998 monitoring found no new disturbance except for two recently introduced items near the cross and near the back wall. Otherwise the only disturbance is from small animals in the form of scat and burrows. Monitoring work at SEW-469 in 1999 will include setting up a second brass marker and creating a detailed map of the site using GPS.
