Exxon Valdez Oil Spill
Restoration Project Final Report

Montague Island Riparian Rehabilitation

Restoration Project 97139C1
Final Report

November 1998

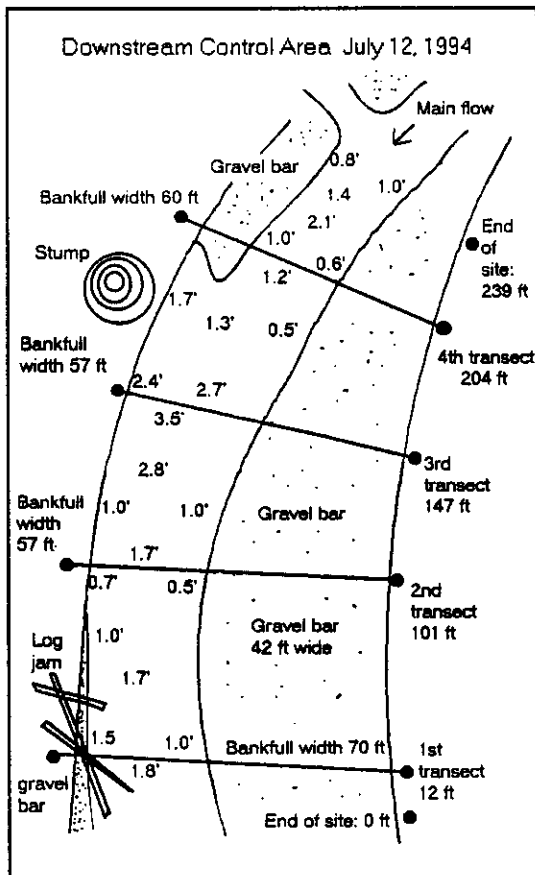
Figure 1 a. Downstream control site in 1994.

We were unable to determine whether any changes in the downstream monitoring site were due to the effects of the structures. Unfortunately, a channel shift just above the downstream study area radically changed the site. A large section of the main gravel bar eroded, a pool filled, and a wide shallow riffle was created. The substrate size decreased significantly in the area, but this and the other changes were most likely due to the channel shift rather than any effect caused by the remaining structures. There was no evidence of revegetation or narrowing of the channel.

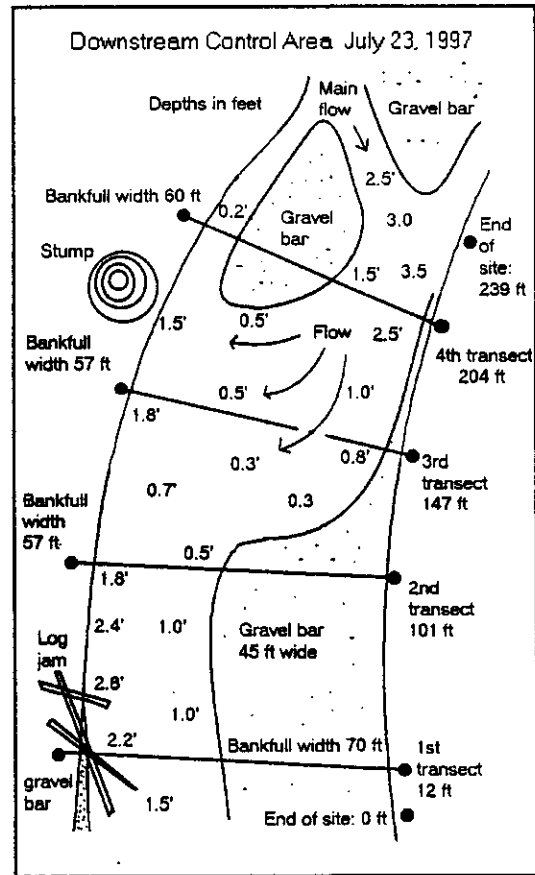
Figure 1 b. Downstream control site in 1997.

As mentioned earlier, we had hoped to indirectly assess the cumulative effects of the structures by monitoring changes in substrate size and channel geometry at the downstream study site. MacDonald et al. (1991) recommended monitoring individual pools and riffles to detect substrate changes, which was our intention. However, the radical change of the pool and riffle boundaries caused by the shifting of the stream has masked any effect the structures may have had. The significant decrease in substrate size in the study site appears to be a result of the stream expending its energy as it hits the bank, rather than an overall reduction in stream velocity caused by the structures.

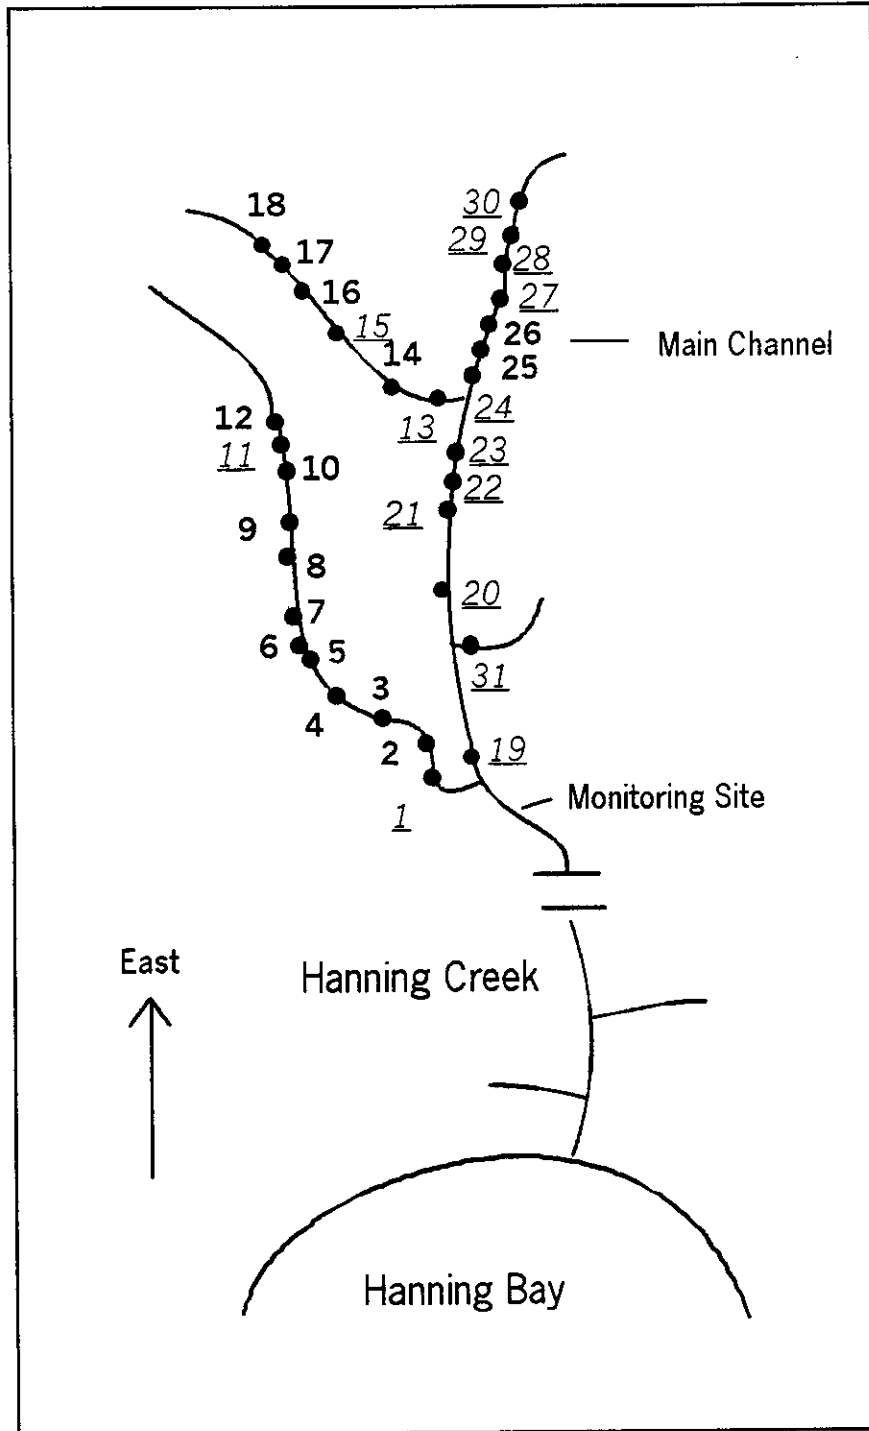
Although all of the structures in the Hanning Creek watershed survived two bankfull floods during the summer and fall of 1994, almost half of the structures failed by 1997 (Table 1). Most of the structures that failed were designed to reduce velocities or protect banks from erosion in the main channel where flows are highest. Only five of the 14 structures intended to reduce velocities are still functioning as intended. One additional structure may function only at higher flows. Of the five structures built to protect banks from erosion, one remains. It is functioning well, however, protecting about 35 m of bank and allowing young alder and Sitka spruce to become established along the shoreline. Ten of 13 habitat structures in the smaller tributaries are functioning as intended, creating 163.4 sq m of pool habitat and 21.4 sq m of spawning area. Juvenile Dolly Varden (*Salvelinus malma*) and one adult have been observed using the habitat created by the structures, but no other species have been seen so far. Diagrams of the remaining structures, the habitat created, and other changes in the channels are presented in Appendix 2.

Appendix 1. Location of structures at Hanning Creek. **Bold** numbers indicate structures which are still functioning. *Italic* and underlined numbers indicate structures which have failed. One other structure at an unnamed creek failed.
