**Exxon Valdez Oil Spill Trustee Council**  
**General Restoration, Habitat Enhancement, Habitat Protection, and Facilities Projects**  
**Quarterly Project Reporting Form**

**Project Number:** 2020131 (Includes 21210131)

**Project Title:** Alaska SeaLife Center Facilities Project \$2,000,000/\$500,000

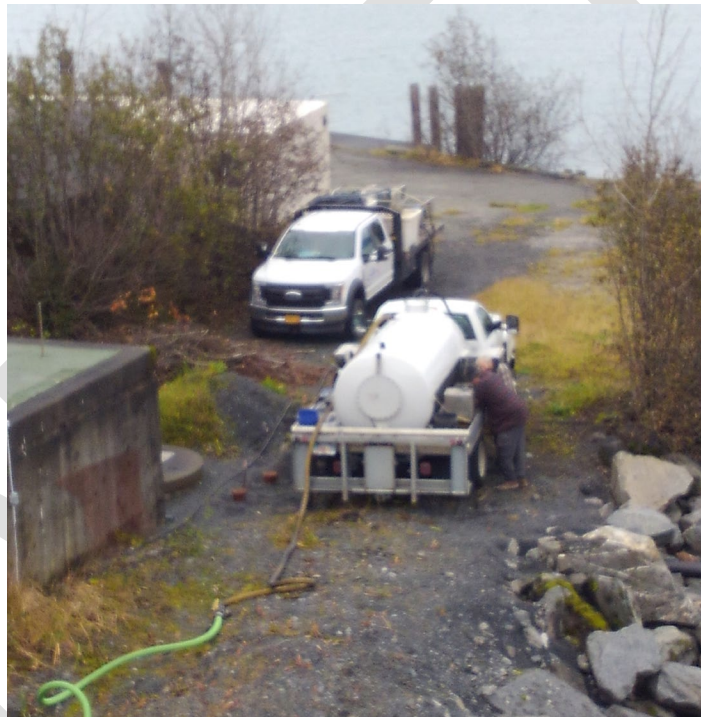
Global Diving with four-person crew documented and surveyed the overall condition of the well (depth of silt layer, intake line penetrations, siphons and pigging station) with an eye to repairing the broken siphon. Removing the mud proved problematical. There is 4 feet of silt and mud piled up in the center of the well rising as high as 6 feet in the corners. The siphon with the booster pump attached was working briefly at removing this until it hit the heavy mud and that immediately bound up the pump. Bernie of Global has submitted an updated proposal that included the use of a hydraulically powered submersible pump. Sedimentation in the well continues to be a major area of concern and has recently caused a heat pump outage due to severely clogged strainers.

*Suction equipment used to support initial dive and inspection of intake wells.*

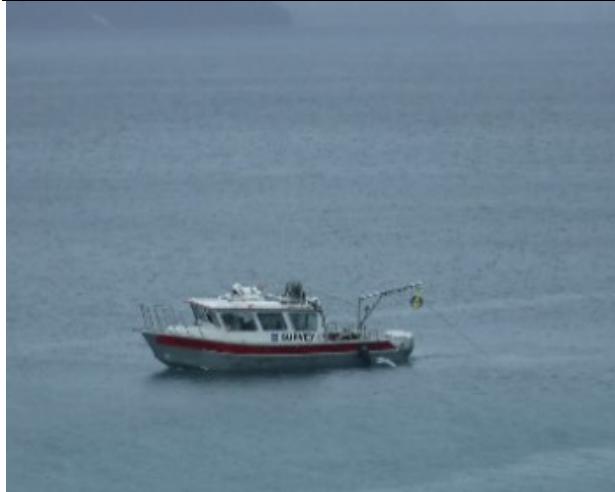
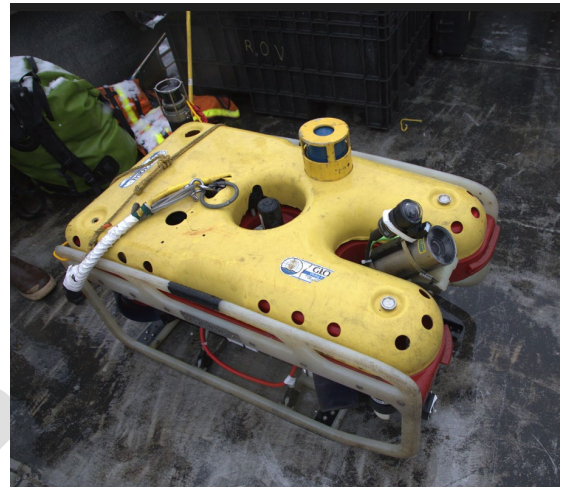
KING2247.JPG

The Global Bathymetric survey of intakes (Part 1) was performed on Wednesday 10/26. They will present a full report in a few weeks. Preliminary results are show the intake for the East side of the well has been found and documented. The intake for the West side of the well appears to be buried. While they know generally where the intake is they were unable to video it.

*Towing side scan sonar (left) and ROV used to inspect intakes (right).*

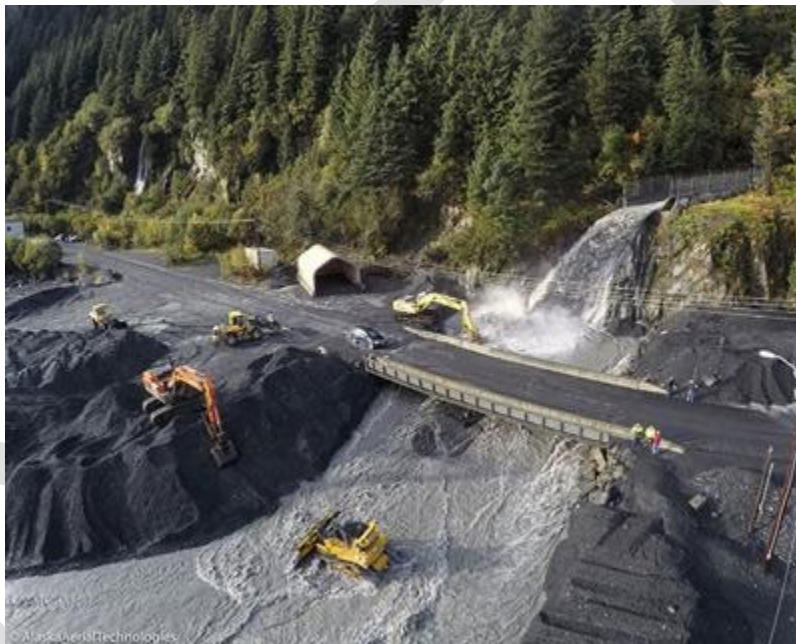
Due to work being conducted by the Army Corps of Engineers on the Lowell Canyon diversion tunnel design considerations for the pump house barrier may change. The Corps has completed seismic studies in the area which will be used to determine the course of repairs. Currently 5 alternatives to the tunnel are open for consideration, with the recommended plan consisting of construction of a completely new tunnel and refurbishment of the old tunnel. This plan if implemented may significantly reduce the risk of flooding to the pumphouse.

*Aerial view of Lowell Creek diversion tunnel during a flood event in 2018. Photo by Alaska Aerial Technologies as published in the Seward Journal.*
