**Exxon Valdez Oil Spill Trustee Council**  
**General Restoration, Habitat Enhancement, Habitat Protection, and Facilities Projects**  
**Quarterly Project Reporting Form**

**Project Number:** 21210131

**Project Title:** Alaska SeaLife Center Facilities Project \$2,000,000/\$500,000

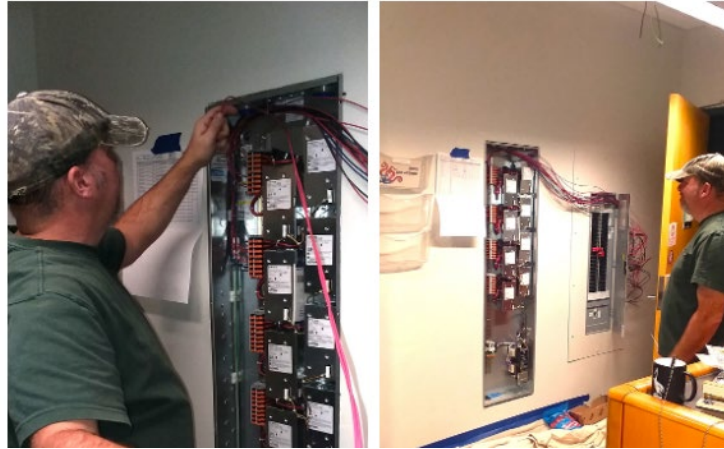
The electrical contractor for Trane began work on the Lutron lighting system upgrades on 10/3/2022, focusing on the installation of the wireless sensor network and replacement of the lighting control panels. Panel replacement had to be closely coordinated with ASLC staff in order to avoid conflicts with animal needs and ASLC functions. As work progressed, several areas were found to have insufficient equipment allocated for the area or too much. However, the contract was able to make changes necessary to minimize additional expenses. The electrician, Kevin Mitchel, installed 14 lighting relay control panels. The wired receiver network was installed which required running data cables and conduit systems throughout ASLC. Approximately 124 occupancy sensors, 179 switches, and 37 wireless sensors have been installed. Lutron technician Greg Booth completed commissioning of this system on 2/16/2023. Training for staff on operating the system was delivered during system commissioning.

Figure 1. Trane subcontractor wiring new lighting control relay panel.

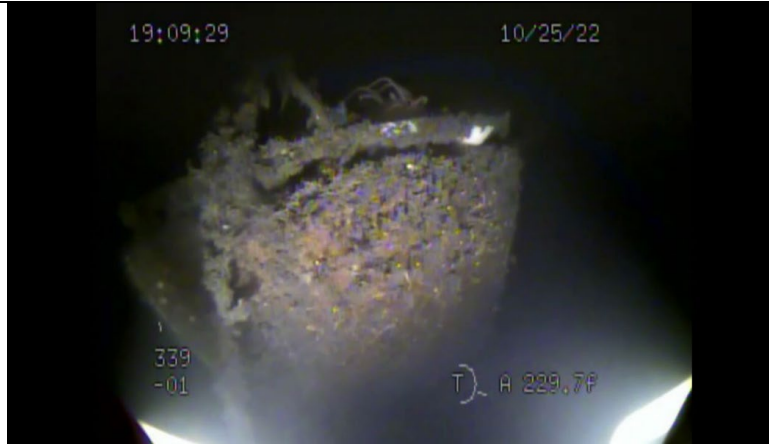
Global Diving & Salvage submitted their report for Phase 2 ROV surveys conducted 10/24/2022 and sub-bottom profiling conducted on 11/1/2022. The sub-bottom profiling survey of the seawater intake pipes determined their position and depth of burial. Global's subcontractor eTrac conducted the sub-bottom survey under the direct supervision of Global's Project Manager. All work was conducted on eTrac's research survey vessel, "Inverness" on 11/1/2022 and 11/2/2022. Global reported finding the East A Line intake and associated pig trap with the ROV. However, the B Line intake appears to be buried in at least 6 ft of silt. The Lowell Canyon diversion tunnel has created a plume of debris that is within 120 feet of B Line and is expected to continue encroaching on the line. These findings support the observed reduced flow from B Line into the intake well, and may help to explain the large gravel inflows into the intake wells. The sub-bottom survey seems to confirm the burial and also revealed the location of both pipelines where they are buried. After review of these findings, ASLC staff contacted PND Engineering for further advice on how to proceed. Global is proposing a follow-up survey in fall 2023 at an estimated cost of \$28,350. The follow-up survey is expected to reveal changes in burial depths and advancement rates, if any, of the Lowell Creek diversion plume.

Figure 2. Pig trap on "A Line" as viewed from Global ROV.

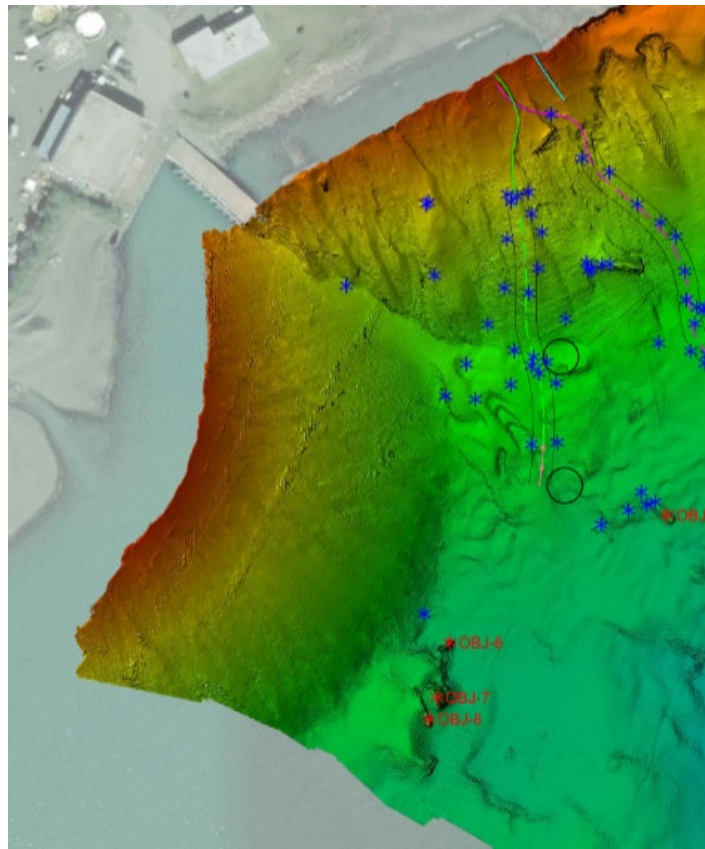
Figure 3. Global Diving sub service hits identifying buried B Line components, overlaid with bathymetric survey data.

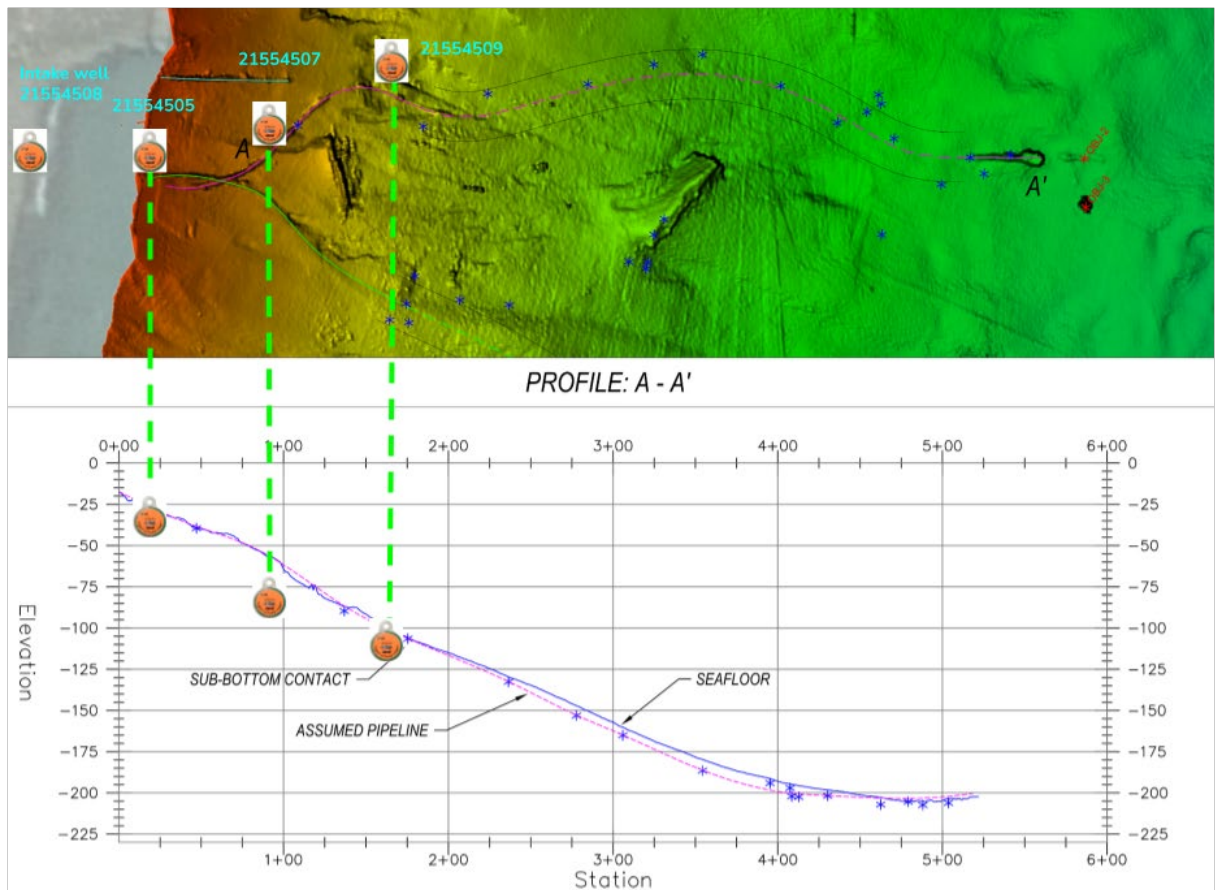
Doug Kenley, P.E. and Vice President PND Engineers Inc. was contacted and relayed the results of the Global intake survey. Mr. Kenley was involved in the original design and construction of the system and is uniquely familiar with the design. PND proposed to assess the conditions and make recommendations for improvements to the seawater intake lines and piping within the wet well. A site visit at low tide conditions was conducted to observe the wet well and a memo describing the findings associated with the site visit with a list of options for repair with corresponding relative construction costs, permitting requirements and a list of permits required was delivered. On 1/28/23 Jake Kopplow, PE, and Jackson Waters, EIT, performed a site investigation of the ASLC seawater intake system. A preliminary report was received outlining repair options on 2/10/2023 and is currently under review by ASLC management. In response to water temperature concerns raised during review of PND proposals ASLC determined that more information was required regarding thermoclines and temperature variations at various depths. Data loggers, required data collection apparatus and software were purchased from Onset HOBO. The study aims to determine the water temperature at depths of 100 feet, 65 feet, and 25 feet below MLLW near the ASLC Intakes over the course of a year and evaluate any patterns or trends in temperature change in support of Critical Water Projects Seawater Life Support systems work.

Figure 4. ASLC planned temperature study data logger locations and depths.

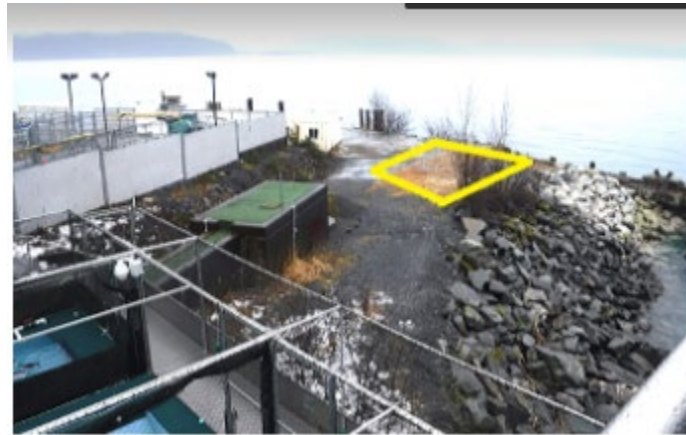
Investigations into intake well sediment removal revealed several factors adding costs and complexity not captured by original cleanout estimates. The first dive conducted by Global in October 2022 increased estimates to 30-40 cubic yards of material requiring removal. Global Diving and Salvage provided a cost estimate of \$59,445 but only provides for divers and their associated equipment and does not offer a performance guarantee and assumes ASLC will obtain necessary permits and construct silt containment. Containment and disposal of the silt and sediment will be required under current regulations and permits. The necessary structures and systems further complicate the process. ASLC operations staff and management are in the process of obtaining separate bids for the work and exploring alternative methods of sediment removal and mitigation.

Figure 5. Proposed location for a sedimentation pond related to well cleanout efforts.

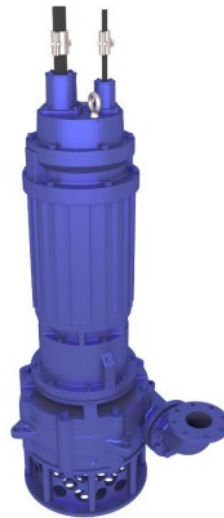
Effluent wastewater has been a problematic and constraining portion of the water supply system. In part this is due to the use of turbine pumps which are not designed for pumping large solids sometimes admitted into the waste wells. Solids handling pumps have been installed however these also have issues regarding priming and efficiency. To combat issues regarding priming, efficiency, and solids handling capabilities a submersible slurry pump was ordered from Beckwith & Kuffel. This model “GPM Eliminator” is designed specifically for abrasive solids and has a built in agitator system that will allow for operation in the sediment and silt present in the well. The expected ship date for this pump is 3/21/2023. This pump will be installed in place of LSS-09.

Figure 6. GPM Eliminator Slurry Pump.

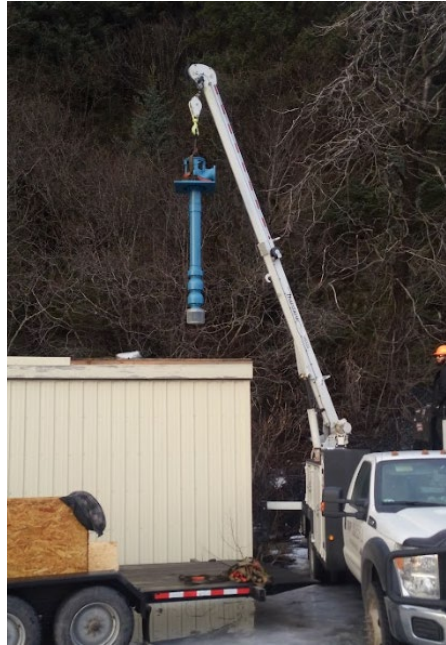
DXP Alaska Pump and Supply installed a new freshwater pump, restoring redundancy in a critical water supply on Wednesday 1/25.

Figure 7. DXP Installing new Goulds vertical turbine pump.

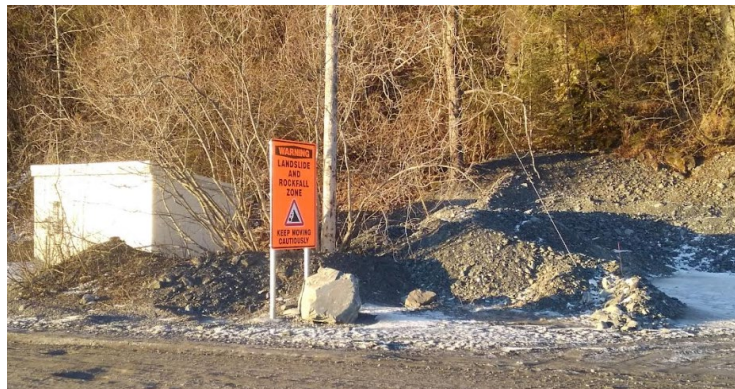
The US Army Corps of Engineers met in December 2022 and do not have a final decision on how they are going to improve the Lowell Canyon Tunnel. The preferred method is still to create a flume across the road out into the bay. This method would put outflow closer to our lines but it may change how the sediment is conveyed which will affect the ASLC B Line intake system. Due to the uncertainty of the direction of the Lowell Canyon Diversion tunnel ASLC is postponing a construction of a barrier wall. Additionally, the City of Seward has left a large mound of sediment and debris alongside the pumphouse and between the existing tunnel that will likely provide some relief against severe flooding should it occur in the interim. The City of Seward Public Works department was contacted and reports that there are no plans to move the gravel pile and additionally advises not to start any major site work until the Corps plan is finalized, remarking that adjustments to infrastructure in the general area may be required.

Figure 8. Freshwater Pumphouse and adjacent gravel berm on city property.
