Exxon Valdez Oil Spill
General Restoration Project Final Report

Kodiak Island Habitat Enhancement Project
Buskin River Watershed

Exxon Valdez Oil Spill Trustee Council Project 17170119
Final Report

April 2023

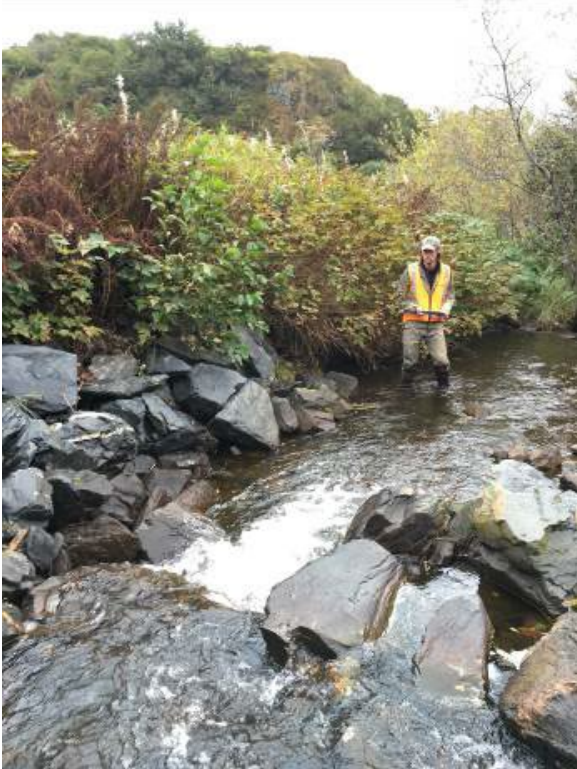
Figure 16. 20700785 - Failed Grade Control Downstream - Before Replacement

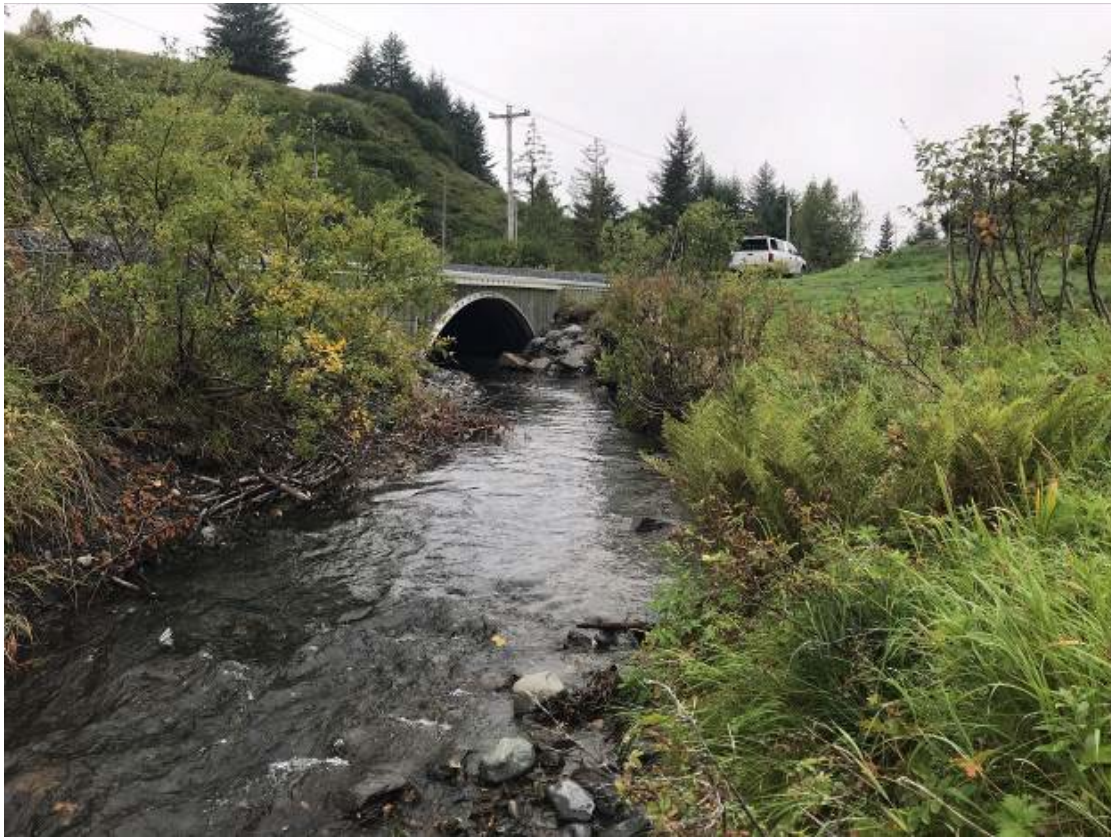
Figure 17. 20700785 After Replacement- Reconstructed Channel and Culvert - Downstream

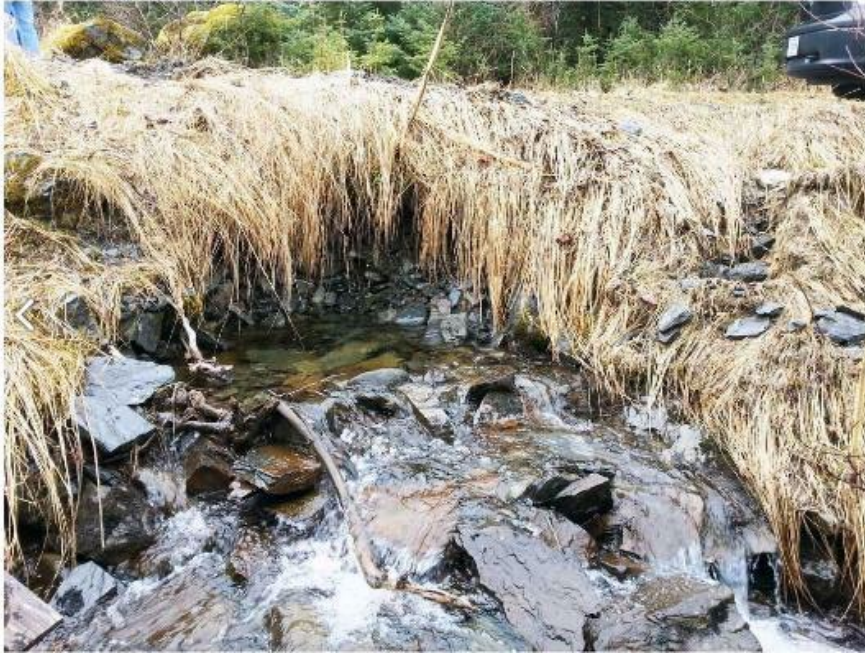
Figure 28. 20703439 – Before Removal (Culvert Buried in Gravel)

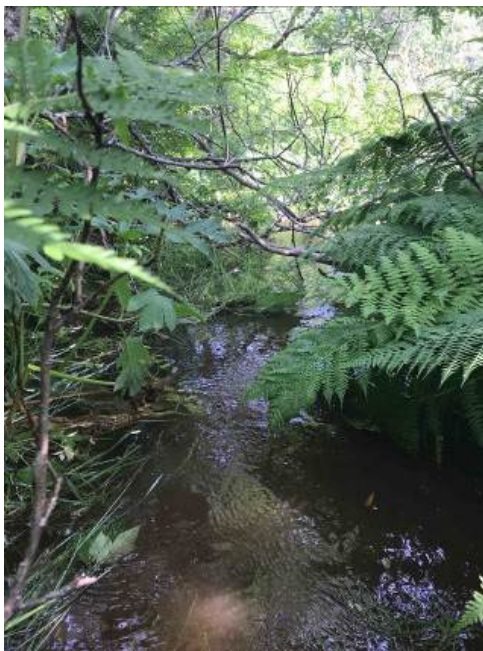
Figure 39. Historical Channel Reconnected Downstream of 10103248 (20703248)
