**Exxon Valdez Oil Spill Trustee Council**  
**General Restoration, Habitat Enhancement, Habitat Protection, and Facilities Projects**  
**Quarterly Project Reporting Form**

**Project Number:** 21210131 (Includes 21210131)

**Project Title:** Alaska SeaLife Center Facilities Project \$2,000,000/\$500,000

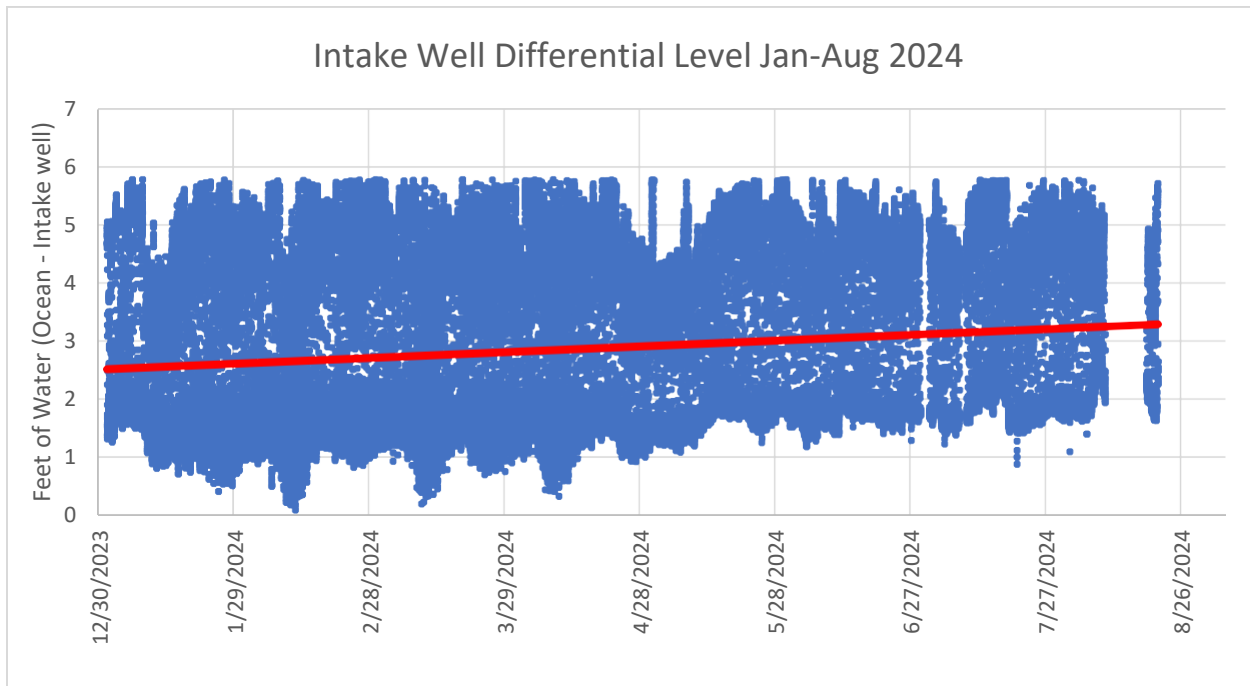
PND Engineering continues to provide technical advice and bid drawings for still needed intake line inspections. Recently ASLC staff has been observing increasing differential pressures on the intake line likely due to fouling of the intake structure and pipes. Operations staff has at times needed to reduce seawater flows significantly during low tide events to maintain minimum intake well levels. PND Engineering and American Marine have been advised of these issues and are developing plans to inspect and clean the intake systems using remote operated vehicles. Due to the depth of the structures, it is anticipated that ROVs can perform more work more frequently than divers working at depths greater than two hundred feet. ASLC is currently waiting on a proposal from AMI for this work to be performed.

Figure 1. A plot of the difference in levels observed locally at NOAA Tide Station 9455090 Seward and as recorded from ASLC intake well reveals a steadily increasing upward trend. Differential levels indicate flow restrictions present in the seawater intake lines are becoming more significant.

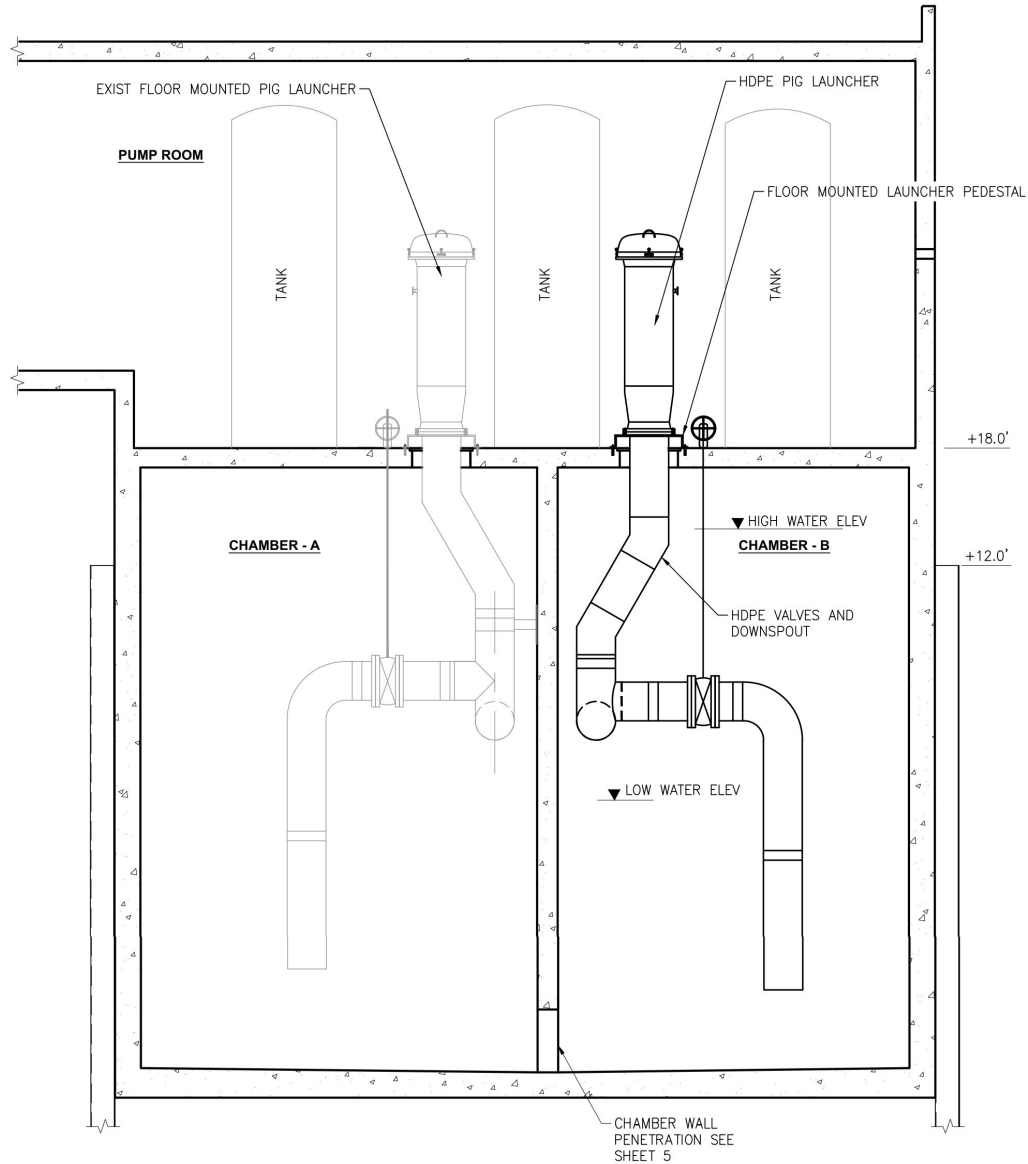
Figure 2. Complete siphon repair and pig launching system as originally proposed by PND 11/13/2023. This plan would be an ideal end product however significant work on the intake pipes for both lines is needed before this plan could be practical. ASLC is directing PND to assist with ocean side intake line work first.

PND Engineers completed design work on a replacement siphon and pig launching system for the west intake line. They began work soliciting cost estimates, however due to the deteriorating conditions with the east intake system ASLC directed PND to develop a less costly and easier to install replacement for the siphon only that could be accomplished within months at significantly less cost and disruption to the system. The requirement for this design was to allow for future modifications to accommodate a pig launcher when time and budget allows. AMI is developing a plan and cost estimate for the siphon repairs.

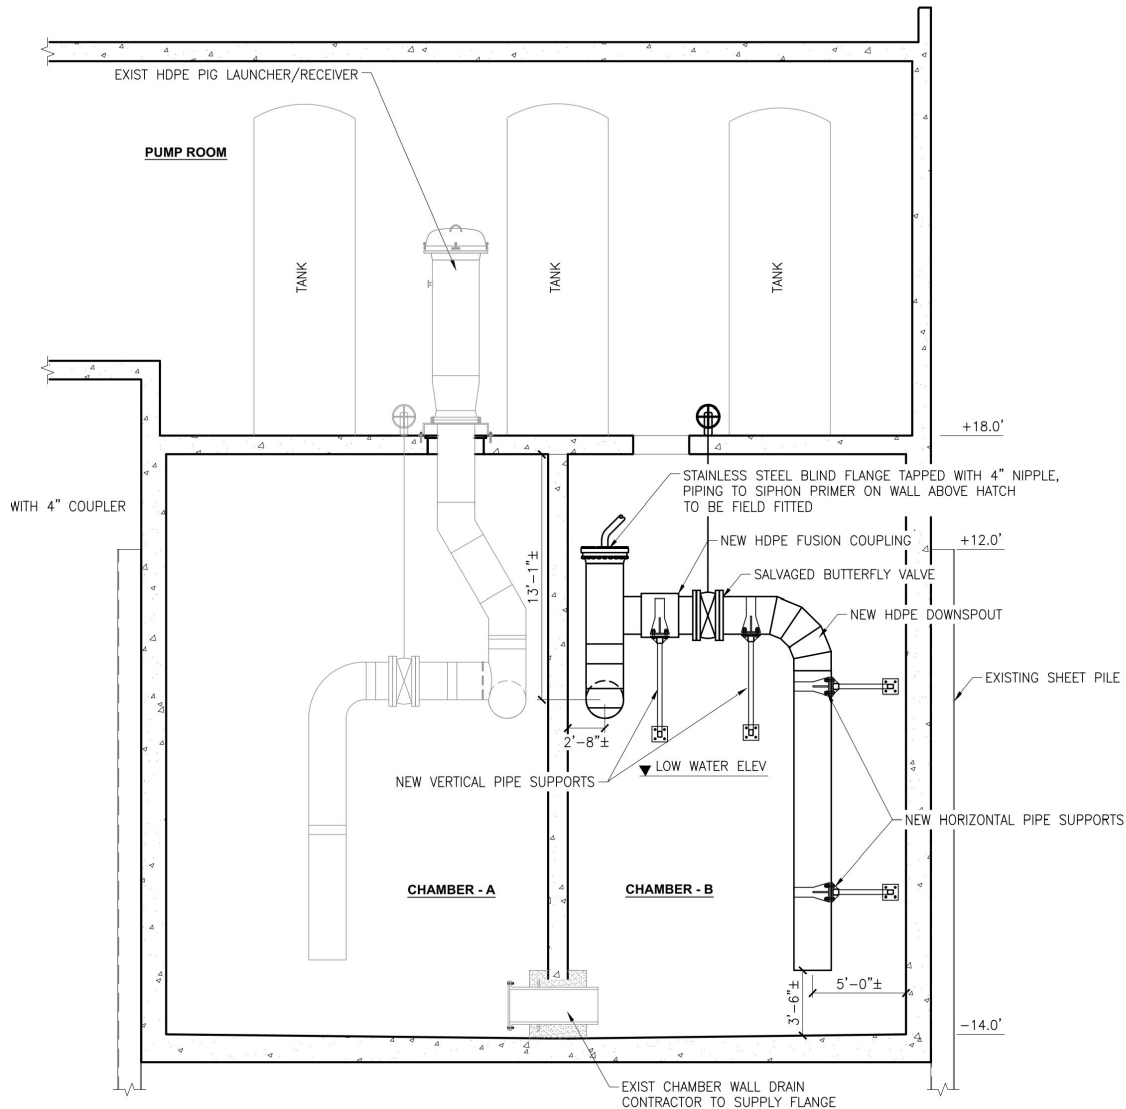
Figure 3. Revised intake well siphon repair plan per ASLC request for timelier and budget conscious repair efforts.

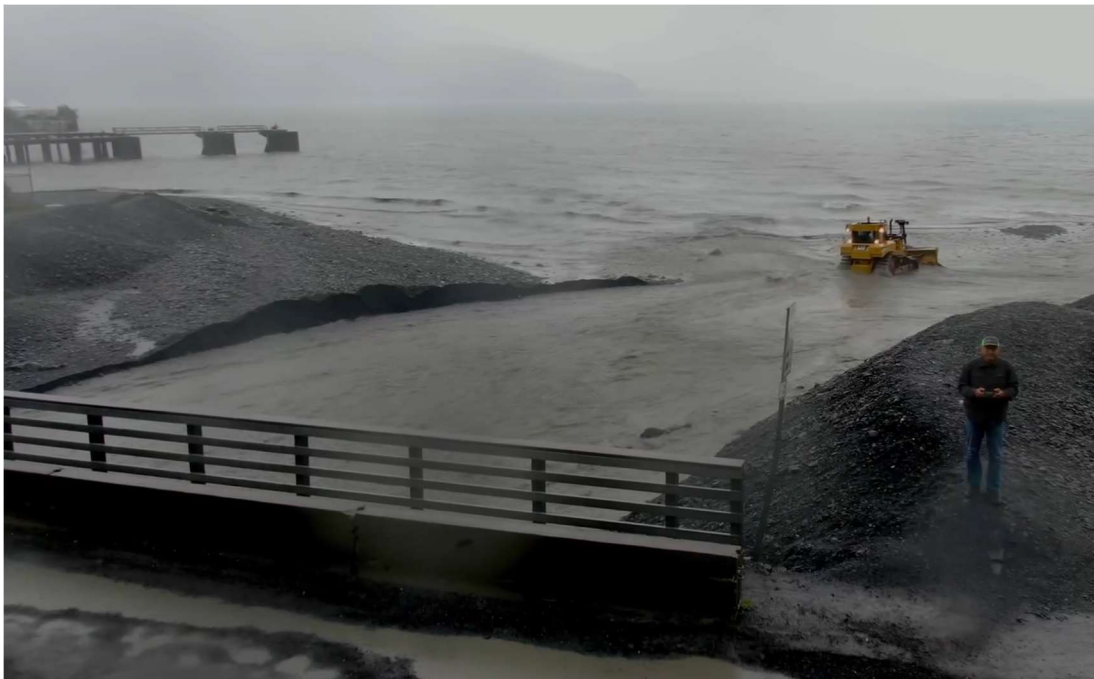
ASLC continues to monitor USACE plans for the Lowell tunnel diversion. Recent flood events while also causing a serious silting event in the aquarium also serve to underscore the need for a pump house barrier if USACE plans do not progress forward. Currently a large debris and rubble mound created by the city serves as a defacto barrier for the pumphouse and according to the public works director there are no immediate plans to move the mound.

Image 1. City and contractor crews work to push sediment into the bay to prevent Lowell Creek waters from overtaking Lowell Point Rd bridge.

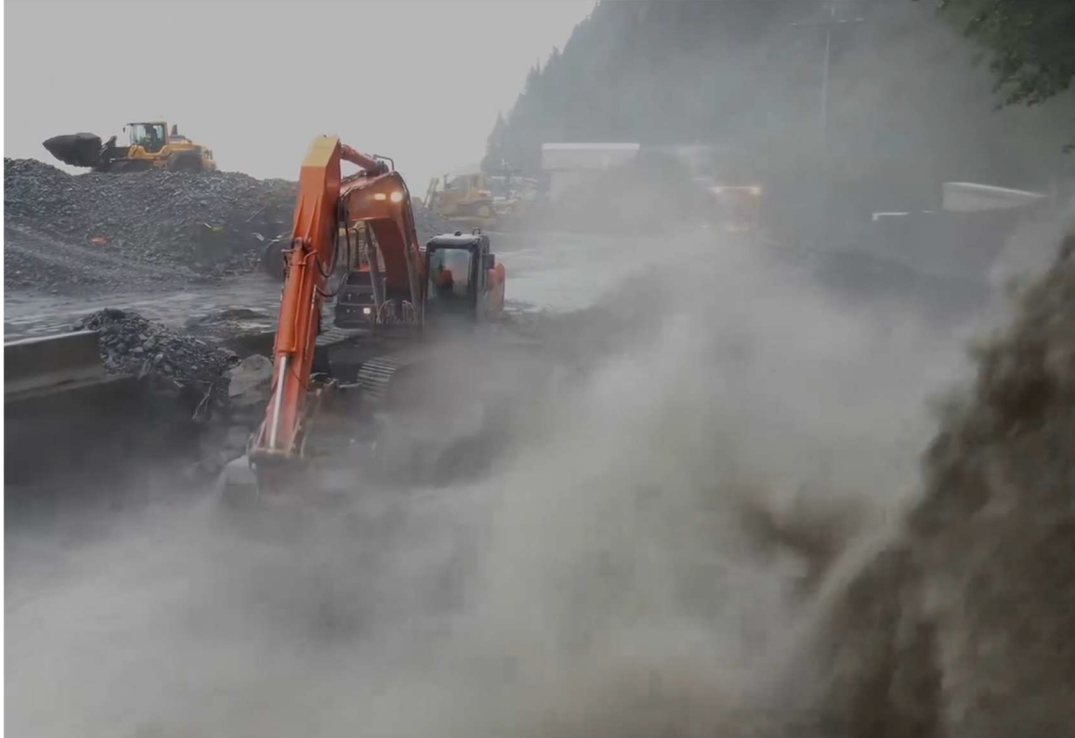
In addition to the flow restrictions from marine fouling a significant rain event around August 6-8 causes significant silting because of Lowell tunnel flows. At this time an undetermined amount of silt was ingested into the seawater intake wells. ASLC staff will use the next AMI visit to survey the well and determine precisely how much sediment accumulation can be expected from these events since the well was recently cleaned. For at least one day the public aquarium water quality was so poor that a 50% discount was given to guests as accommodation. Large amounts of silt were deposited in habitats requiring additional cleaning dives by ASLC staff. These impacts were noted and will weigh in on future design efforts with PND Engineering.

Image 2. An excavator removes sediment from the Lowell tunnel outfall directly adjacent to the ASLC fresh water pumphouse August 8, 2024. Photo credit James Unrein.
