Exxon Valdez Oil Spill Trustee Council
General Restoration, Habitat Enhancement, Habitat Protection, and Facilities Projects
Quarterly Project Reporting Form

Project Number: 21210131 (Includes 21210131)

Project Title: Alaska SeaLife Center Facilities Project \$2,000,000/\$500,000

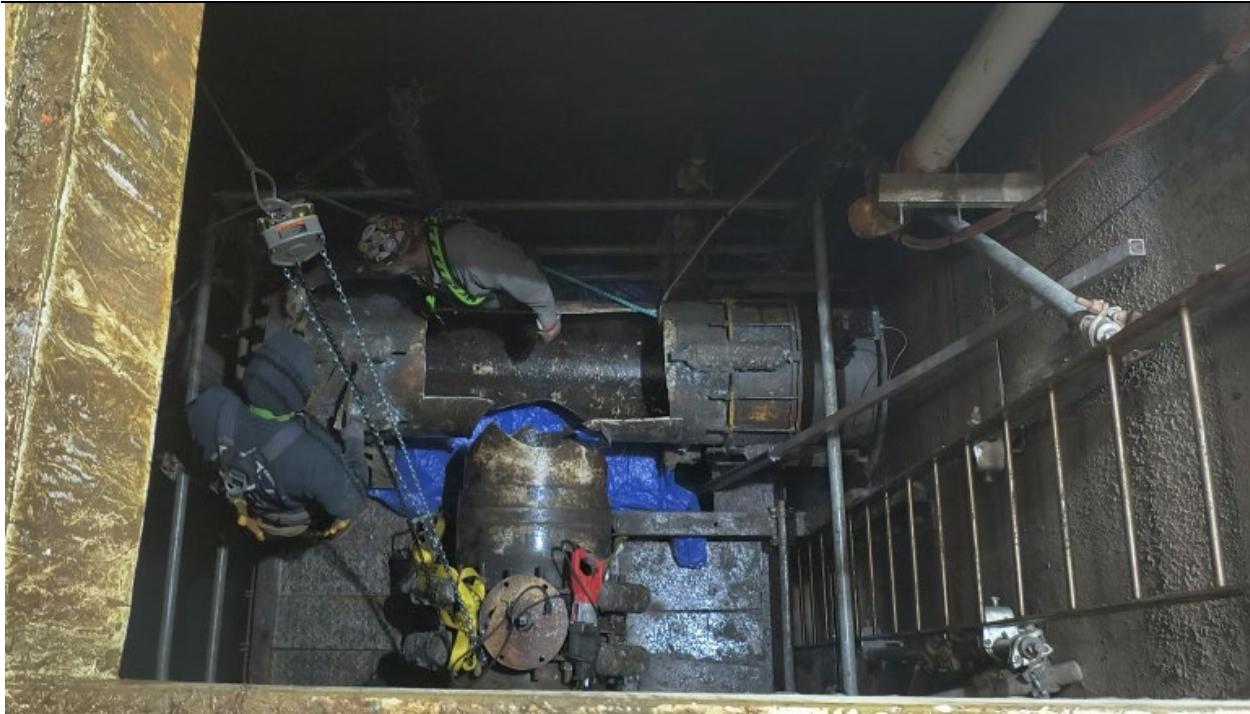
Image. AMI crew in process of removing damaged pipe to be replaced.

Initial work inside the wetwell involved diving and demolition of existing and faulty pipe. A scaffold platform was installed at approximately 15-foot elevation inside the well to eliminate the need for further diving operations during construction. ASLC Project Manager developed a cross over flange and manifold with an isolation valve that was installed to allow for continued use of Chamber B during construction. Prior plans called for isolating the well completely however this would limit pump options for the life support crew, and allowing water to stagnate could potentially cause water quality issues that were then avoided by utilizing the cross over.

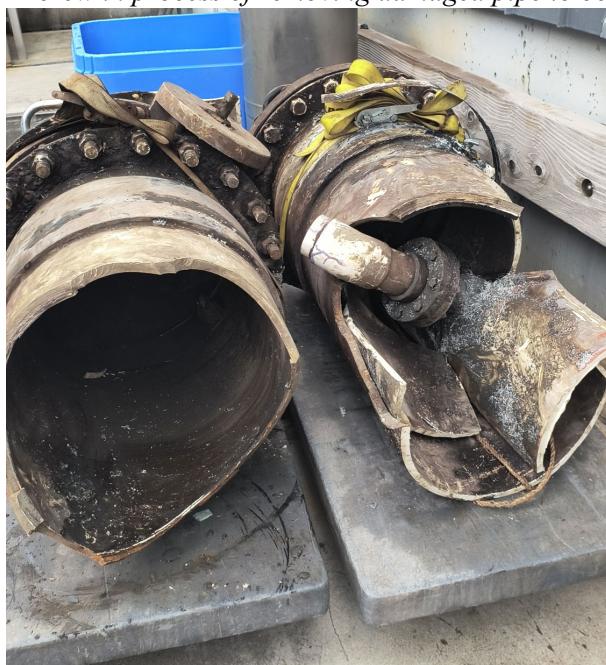
Image. Broken 24" PVC pieces that resulted in the functional loss of one intake line, ready for disposal.

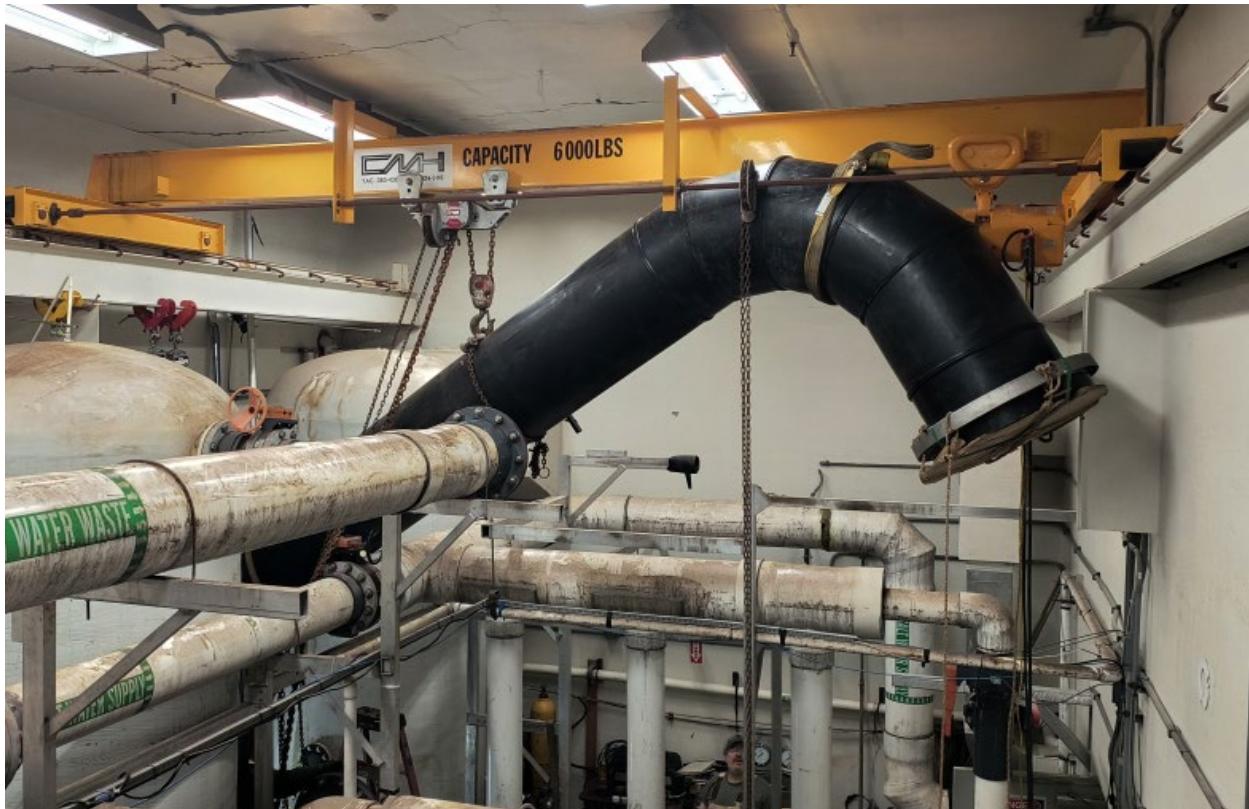
Despite careful calculations from PND engineers, the new siphon pipe would not fit as constructed. American Marine was forced to demobilize on September 12 after completion of all demolition work, preparation work on the incoming line stub, and the attempt to install the new pipe. An additional mechanical coupling was ordered with the plan to segment the siphon pipe allowing for easier installation.

Image. Siphon downcomer section proved to be slightly too large to install into well, requiring an additional couple be used to complete installation.

American Marine resumed construction December 7 and successfully moved all new pipe into the intake well and began installing brackets. An additional demobilization was decided on effective December 15 due to a longer anticipated cure time for epoxy resin used in anchor bolts. The crew will re-convene after the new year to complete the installation.

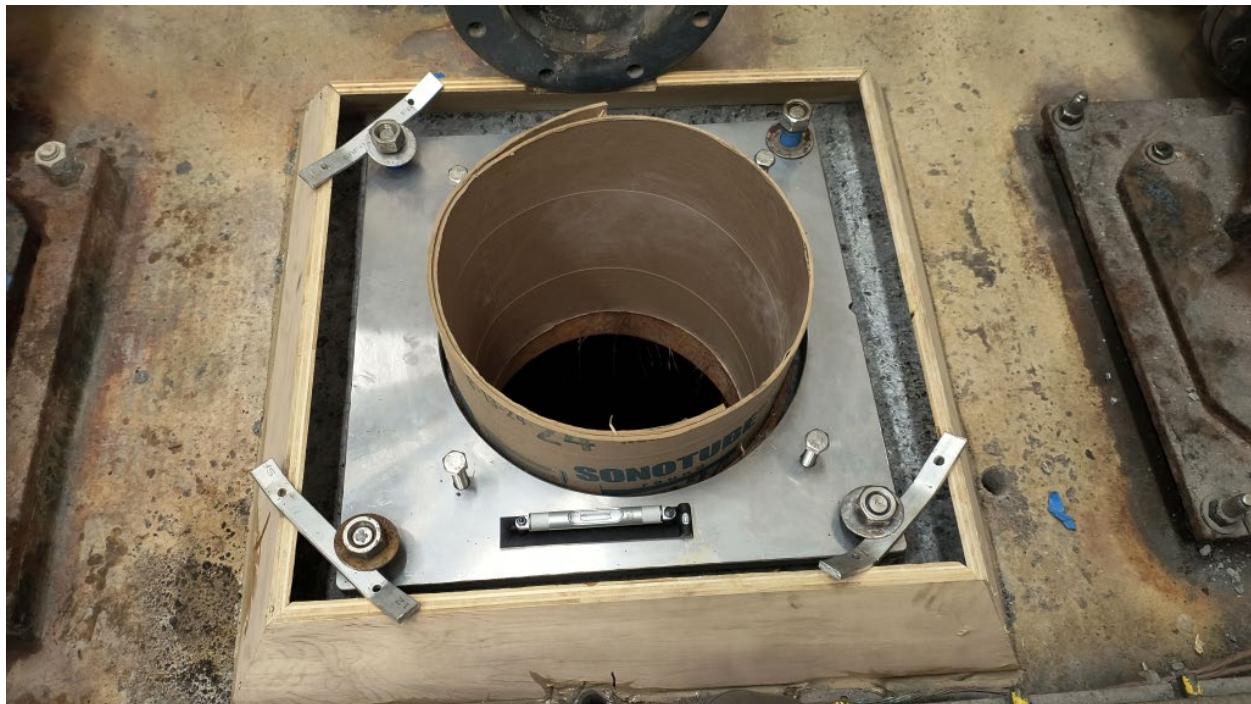
The operations crew has made significant gains keeping critical seawater pumps operating but has also suffered additional pump failures and needed machine shop assistance from GLM Energy. GLM was able to provide additional assessments to identify issues including vibration, corrosion, and electrical problems. In this process an additional discovery was made by ASLC that the pump bases from original construction were not level, and had not been installed to original plans. ASLC revised plans based on updated standards and contracted with DAMA industrial to repair two pump bases. The process involved procuring replacement plates cut by Catalyst Marine, final finishing by GLM Energy to specified flatness, grouting by DAMA, and final leveling and positioning by ASLC.

Image. Pump base for LSS-2 is checked and adjusted for level to API specifications for pump bases prior to grouting by DAMA Industrial.
