Exxon Valdez Oil Spill Trustee Council
General Restoration, Habitat Enhancement, Habitat Protection, and Facilities Projects
Quarterly Project Reporting Form

Project Number: 21210131 (Includes 21210131)

Project Title: Alaska SeaLife Center Facilities Project \$2,000,000/\$500,000

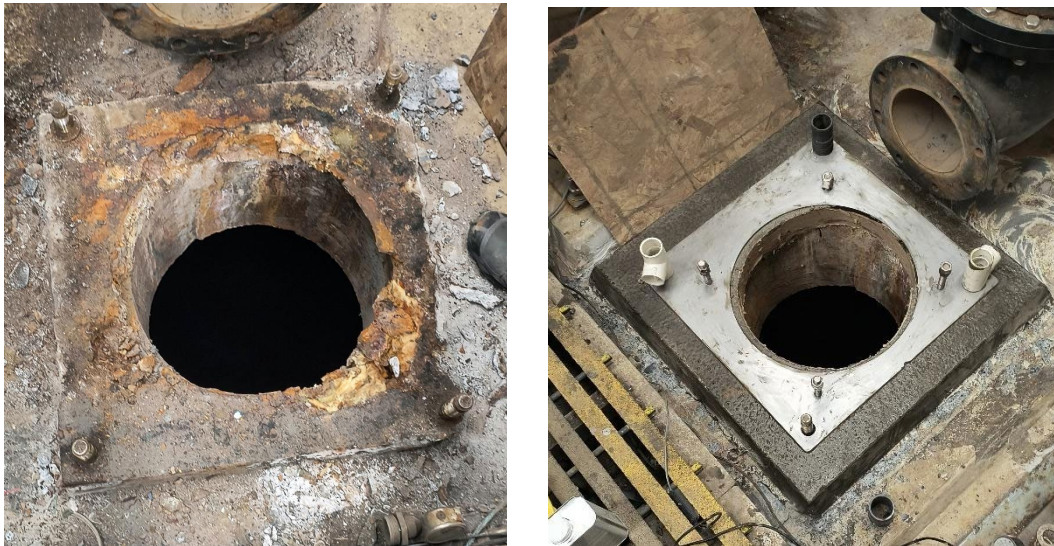
Foundation repair work to pump bases and concrete repairs for wastewater collection drains were required. DAMA Industrial performed these tasks. One pump base still requires epoxy grout repairs. The repairs to the pump bases greatly reduce vibration and bearing wear on the vertical turbine pumps leading to an extended time between overhauls and improved system efficiency.

Image 1. Condition of grout after removal of bedplate shown (left) and after replacement bedplate installed and precision leveled in new grout (right).

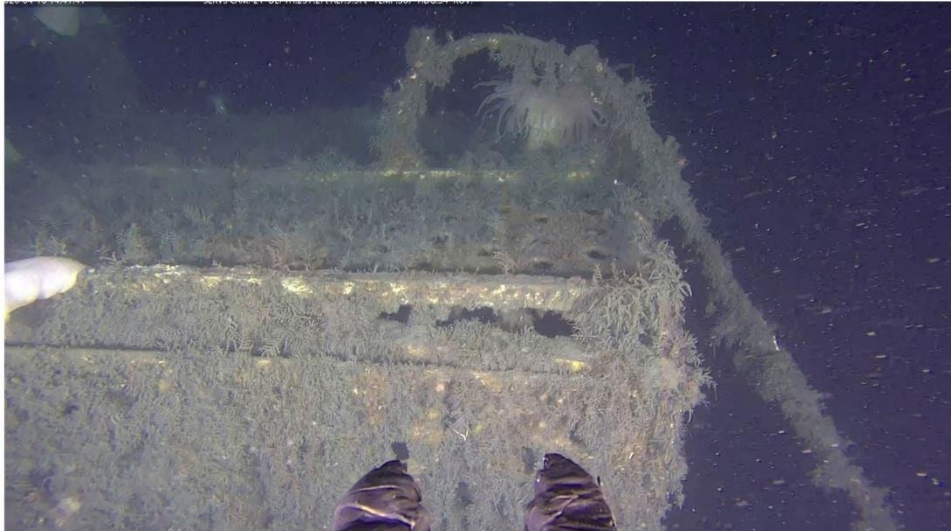
Global Diving provided updated imagery of Intake Line A “Pig Trap” from an ROV while they were conducting other work in the area. The imagery and video show the trap is partially opened, heavily fouled, and from the video, water infiltration appears to be less than anticipated under normal operating conditions.

Image 2. ASLC A Line “Pig Trap” on intake, courtesy Global Diving & Salvage, Inc. 5/7/2026

ASLC intends to continue intake line work and inspections including updating bathymetry to survey possible undersea advancement of the Lowell Tunnel sediment plume and plan for possible cleanout efforts on A Line.

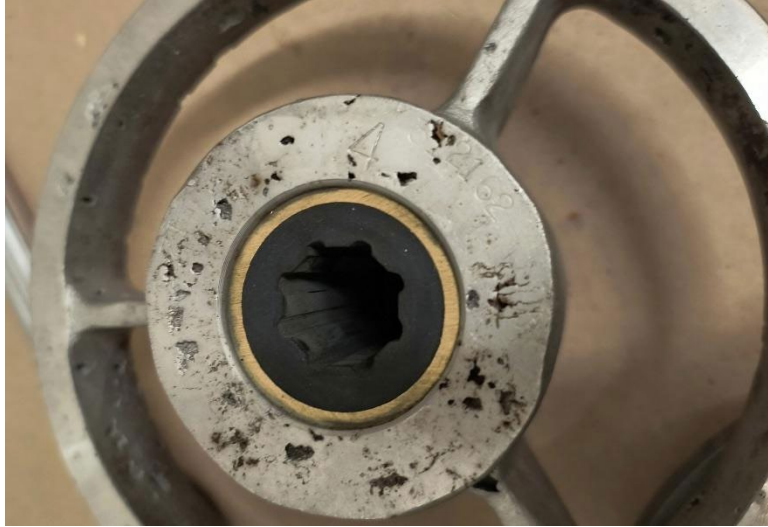
GLM Energy completed repairs to the LSS-3 supply pump, and reinstalled the pump on the renewed bedplate. The pump is running smoothly and supplying good pressure, however it is worth noting the castings are eroded to the point where another rebuild may not be possible. ASLC is working with GLM energy on plans to construct replacements for the worn out cast components. This pump was reinstalled with a new electric motor. The motor that was removed was sent to Superior Electric for inspection and renewal.

Image 3. LSS-3 line shaft bearings replaced, but with notable pitting and corrosion on metal.
