Exxon Valdez Oil Spill
Restoration Project Final Report

**In Stream Habitat and Stock Restoration for Salmon
Otter Creek Barrier Bypass Subproject**

**Restoration Project 94139-B1
Final Report**

United States Department of Agriculture
Forest Service

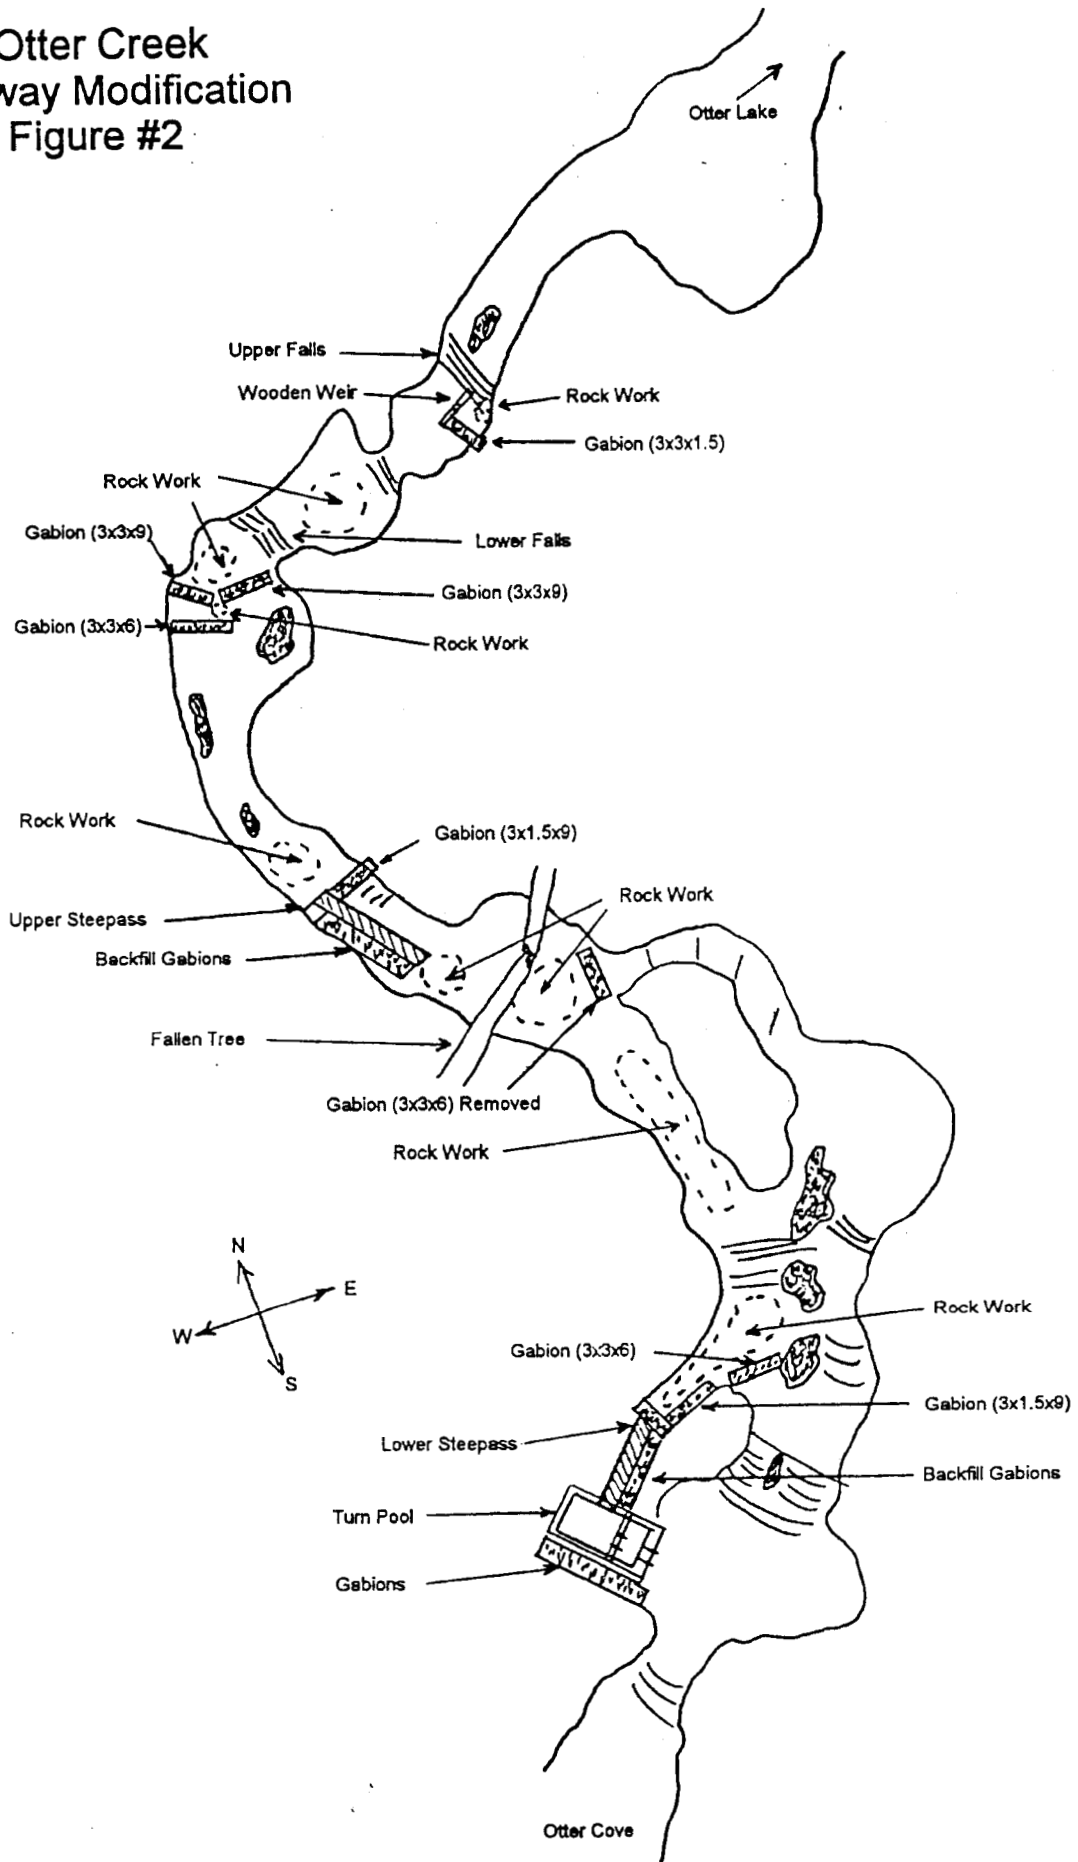
Otter Creek Fishway Modification Figure #2

Forest Service monitoring of this fishway indicated that both pink and coho salmon successfully negotiated both steeppasses. Coho were successfully proceeding upstream by jumping two small falls (Figure #2) above the steeppasses. Pink salmon were blocked from further upstream movement by the first small falls located about 100 feet above the upper steeppass. The other small falls, located about 150 feet above the upper steeppass, was determined to be a likely barrier to pink salmon. Each of these falls is approximately five feet high. It was also likely, though not observed, that these two small falls would be a partial barrier to anadromous cutthroat trout and Dolly Varden, limiting some upstream migrations of these species. The Forest Service conducted temporary experimental modifications to these barriers by creating pools during the 1993 field season. This work established that adequate jump pools at the base of these barriers would allow pink salmon access over the falls. Also during 1993, approximately 500 pink salmon were dip netted over the barriers to monitor upstream migration. The stream reaches above the barriers, the lake and the inlet streams to the lake were surveyed to determine if these pink salmon were dispersing upstream of the barriers. Thirty pink salmon were counted in the stream leading to the lake and 20 at the inlet streams to the lake, some fish were noted to be engaged in redd building activity. This provided enough information to suggest that pink salmon would utilize spawning habitat above the barriers if they could access that habitat.

Figure 2. Locator map showing Otter Creek fish pass modifications. Otter Creek is located on the northeast end of Knight Island, and it flows into the Bay of Isles.

Upper Falls. A jump pool was constructed at the base of the upper falls (Figure #2) by installing a 9 foot()long by 3' wide by 11/2' high (9'x3'x1.5') gabion parallel to and 5' downstream of the falls. The old gabion that was previously in this location had to be removed to allow the new one to be repositioned to accommodate the addition of a wooden weir. The gabion was anchored in the stream channel by 17/8 inch (") galvanized pipes drilled and mortared into the bedrock. To enclose the pool, a wooden weir (Figure #3) constructed of two pressure treated 8 inch x 8 inch (8"x8") boards capped with pressure treated 2"x6" boards was installed. A "V" shaped notch was cut in the center to allow fish a direct passageway into the pool. The notch was cut approximately 12" wide and 7" deep. The 8'x8's were pinned together with 3/8" rebar and the base of the weir was grouted with an underwater epoxy mortar. A rock drill was used to chip away an area of bedrock, 16"x24" from the face of the upper falls to improve the jump pool.

Lower Falls. Two 9'x3'x3' gabions were removed and then reinstalled at the lower falls in a slightly different configuration. The gabions were anchored in the same manner as the gabion at the Upper Falls, (Figure #2 & #3). Approximately 12" of loose rock was removed from the bottom of the pool. A new 6'x3'x3' gabion anchored by a 17/8" galvanized pipe drilled and mortared into bedrock was installed immediately downstream of the primary jump pool at these falls. Approximately 12" of loose rock was removed from the bottom of this intermediate step pool and 10" of bedrock was drilled out.

Upper Falls. A jump-pool that is 5' by 6.5' averaging 2.5' in depth during moderate stream flows was created. There is a vertical jump height of 12" from the pool over the falls during moderate stream flows. The "V" shaped notch that was cut in the wooden weir will allow fish direct passageway into the pool with a vertical jump of 14" from a downstream pool into the notched passageway. This pool allows pink salmon improved passage over the falls at all but extreme low and high flows.

Lower Falls. A larger 9'x10' jump pool was created at the base of this five foot falls to reduce the vertical jump to 12" during moderate stream flows. The new gabion placement reduces the outlet to a 10" wide slot with a higher control point. This has the effect of raising the elevation of the pool and reduces the jump height. This provides an average pool depth of 3 feet. At moderate flows, water will slightly overtop the gabions. The 6'x3'x3' gabion forms a second jump pool immediately downstream of the primary (double gabion) jump-pool. This step-pool was required since the control point of the primary pool was raised. This provides pink salmon easier access into the primary jump pool's outlet by shortening the vertical jump height to 12" and reducing water velocity at the outlet. The step pool is 5'x7' with an average depth of 2 feet.

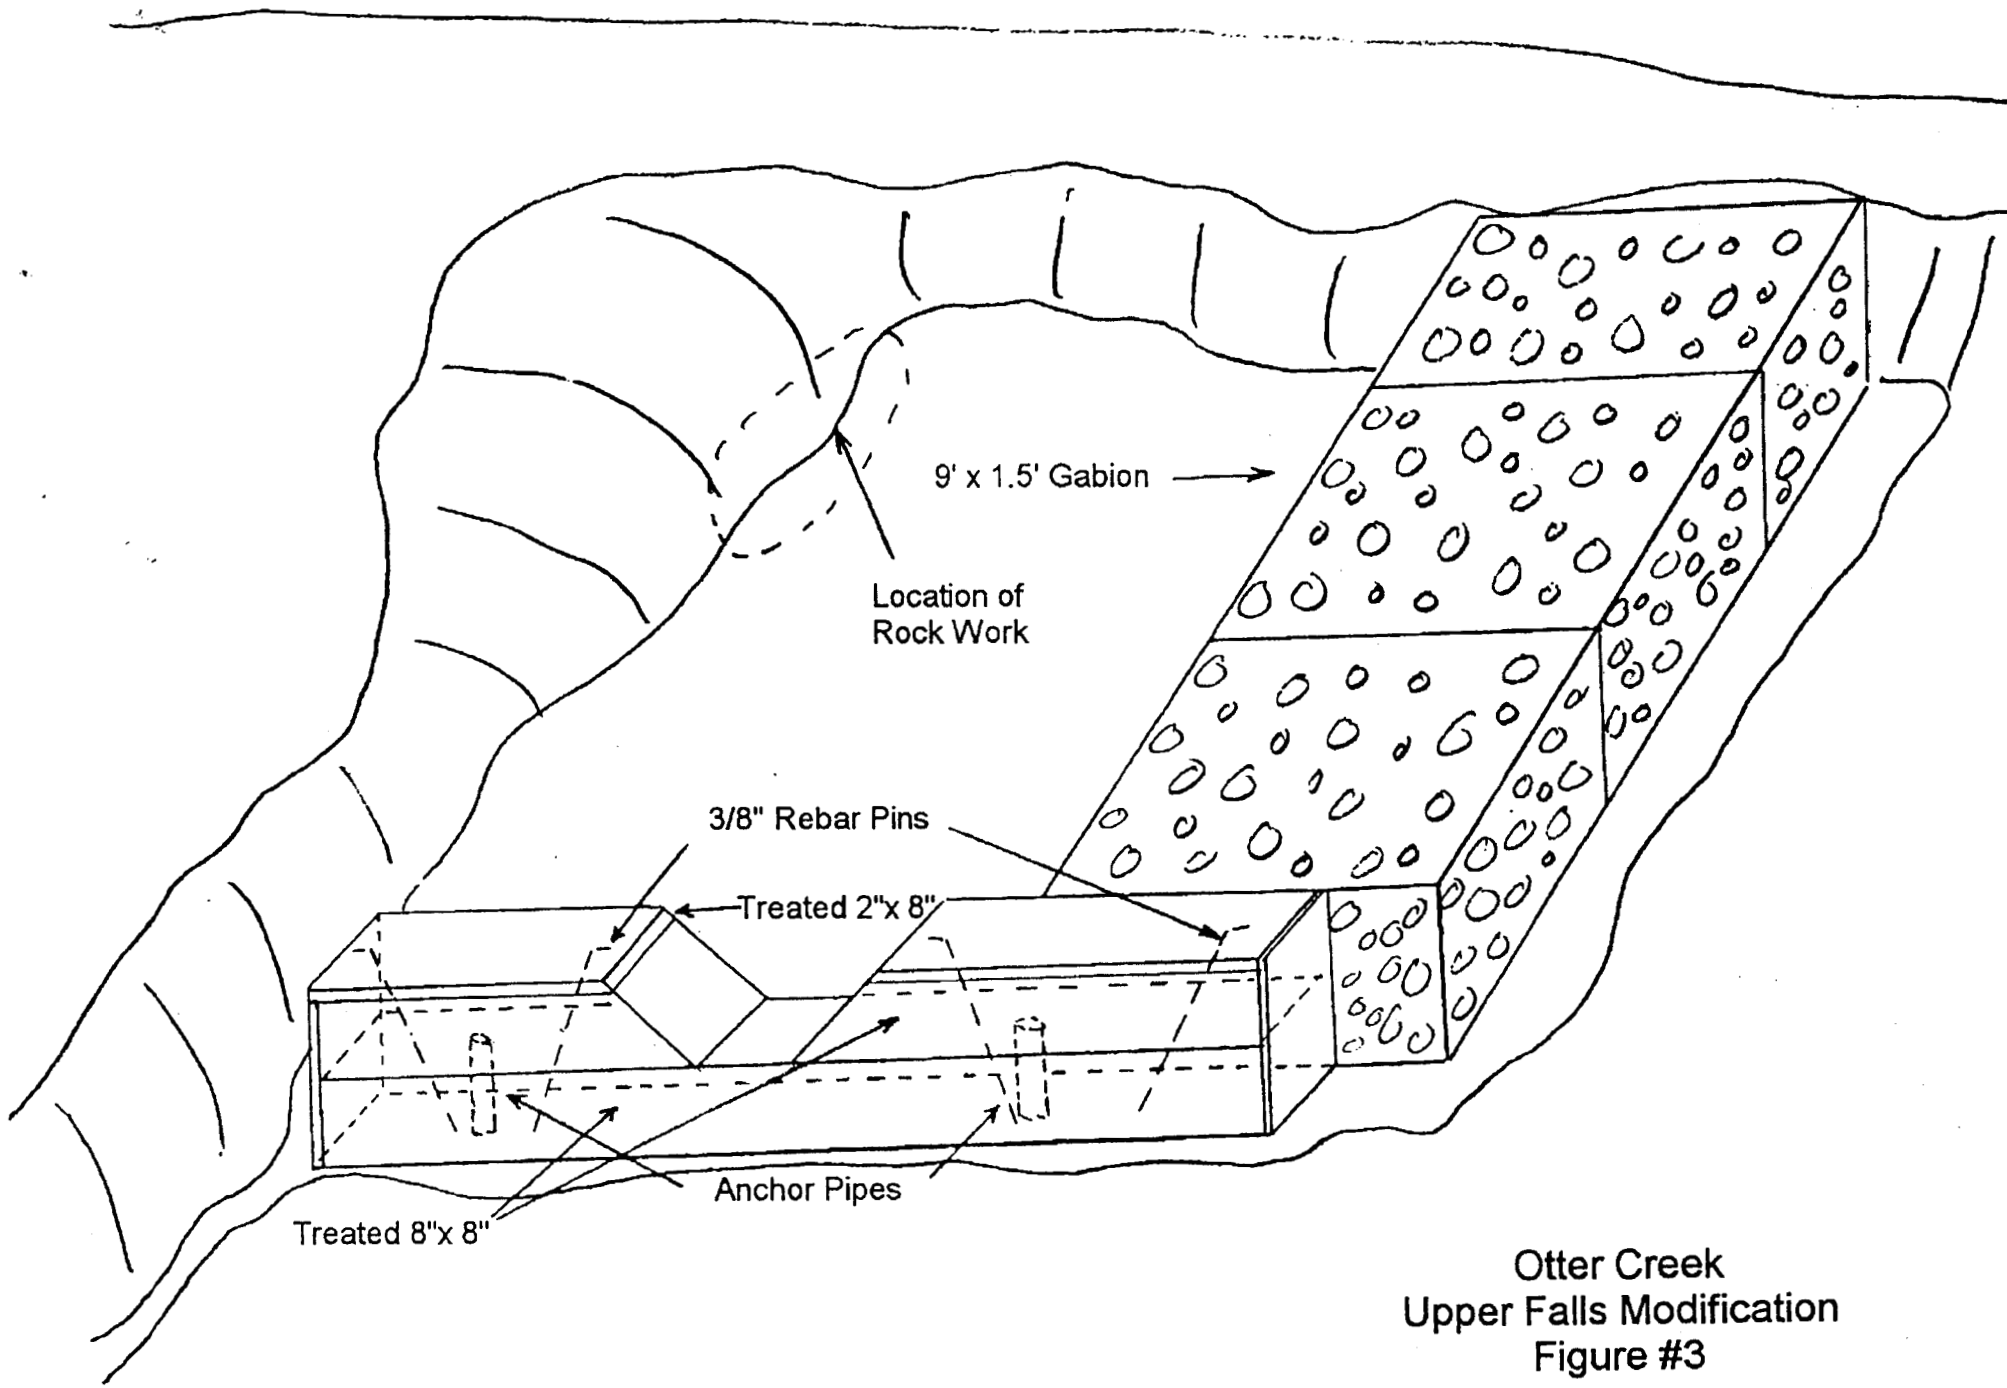
Otter Creek
Upper Falls Modification
Figure #3

Figure 3. Detail drawing of the modifications made at the upper falls on Otter Creek. Otter Creek is located on the northeast end of Knight Island, and it flows into the Bay of Isles.

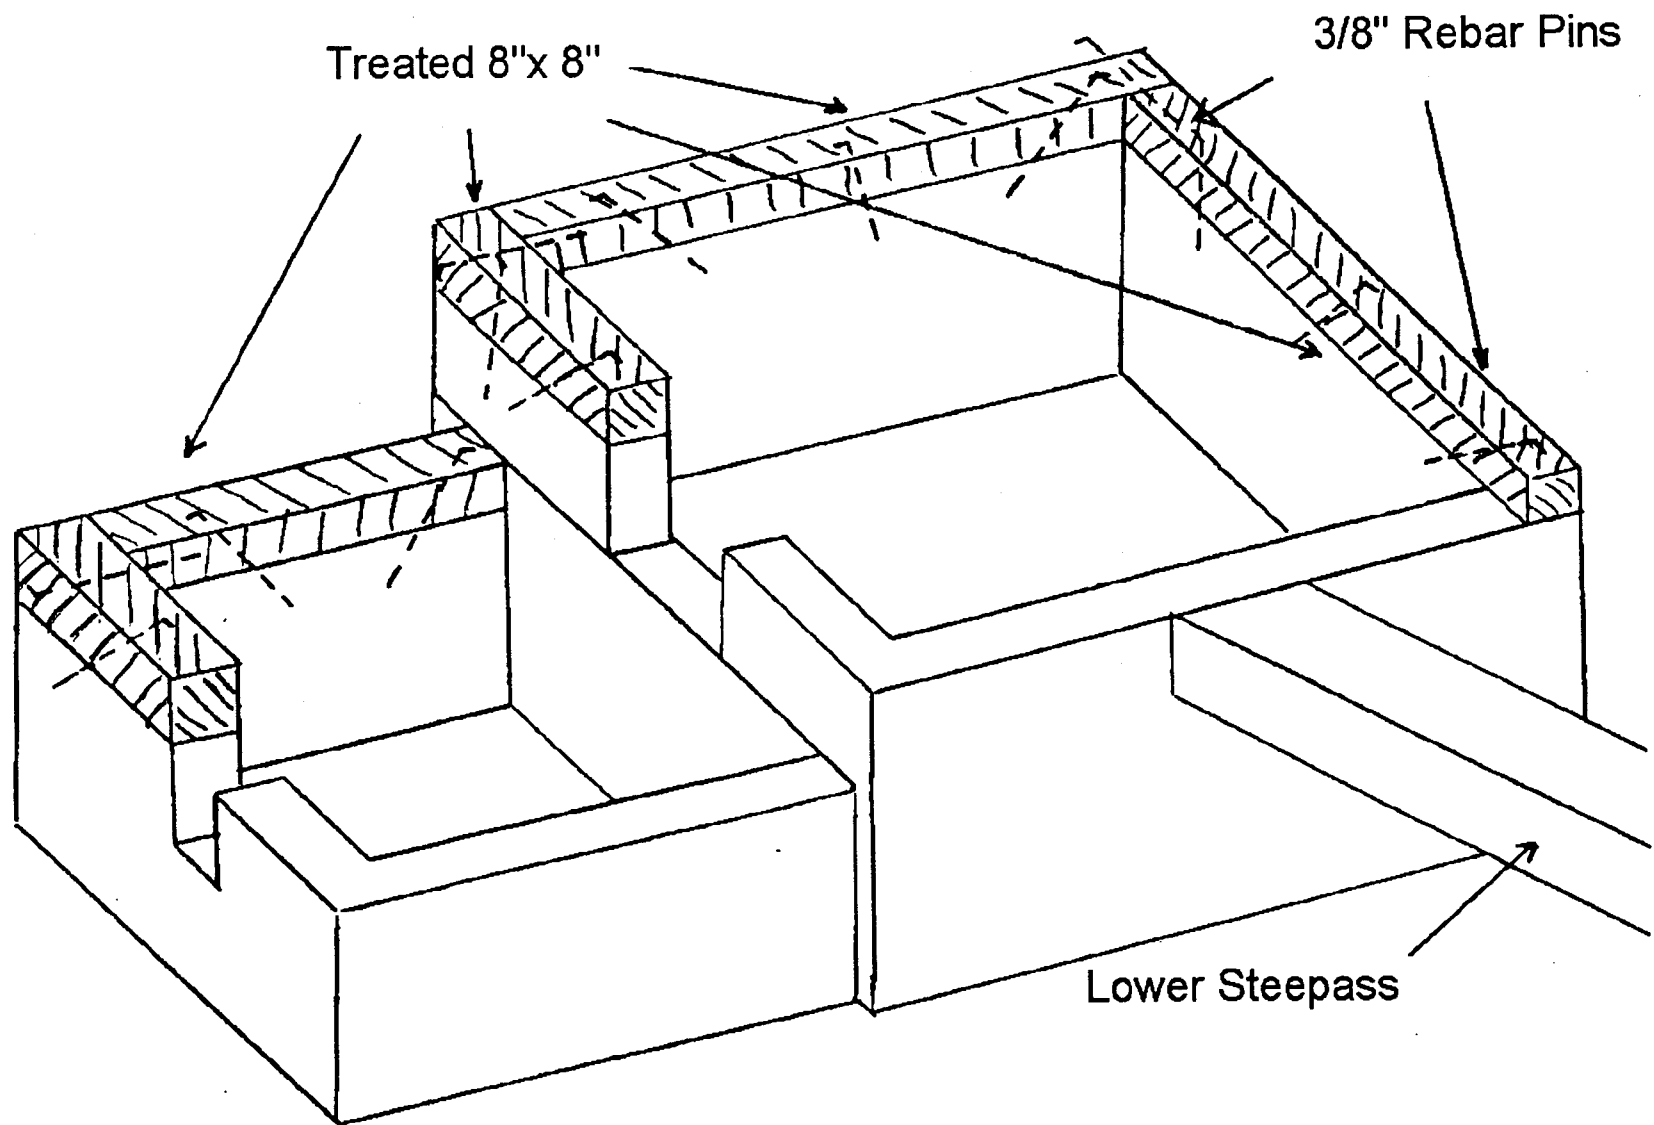
Otter Creek
Turning Pool Modification
Figure #4

Figure 4. Details of modifications made on the turning pool in Otter Creek. Otter Creek is located on the northeast end of Knight Island in Prince William Sound, and it flows into the Bay of Isles.

Lower Steeppass and Turning Pools. Two gabions, 6'x3'x3' and 3'x3'x1.5', in the resting-pool above the steeppass were replaced. Removal of several large boulders and loose rock further improved the resting pool. The steeppass was found to be in good condition. The plywood covers were removed and not replaced to facilitate future maintenance as was done with the covers to the upper steeppass. The baffles of the steeppass were cleaned of debris. The backfill gabions were in fair condition, minor wire repairs and repacking with rock were made to the backfill gabions along the sides of the steeppass. The turning pools at the entrance to the steeppass were in good condition. The elevation of the walls on the downstream sides of the turning pools were raised 8" by adding pressure treated 8"x8" boards (Figure #4). Rock debris from the entire fishway was removed to improve holding water and jump-pools.

Lower Steeppass. The work in the pool above the steeppass resulted in an average pool depth of 3 feet. It is expected that these repairs will last approximately three years after which complete replacement may be needed. The higher walls added to the turning pools will act to restrain fish within the pool from injuring themselves by jumping over the former lower walls of the pools and bouncing on the bedrock outcrops below the pool. The upstream side of the turning pool was left low to allow fish to re-enter the pool if they came back out of the steeppass, or were washed down at high flows.
