Exxon Valdez Oil Spill Trustee Council
General Restoration, Habitat Enhancement, Habitat Protection, and Facilities Projects
Quarterly Project Reporting Form

Project Number: 21210131 (Includes 21210131)

Project Title: Alaska SeaLife Center Facilities Project \$2,000,000/\$500,000

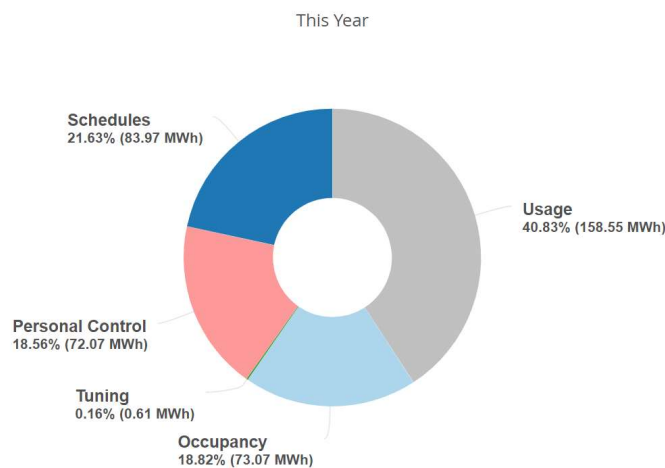
The Lutron lighting control system continues to perform well with minor issues easily handled by ASLC staff. No expenses were associated with the lighting controls for this period, however, it is worth noting that the system continues to provide savings that were not present or difficult to achieve before installation. Specifically, the occupancy sensors that did not work before installation have saved a reported 73 MWh, and “Personal Control” or switches, that did not work prior, saved an additional 72MWh.

Figure 1. Lutron system energy savings based on control methods, shown for Jan to May 2024

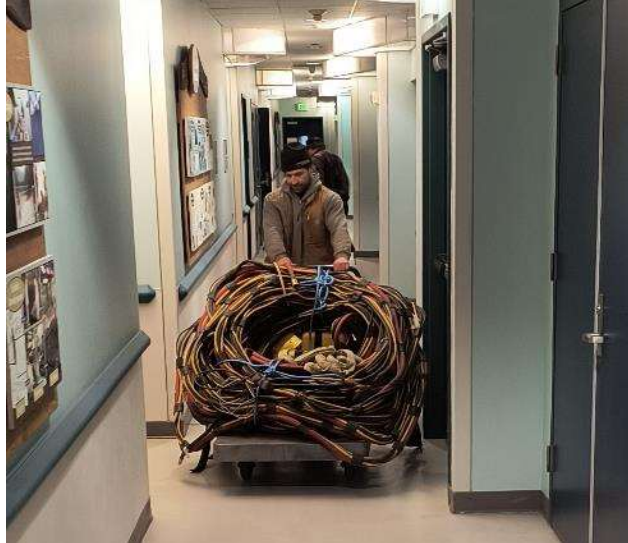
Image 1. American Marine divers transport equipment through ASLC research corridor to ASLC intake well.

Intake well dredging was conducted by American Marine Inc from April 23 through April 25. Site prep was conducted on April 22 which included staging of dive equipment, running hydraulic and water hoses, positioning pumps, trailers, and sediment control bags. Hydraulic submersible pumps were used in the intake wells backed up by a diesel-powered pump outside the building. Dredged spoils were pumped into containment bags and the material remains onsite awaiting disposal. Several bolts were ingested into the pumps causing significant damage and slowdowns however AMI had backup pumps and enough personnel to handle these slowdowns without a major impact on dredge operations. A total of 3 containment bags were filled with one failing early in the process. One containment bag is technically capable of holding the entirety of the material dredged, however, due to the fine nature of the silt bags would clog frequently and need to be changed out. The first bag ruptured but only minimal sediment was lost and remained trapped on the geotextile fabric under and around the bag. It was estimated that 10-15 cubic yards of silt was removed after dewatering. In the intake well it was 5- 6 feet deep in some areas which mathematically indicated approximately 35 cubic yards of intake well space was occupied by the silt with water present. PMP-100 was buried in the well and LSS-2 and 3 had their screens mostly blocked. Pumps are performing much better now with notable water quality improvements in the habitats.

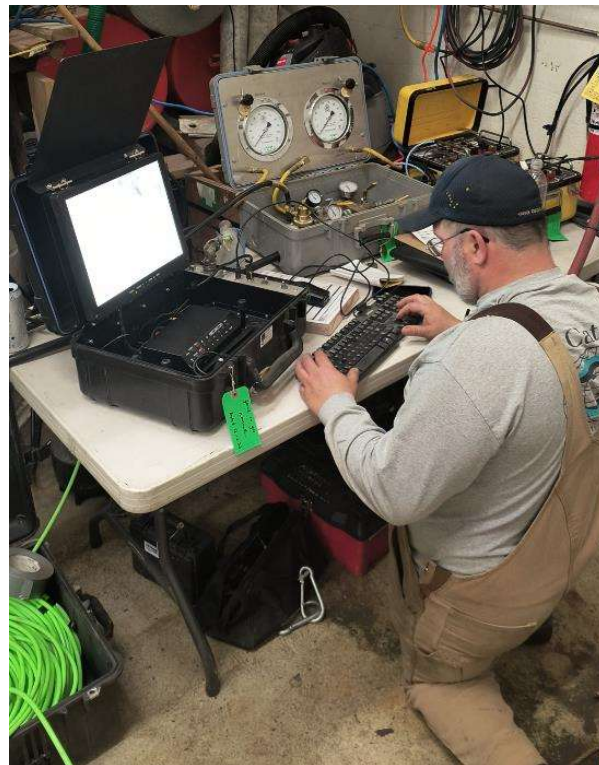
Image 2. American Marine foreman monitors equipment and diver in the intake well performing dredging operation.

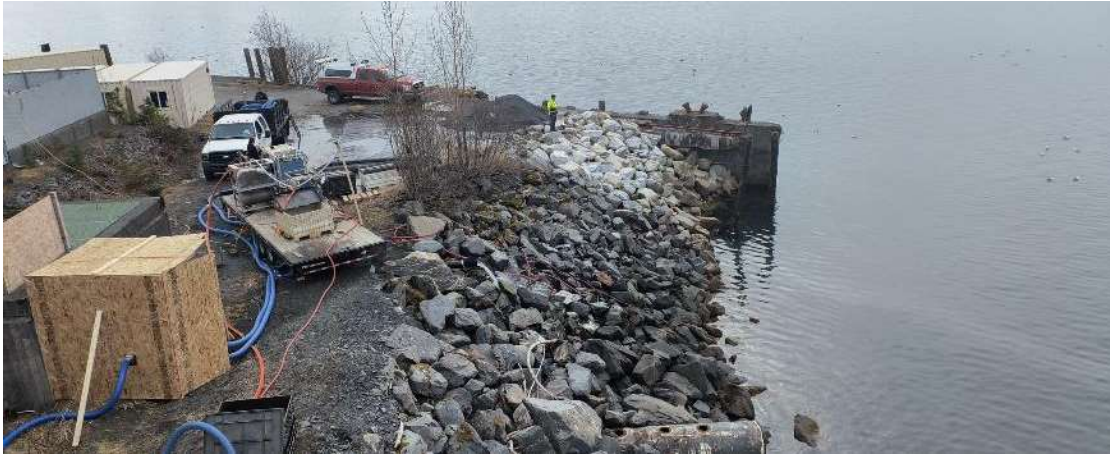
Image 3. PND Engineer (center, in high vis jacket) monitors runoff water from dredging operation ensuring compliance with USACE permit and the performance of the sediment collection bags. A plywood enclosure was constructed around a large diesel pump to reduce noise exposure for ice seal and common murre habitats.

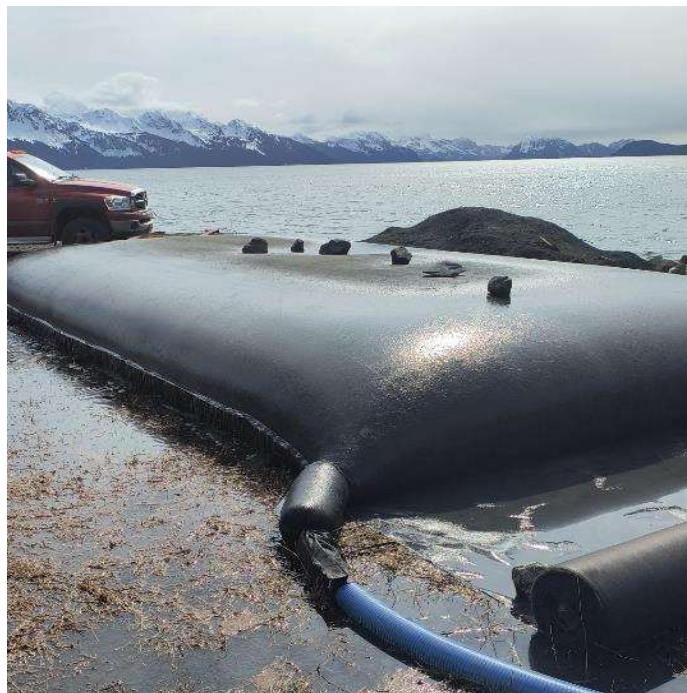
Image 4. One of four sediment collection bags that were used to contain dredge materials and filter process water.

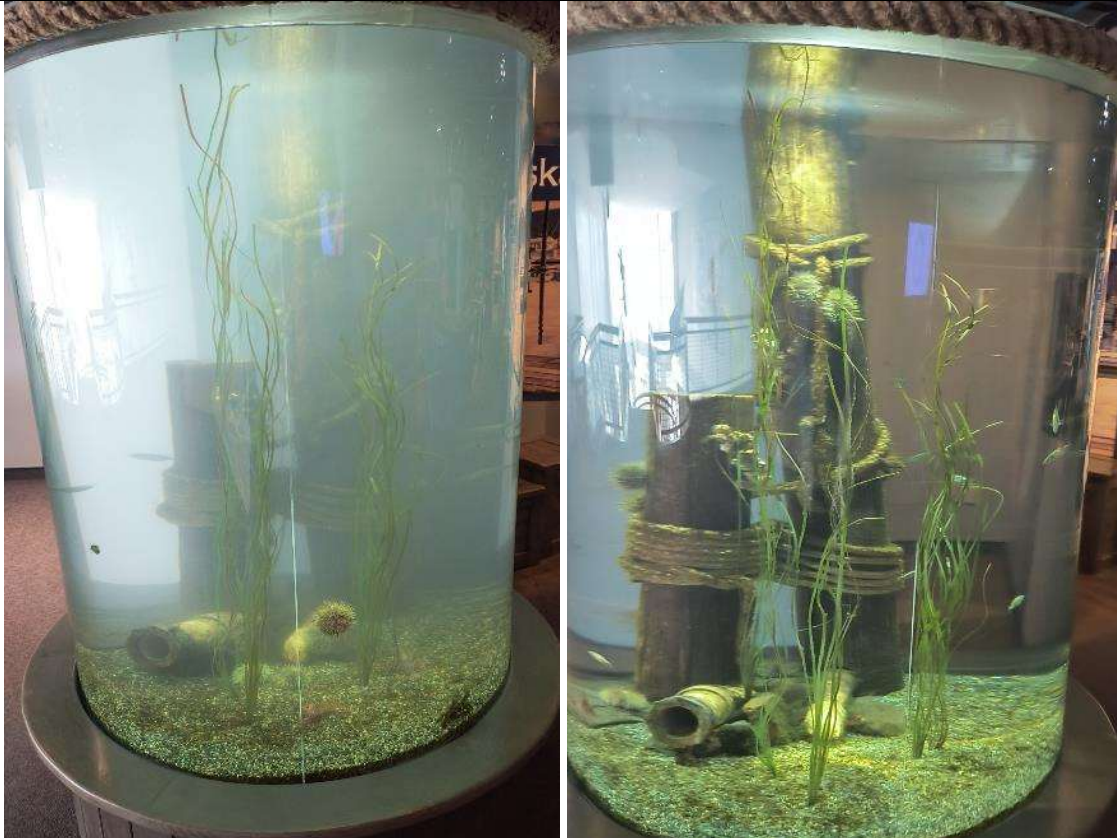
Image 5. Dredging operation did cause slight increases in habitat turbidity which quickly cleared after operations were complete.

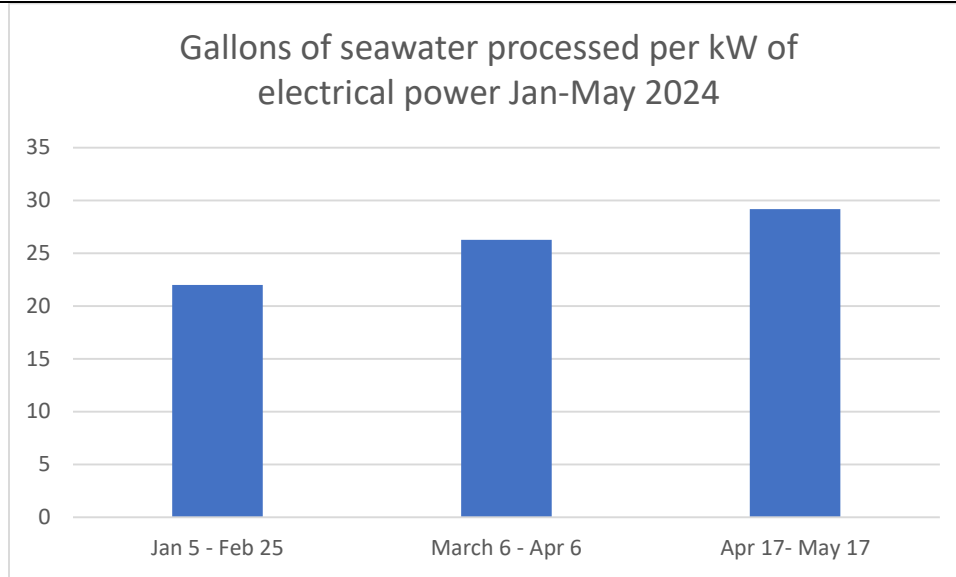
Figure 2. Average water supplied and processed in gallons per kilowatt for seawater “as found” left, after installation of turbine pump LSS-13 in waste well, center, and currently using new pumps from IPA and reducing the use of older existing pumps, right.

All new LSS pumps have been installed and tested. The seawater intake system is not fully functioning and is adaptable to support various configurations needed for operating the system as designed. IPA installed and configured LSS-4 (previously purchased for LSS-2 position that was instead rebuilt), LSS6, and LSS-7. ASLC staff verified the installations and also upgraded or replaced several critical flow sensors on the system. ASLC staff continues to monitor pump performance both in terms of energy and flow. The new pumps in conjunction with dredging the intake well have improved energy efficiency between 5 and 10 percent, resulting in significant utility cost savings. The system as a whole has been determined to be functioning between 25% and 33% more efficiently. This represents a significant cost savings in energy.

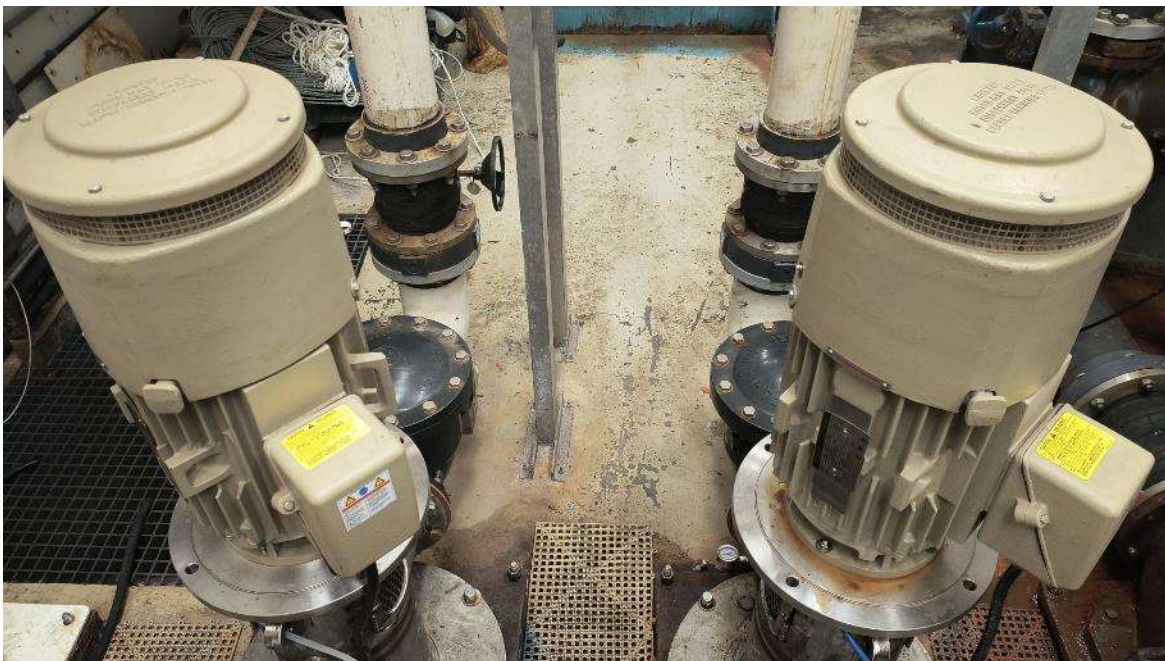
Image 6. Newly installed pumps LSS-6 and LSS-7 provide for greater efficiency and bring critical water systems back into design operating pressures,
