Progress report on “Factors Responsible for Limiting the Degradation Rate of Exxon Valdez Oil in Prince William Sound Beaches”.

PIs: Boufadel, Venosa, and Wrenn.

The studies were conducted on two sheltered (lentic) beaches in Eleanor Island in Prince William Sound. They are:

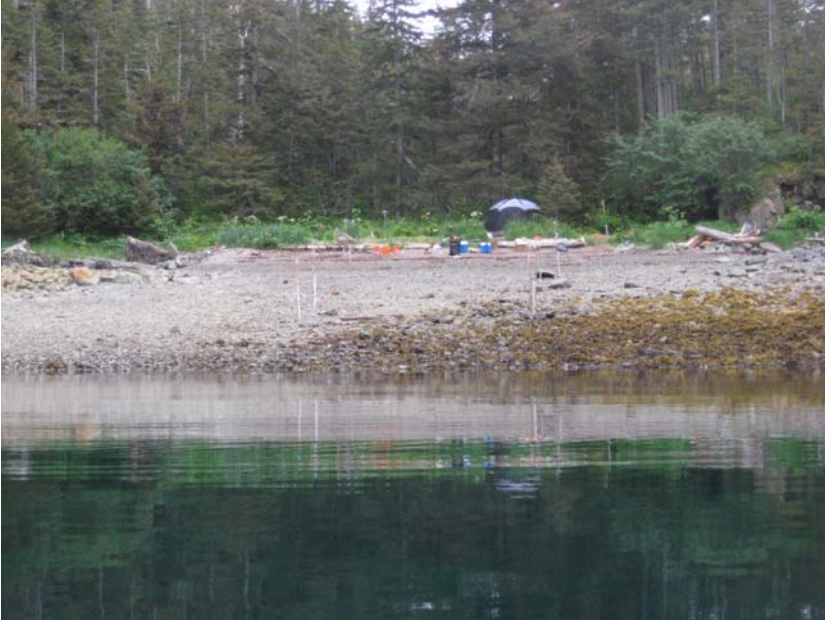
Figure 1: Photo of Beach 1. Note the wells along two transects.

Beach 1: EL056C at coordinates: 147° 34' 37.21" W; 60° 33' 4.56" N (Figure 1)

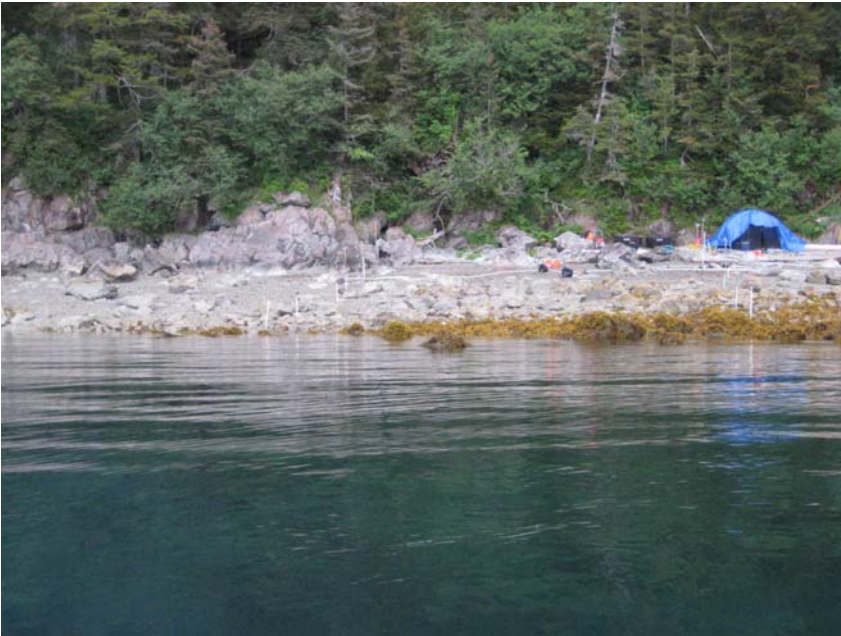
Figure 2: Photo of Beach 2. Note the wells along two transects.

Beach 2: EL058B at coordinates: 147° 34' 17.42" W ; 60 33' 45.57" N (Figure 2)

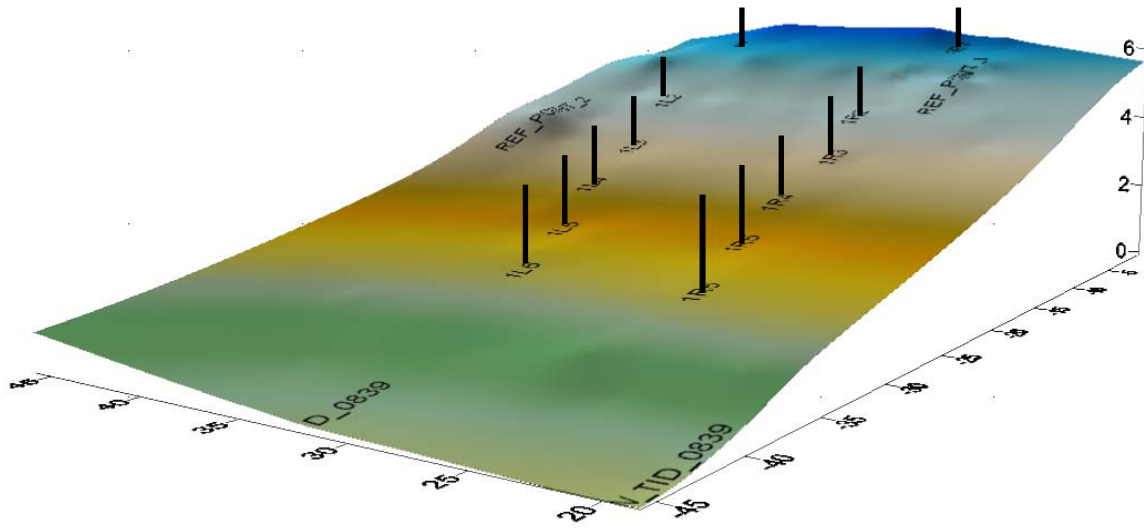
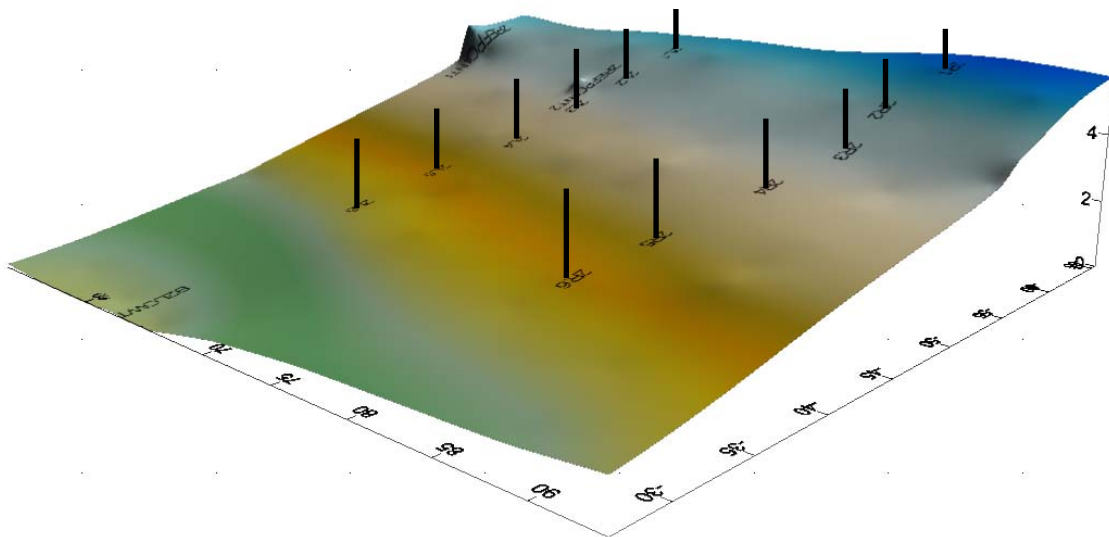
Figure 3: Topography of Beach 1 (E056) and Beach 2 (E058) along with location of wells. All distances are in meter. The most seaward location represents the lowest low tide.

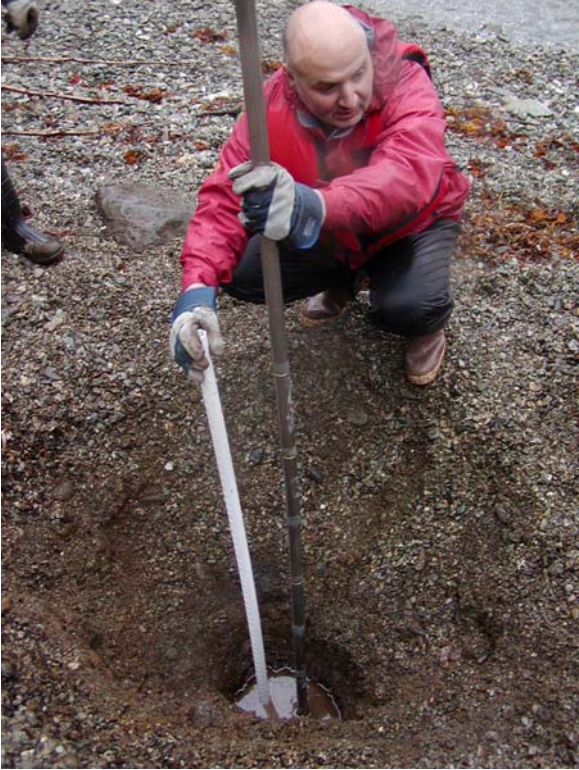
Figure 4: Placing of the water level well (the white PVC pipe) and the multiport sampling wells prior to refilling the pit.

Each transect consisted of six sampling locations for water level and for solutes. The water level was measured by placing a LevelLogger sensor in a slotted PVC pipe that was capped. The sensor measures the water pressure (primary measurement) and temperature (secondary measurement). Adjacent to the slotted PVC pipe, a stainless steel multiport sampling well was placed and it allowed us to take samples at four depths in the beach (approximately at the depths of 25 cm, 50 cm, 75 cm, and 100 cm). The solutes of interest were nutrients (nitrate, phosphate, and ammonia), dissolved oxygen (DO), and the tracer, lithium nitrate).

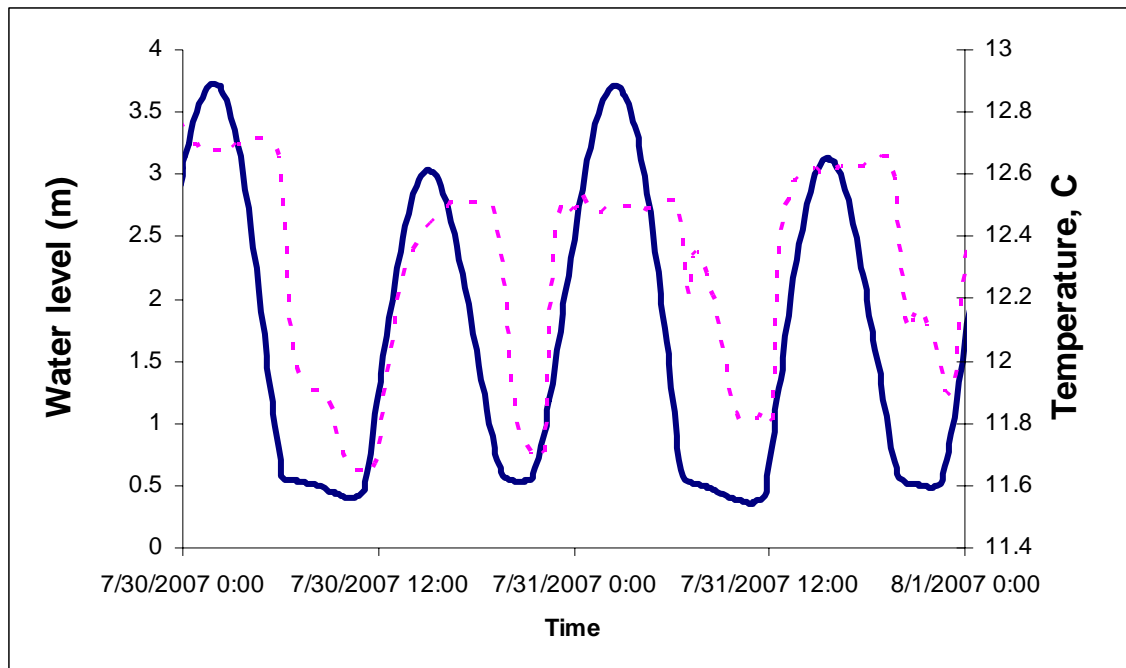
Figure 5: Variation of the water level (solid line) and temperature (dashed line) at Well R6 of Beach 1. Note the increase of the water temperature with the tide, which suggests that seawater enters the beach as the tide rises.

Currently, only the data provided by the LevelSensor are available (i.e., water level and beach water temperature). We report in Figure 5 some of the results for Well R6 of Beach1.
