Exxon Valdez Oil Spill
Restoration Project Final Report

Chenega Shoreline Restoration

Restoration Project 98291
Final Report

March 1998

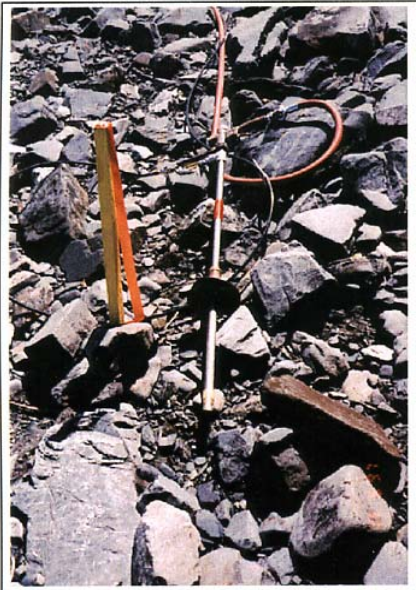
Modified airknife use for surfactant injection. Photo by D. Easton

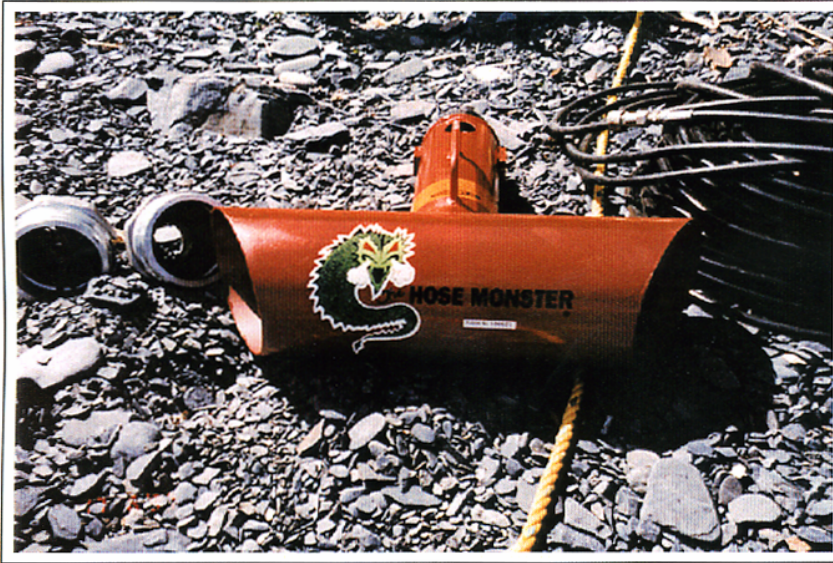
The Hose Monster®, an energy dissipater, was used to aid deluge flooding. Photo by D. Easton

Water Deluge and Flushing. Three diesel-driven 6inch centrifugal pumps rated up to 1500 gallons per minute each of seawater for deluge and flushing. The pumps were staged aboard the landing craft. Six-inch suction hoses with intake screens were placed overboard to supply the pumps. Six-inch, lay-flat hose delivered water from the pumps to the on shore deluge header and manifolds. The deluge header was placed just above the treatment area and consisted of six-inch plastic hose perforated at intervals along its length to provide a continuous flow of water across the entire length of the treatment area.

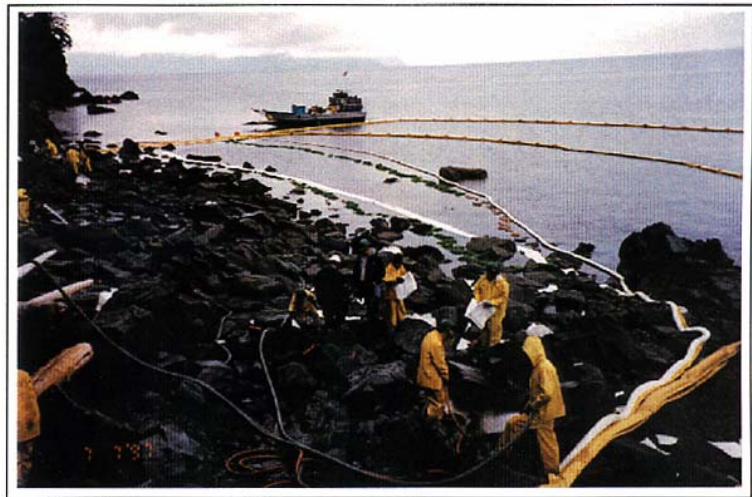
Typical boom and sorbent deployment. Shown here is LA 015C-1. Photo by J. Ginter

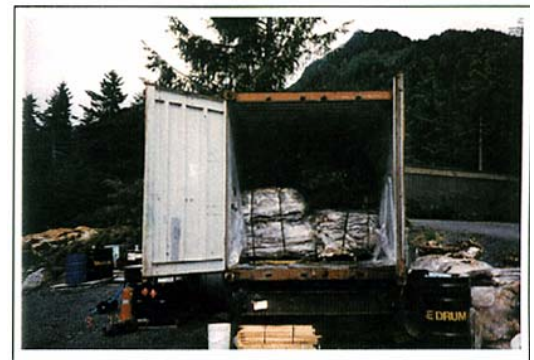
Oiled pads were stored in lined trailers at the village of Chenega Bay. Photo by J. Ginter

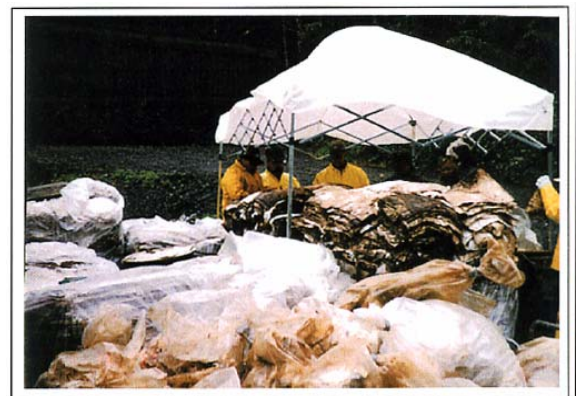
Crew works to consolidate waste at Chenega staging area. Photo by J. Ginter

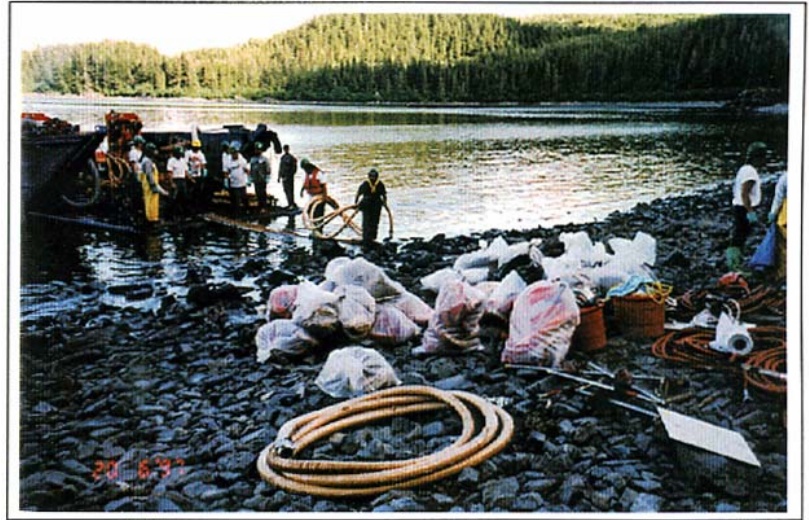
Waste and equipment is loaded onto a landing craft at the end of a work day. Photo by J. Ginter

Certain items, such as sorbent materials, air knives, manifolds, safety equipment and PES-51[®], were unloaded from the landing craft and moved to the beach at the start of work each day. Upon completion of the day's effort, all oily waste and trash would be loaded onto the landing craft, along with all smaller tools and equipment.

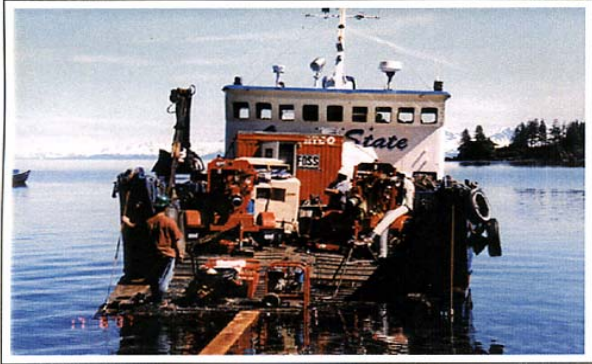
The landing craft *Ocean State* and equipment. Photo by J. Ginter

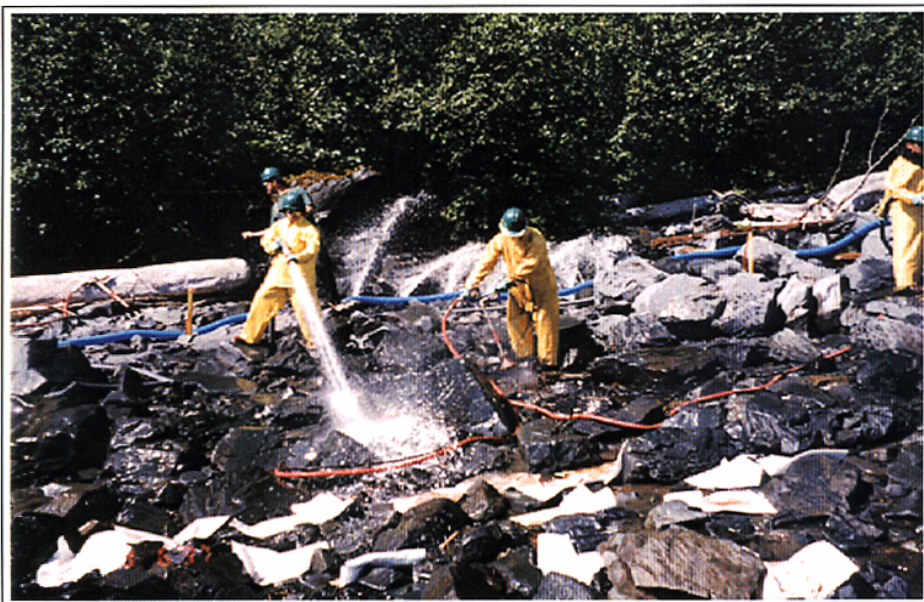
Airknife injection and flushing at LA 020B. Photo by J. Ginter

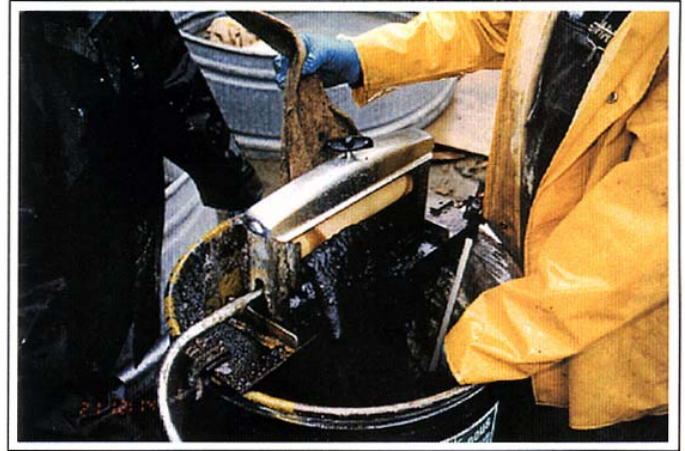
Extracting oil from sorbent pads to estimate oil content. Photo by J. Ginter

Individual grab sample of materials were composited into batches and weighed. A measured amount of PES-51[®] was poured into a container. The sorbent materials were added, soaked until saturated, agitated, and rung. After a batch of material had been through the extraction process, three aliquots of the extract were collected for laboratory analysis. The remaining extract was discarded into a waste drum and the process repeated for the next batch of materials.

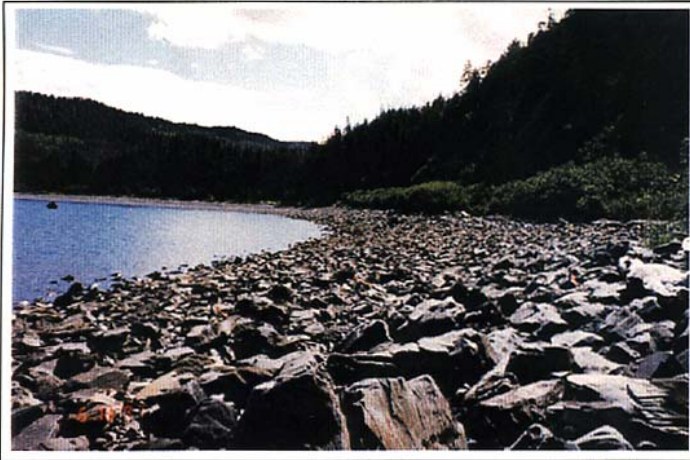
The treatment area of beach LA 020B, looking South. Photo by J. Ginter

The beach is armored with angular boulders and cobble overlying a gravel substrate. The proportion of boulders to cobble increases from south to north. A group of three large (approximately 3-meter diameter) boulders just south of the center of the segment provides an easily recognizable landmark. A small stream crosses the segment near the northern boundary

Residual oil. Oil was present largely as patches of asphalt pavement and surface oil residue in gravels and cobbles between boulders in the upper intertidal. Heavy and moderate subsurface oil was noted toward the center and southern end of the segment. Patches of residual oil were also found in the middle intertidal in the vicinity of a large boulder near the center of the segment. No oil was present in or around the stream bed, or in the lower intertidal.

Treatment efforts. The segment was broken into four sub-segments (LA 020B-1 through LA 020B-4) corresponding to four boom sets with the stream near the north end of the segment falling between sub-segments three and four. Treatment proceeded south to north, beginning with LA 020B-1 on June 17 and ending with completion of LA 020B-4 on June 25. (June 23 was taken as a crew rest day.)

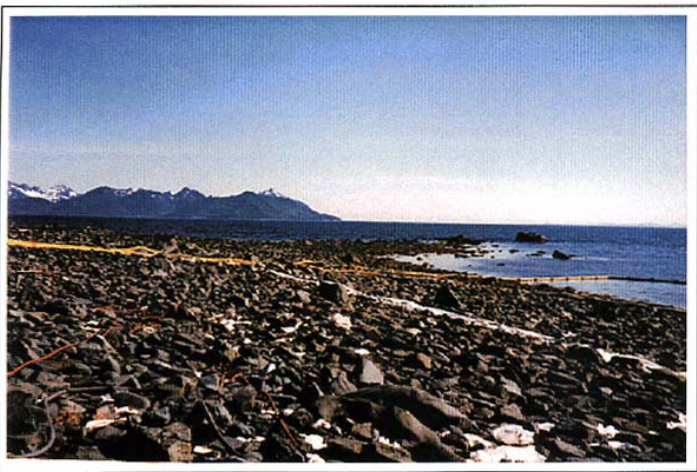
The reef point at LA 020C, approaching low tide. Photo by J. Ginter

The area between the southern limit and the reef is covered in boulders and cobble, with size decreasing towards the reef. The area directly above the reef consists of vertically-fractured shale bedrock with very little other coverage. Northwest past the reef, there is another transition from bare shale bedrock to bedrock covered with gravel and small cobble. Some of the cobble appears evenly distributed (reportedly the result of mechanical treatment in 1991). Continuing further northwest, the cobble cover gives way to large outcroppings of exposed bedrock and large angular boulders for the last 200 meters.

Residual Oil. South of the reef, oil was found in sporadic patches of surface asphalt and oil residues in the upper intertidal. Oil in the upper intertidal immediately above the reef point was found as surface asphalt in the crevices of the shale bedrock. The oil appeared highly weathered, yet when probed would ooze liquid. Continuing north past the reef, in the area of small cobble, oiling was sporadic although there were areas of patchy surface asphalt and heavy subsurface oil residues below the cobble armor. Further north, pockets of oil residue were found among the larger boulders and bedrock formations. Surface and subsurface oil was present in this area in both the upper and middle intertidal. The upper intertidal area above the shale bedrock point near the north end of the segment contained pockets of asphalt in bedrock recesses. The northernmost 100 meters contained patchy asphalt and surface oil residue amongst very large angular boulders.

Treatment Efforts. The segment was broken into ten sub-segments (LA 020C-1 through LA 020C-10) corresponding to five treatment areas (sub-segments 1, 4, 6, 7 and 9) and five areas not treated (sub-segments 2, 3, 5, 8 and 10). Treatment took place between June 26 and July 6. July 4 was a crew rest day.

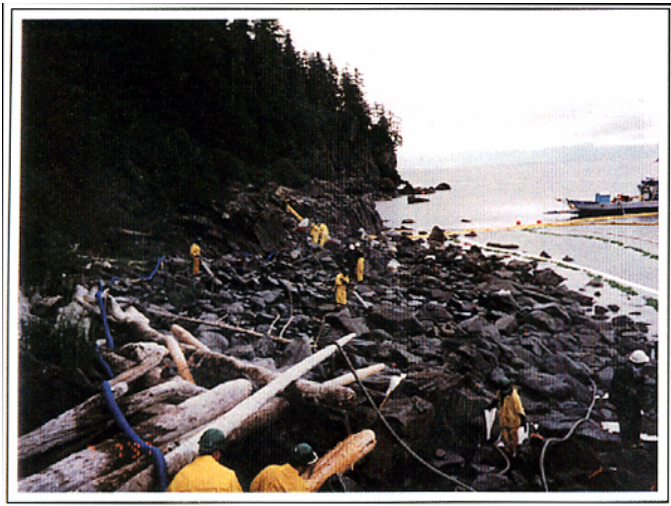
The sub-segments targeted for treatment include a number of bedrock outcrops, some over three meters in height. Much of the area is armored with large angular boulders above bedrock with some gravel substrate. The size of the boulders decreases moving southeast, with increasing cobble. An abundance of plant and invertebrate life was noted in the lower intertidal zone at the northwest end of the treatment area.

Northern end of the treatment area at LA 015C. Photo by _j. Ginter

and middle intertidal. The area with the heaviest oiling was in the vicinity of the bedrock outcrop in the center of the treated area continuing offshore to another bedrock outcrop in the middle intertidal. Patches of surface and subsurface asphalt, oil residue, and tar were also found in the cobble area at the southeastern end of the treated area.

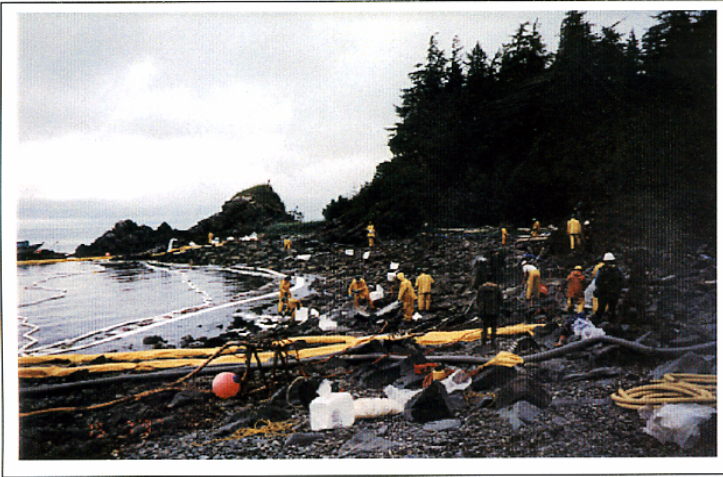
Treatment operations at EV 039A, looking east. Photo by J. Ginter

The area northwest of the stream consists of bedrock with overlying boulders and cobble. A cluster of low, jagged rock extending seaward of this area is exposed at low tide. Southeast of the stream, the substrate consists of cobble, gravels and some sands overlying conglomerate bedrock, with scattered boulders. The pocket southeast of the dividing outcrop contains more sand and finer gravels, while the pocket to the northwest contains more cobble and boulders.

Residual oil. In the area northwest of the stream, oil was found in the middle and upper intertidal as sporadic asphalt, mousse and surface oil residue. Southeast of the stream, oil was present in the middle and upper inter-tidal as patchy to sporadic areas of surface and shallow subsurface asphalt and oil residues.

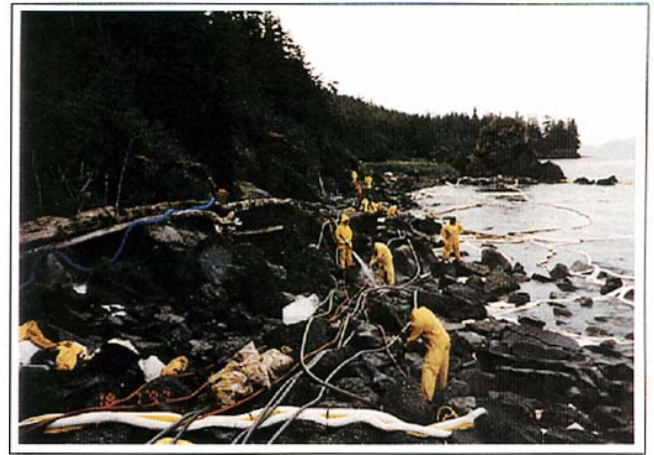
Treatment operations at beach EV 037A, Evans Island.
Photo by J. Ginter

Treatment efforts. The treatment area of EV 037A was small enough that it did not need to be divided into sub-segments, and the entire area was encompassed in one boom set. With offshore access available only from the south, only the larger of the two landing craft was used.

Treatment of the area was delayed by inclement weather on July 17. Treatment was conducted July 18 and 19 generating a moderate amount of oil. A total of 850 square meters of EV037A was treated using 30 gallons of PES-51®. Total treatment time (air knife injection and flushing) was 7.5 hours over two work days.

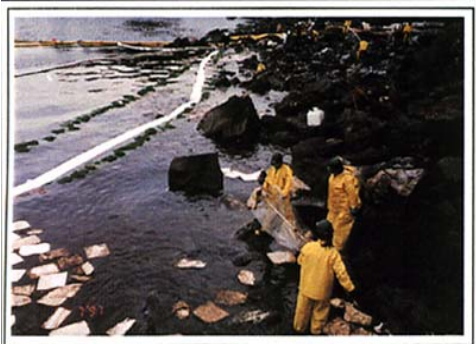
Crew retrieving oiled sorbent pads during treatment at LA 015C. Photo by J. Ginter

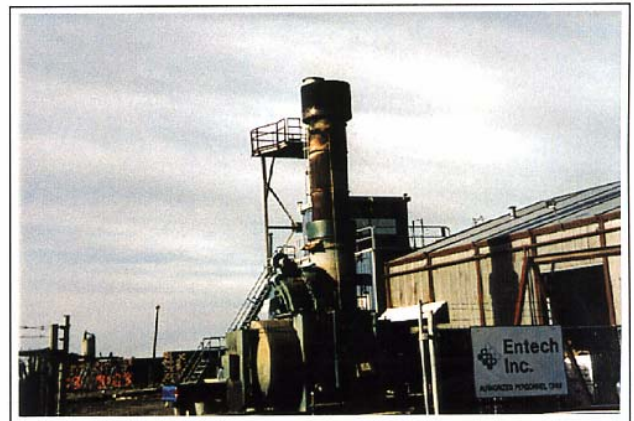
Oiled sorbent materials were incinerated at Entech Inc. in Anchorage. Photo by J Ginter

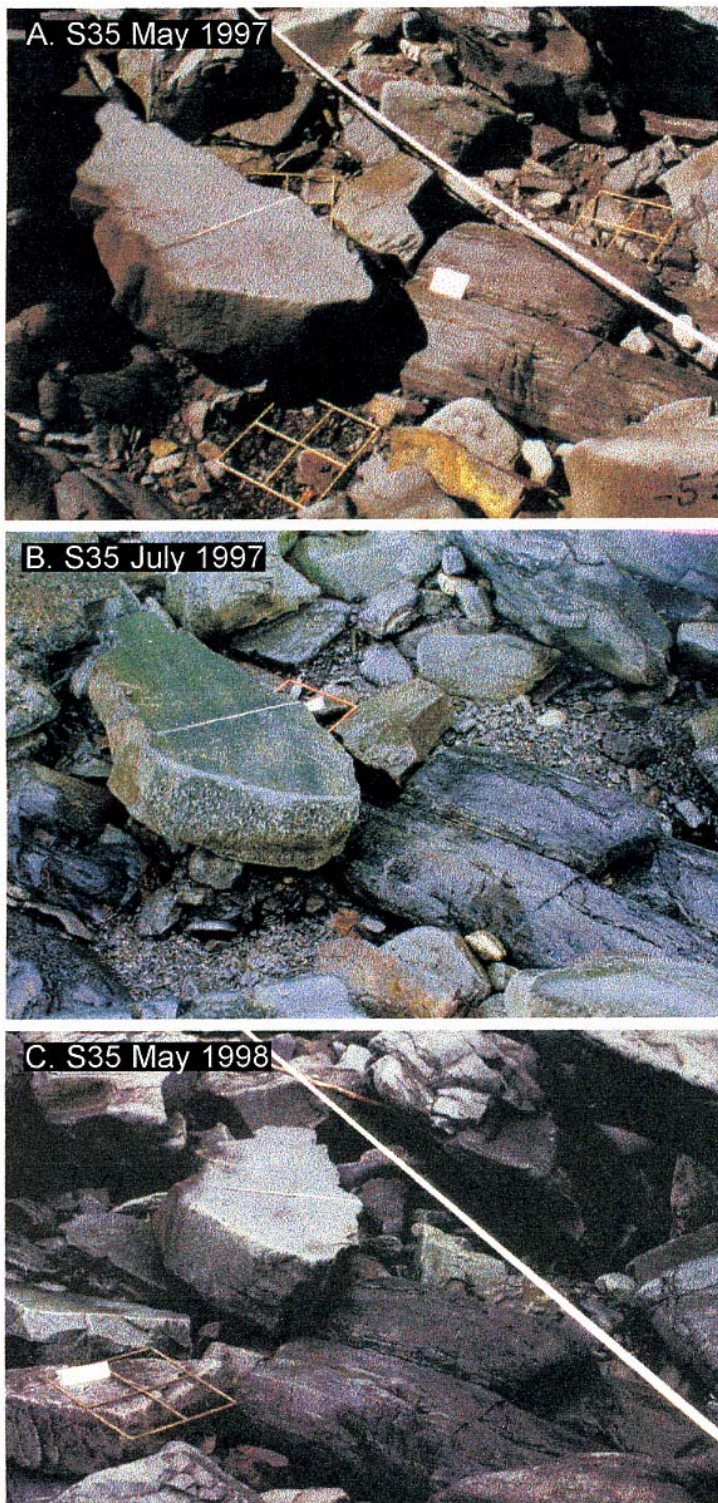
Figure 6-2 Comparison of substrate at an oil sampling site, on the north end of LA020-C, before the cleanup work, within a month after cleaning, and the following year. All three sample quadrats are shown in A. The dark mud, which is especially clear under the front quadrant, is a compacted mixture of oil, sand and gravel. After the cleaning work (B) the three sample areas are typical cleaned loose fine gravel. A "bathtub ring" of oil shows on the front of the prominent flat topped boulder, typical of recently cleaned areas. When C. was taken the following spring, rocks had been thoroughly rearranged by winter wave action. Note how the prominent flat-topped boulder, about one meter long, was moved relative to the buried boulder. (The quadrats are $\frac{1}{4}$ meter on a side.) Also note that the oiled patches previously on the surface have been completely covered by cobbles.

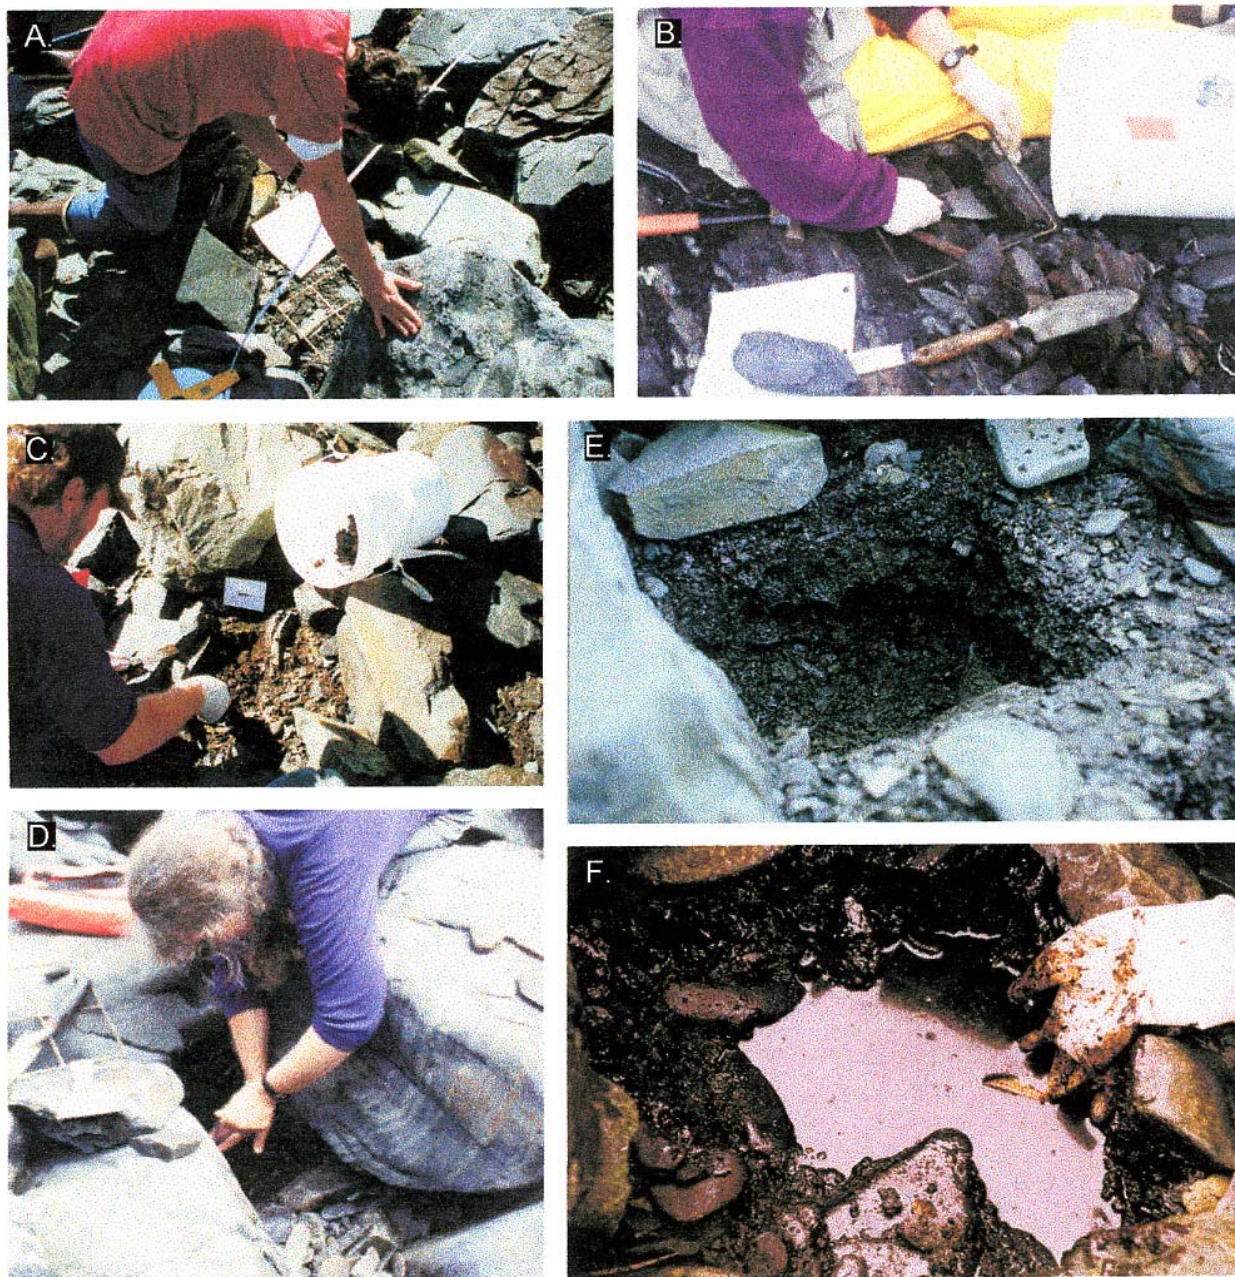
Figure 6-3 Methods used for oil sampling. A shows surveying of quadrant locations. B, C & D show excavating below quadrats. E shows a particularly dry sample hole. Note that oil is sticking the gravel together at the top few cm of the hole, allowing it to retain its square shape, but that unoiled gravel in the bottom of the hole has caved in. F shows a particularly wet and oily hole, with plastic glove for scale.

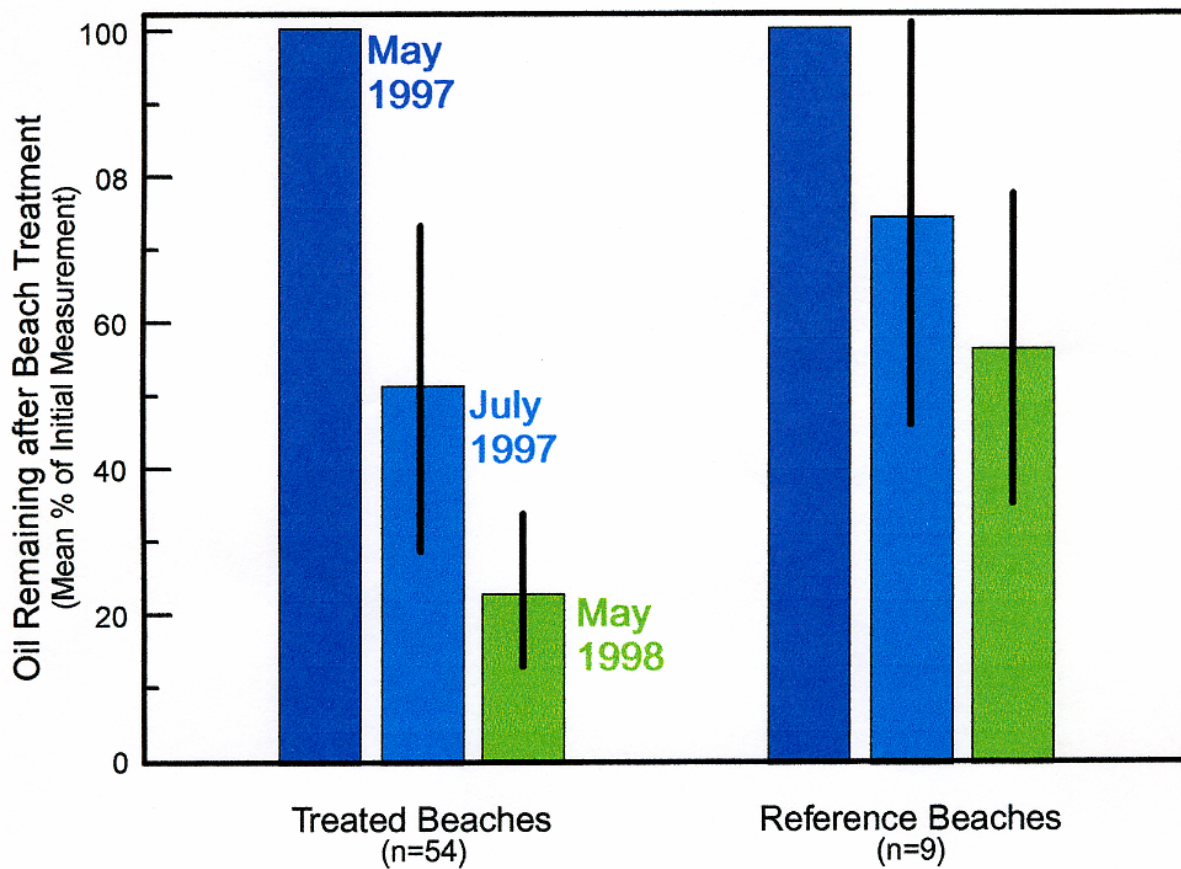
Figure 6-4 Decreases in oil at sample sites over time. Oil is measured in terms of mass per unit area of beach (g of oil / m² of beach). The mean initial (before cleaning) amounts of oil are assigned the value of 100%, and the mean amounts of oil just after the cleaning work (July 1997) and a year later (May 1998) are presented relative to the initial amounts. Colors indicate sample dates. Quantities of oil decreased at reference sample sites, but only about half as far as quantities of oil were reduced at cleaned sites.

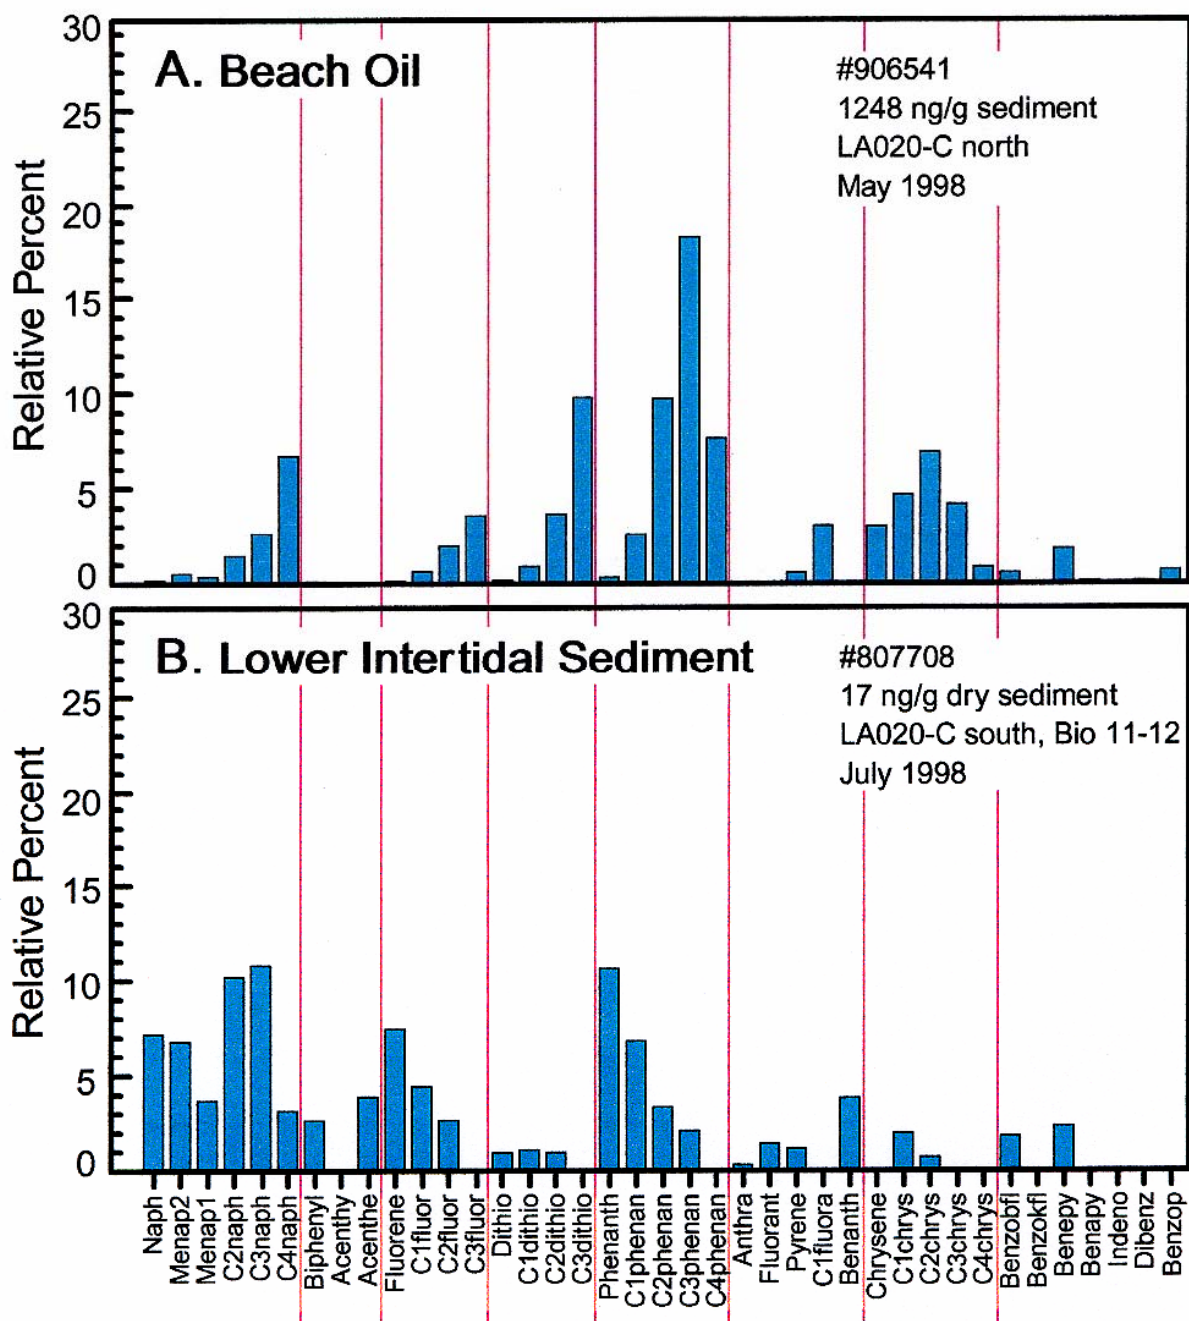
Figure 6-5 Relative concentrations of polycyclic aromatic hydrocarbons (PAH) in oil samples analyzed by GC/MS ("fingerprints"). A represents the oil that covers much of upper Sleepy Bay, typical moderately weathered EVO. B represents the very small quantities of PAH present at the MLLW line, a typical background of traces of coal.

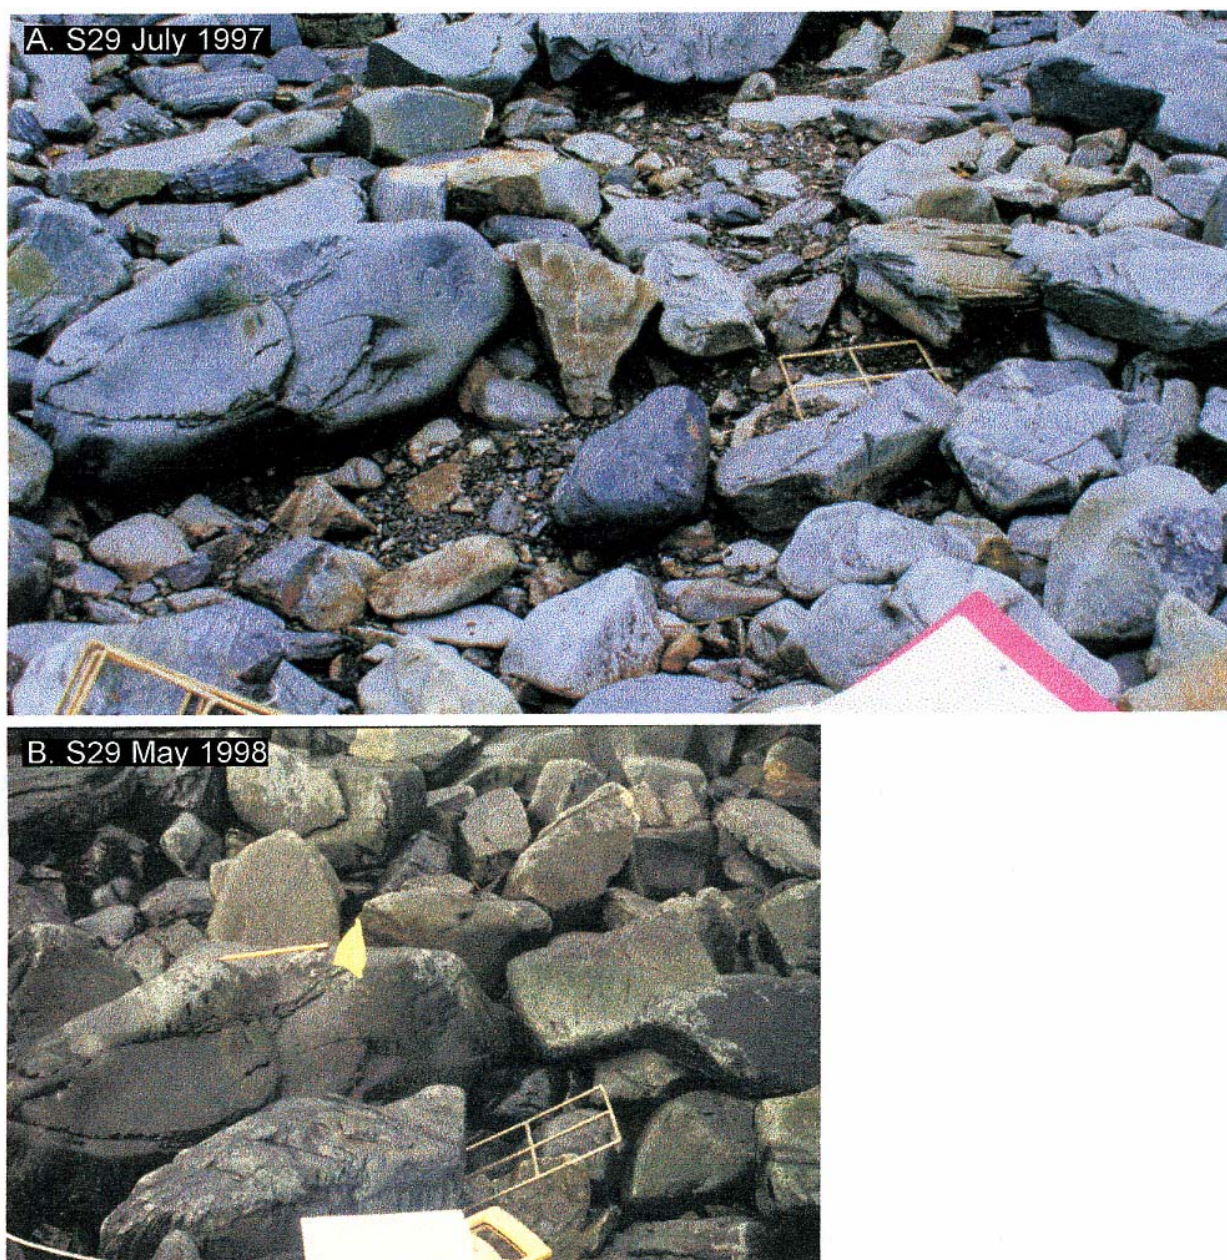
Figure 6-6 Comparison of substrate at an oil sampling site, just north of the reef in the middle of LA020-C, within a month after cleaning and the following year. Note that the only rock clearly in the same location in both pictures is the meter long boulder that is marked with a yellow flag in B. (For scale, the quadrats are $\frac{1}{4}$ meter on a side.) The three designated sampling points are obvious in A., although only one is indicated by quadrant location. The oil at all three points is buried in B.

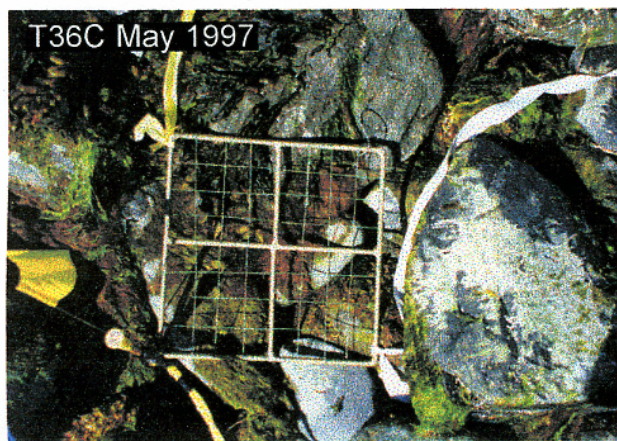
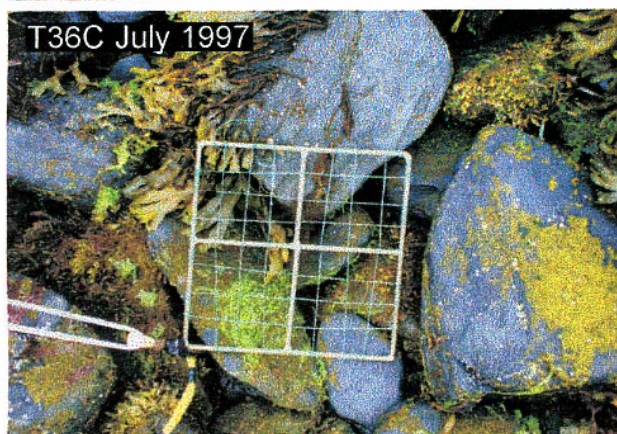
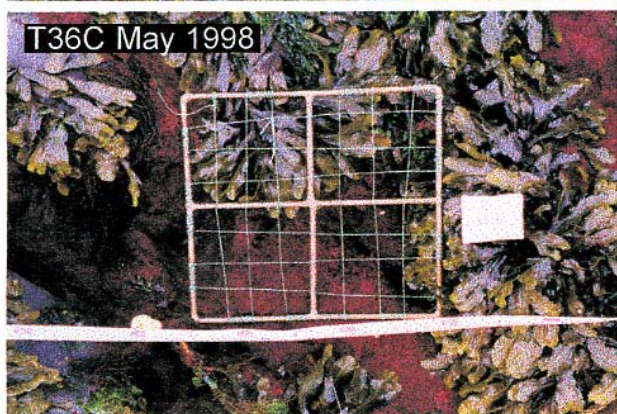
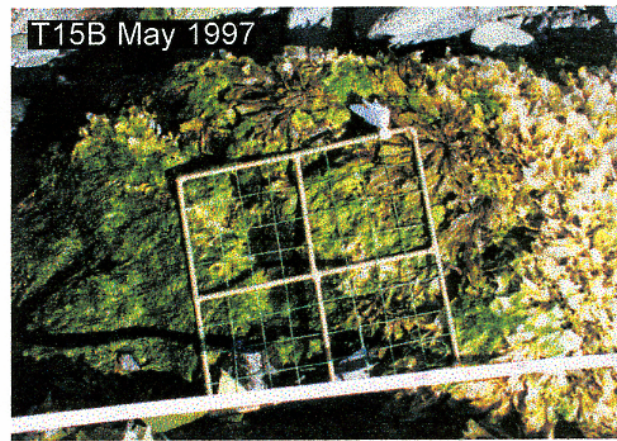
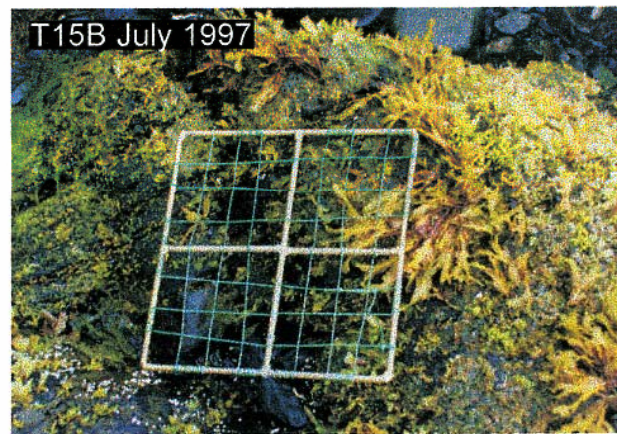
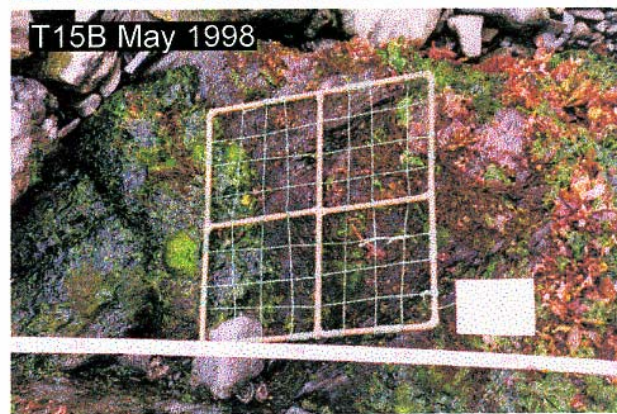
Figure 11-2 Comparison of the algae present at the locations of two 25 cm x 25 cm quadrats, one a reference quadrat (on LA020-D, away from the cleaning work) and the other a treatment quadrat (on the north end of LA020-C, directly below where cleaning work took place). The May 1997 photographs were taken before the cleaning, the July 1997 photographs were taken within a month after cleaning, and May 1998 photographs were taken the following year. Visible changes over time are no greater at the treatment site than at the reference site.

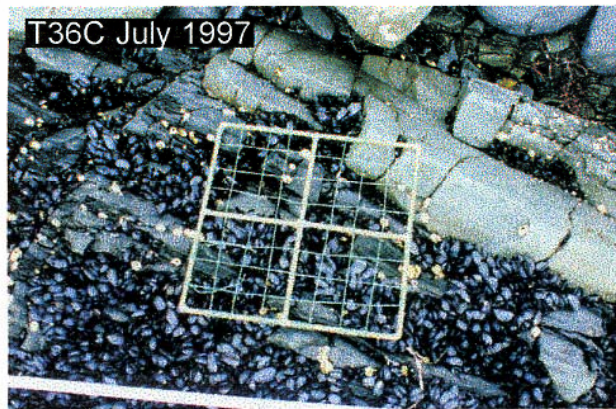
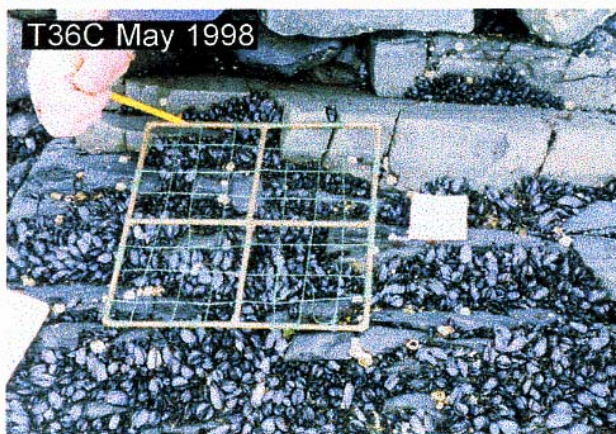
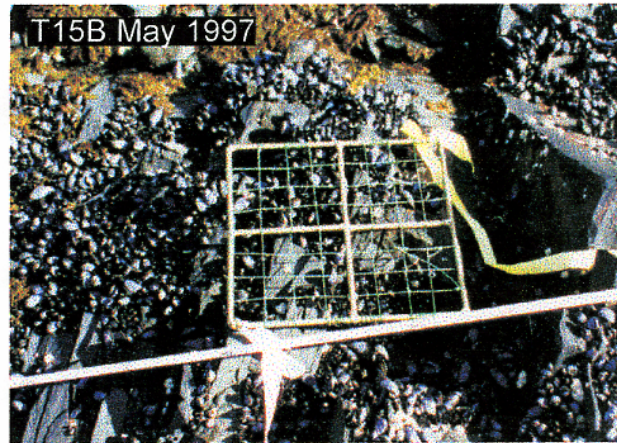
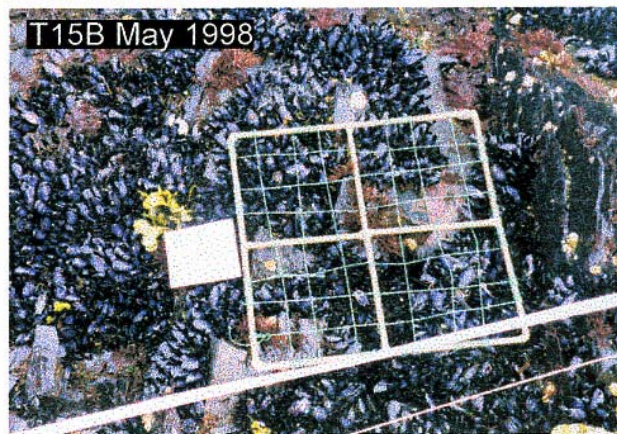
Figure 11-3 Comparison of the mussels present at the locations of two 25 cm x 25 cm quadrats, one a reference quadrat (on LA020-D, away from the cleaning work) and the other a treatment quadrat (on the north end of LA020-C, directly below where cleaning work took place). The May 1997 photographs were taken before the cleaning, the July 1997 photographs were taken within a month after cleaning, and May 1998 photographs were taken the following year. Visible changes over time are no greater at the treatment site than at the reference site.

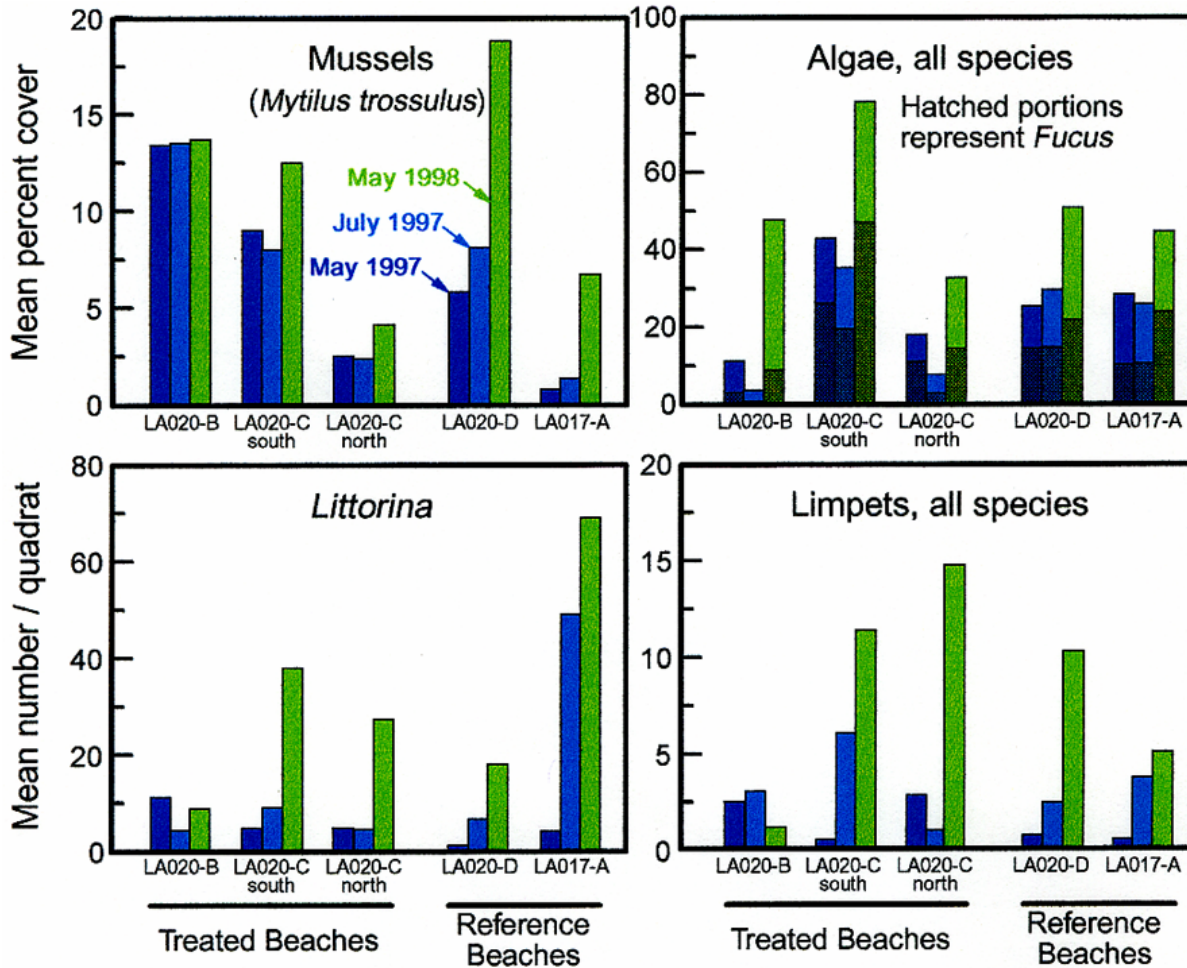
Figure 11-4 Changes over time in quantities of small biota in fixed quadrats on cleaned and reference beaches. Colors indicate sample dates: initial (before cleaning), just after the cleaning work (July 1997) and a year later (May 1998). Changes on different beaches have little relationship to whether the beaches were treated or reference, and no relationship that can logically be tied to the cleaning process. Note, for instance, the large set of *Littorina* on one of the reference beaches in July of 1997, followed the next spring by greatly increased numbers of *Littorina*s on all of the beaches except one.

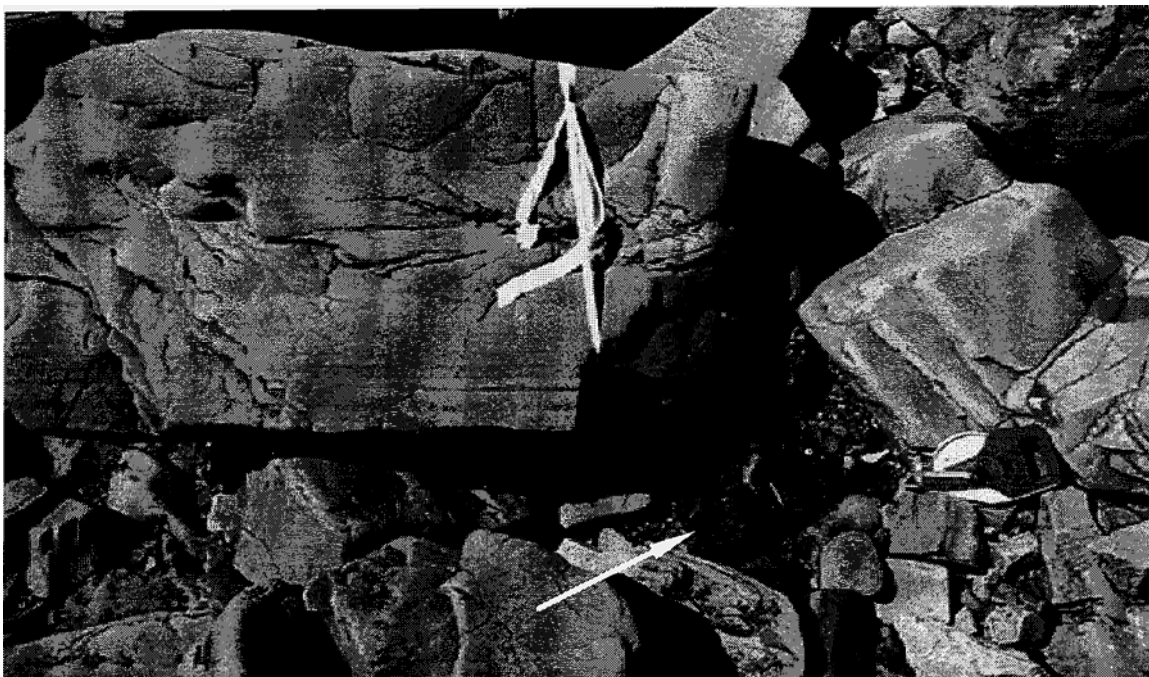
Conditions before treatment, photo reference point 5, LA 020B. Note oily asphalt patch below and right of flagged rock. Photo taken 6/17/97.

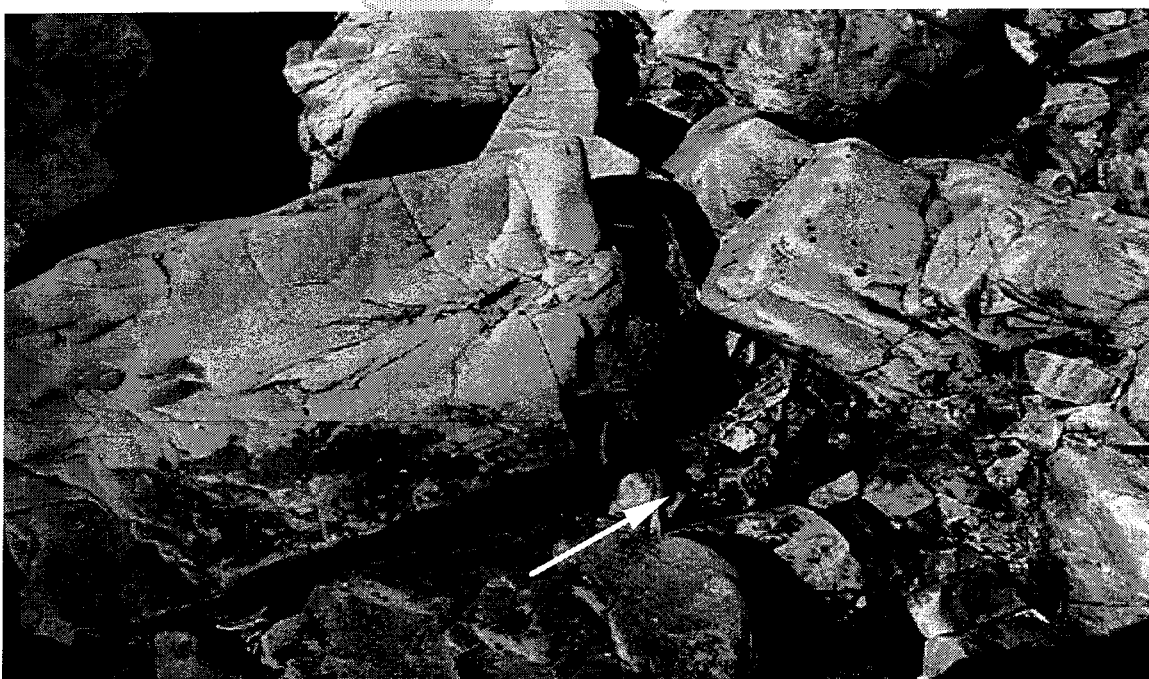
Conditions after treatment, photo reference point 5, LA 020B. Note unconsolidated cobble between boulders, center of picture. Photo taken 6/24/97.

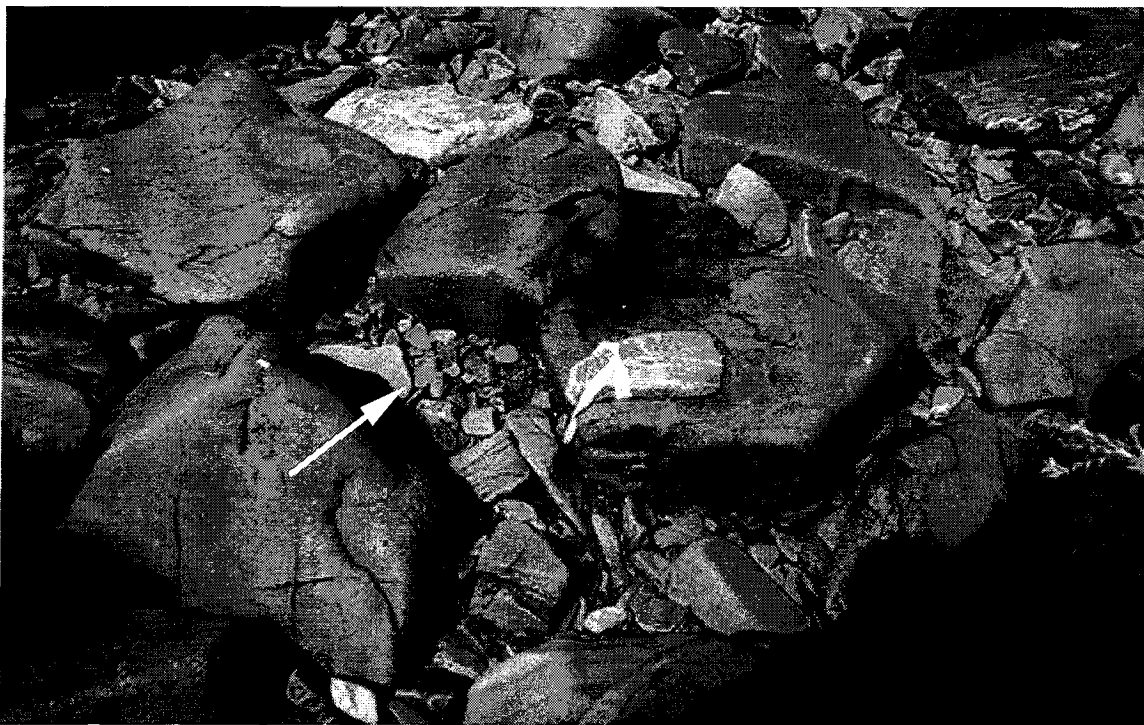
Photo reference point 1, LA 015C, before a between boulders is consolidated asphalt mat. Photo taken 7/6/97.

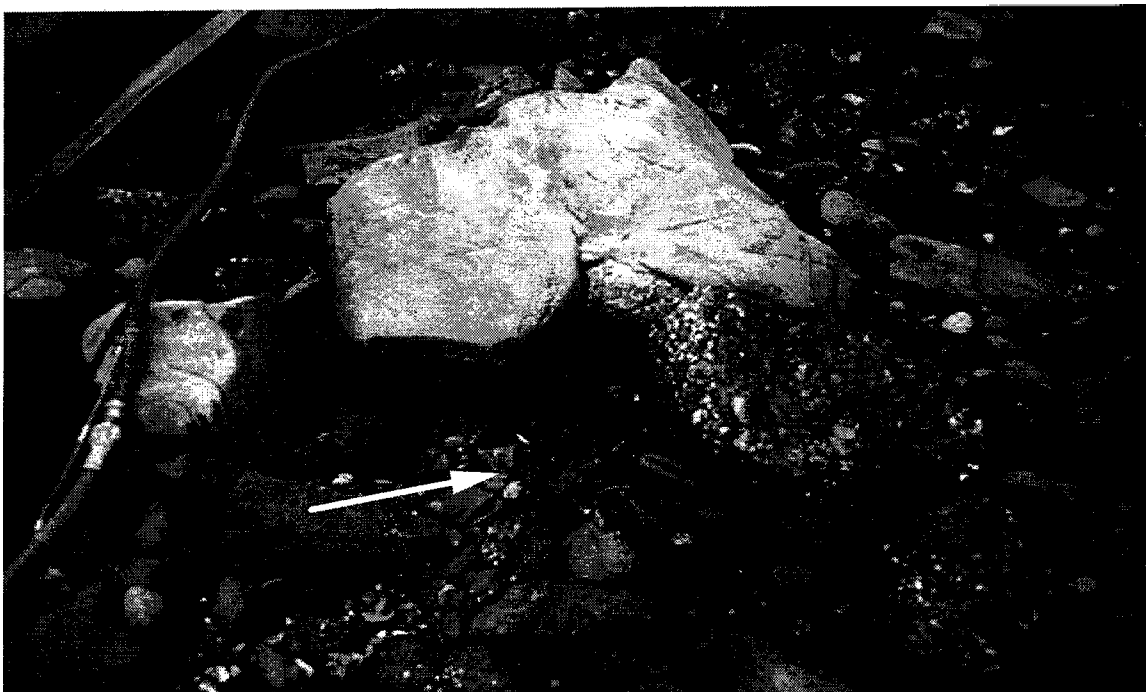
Conditions before treatment, photo reference point 4, EV 039A. Gravel and cobble consolidated in asphalt mat. Photo taken 7/16/97.
