Exxon Valdez Oil Spill
Restoration Project Final Report

Chenega Shoreline Restoration

Restoration Project 98291
Final Report

March 1998

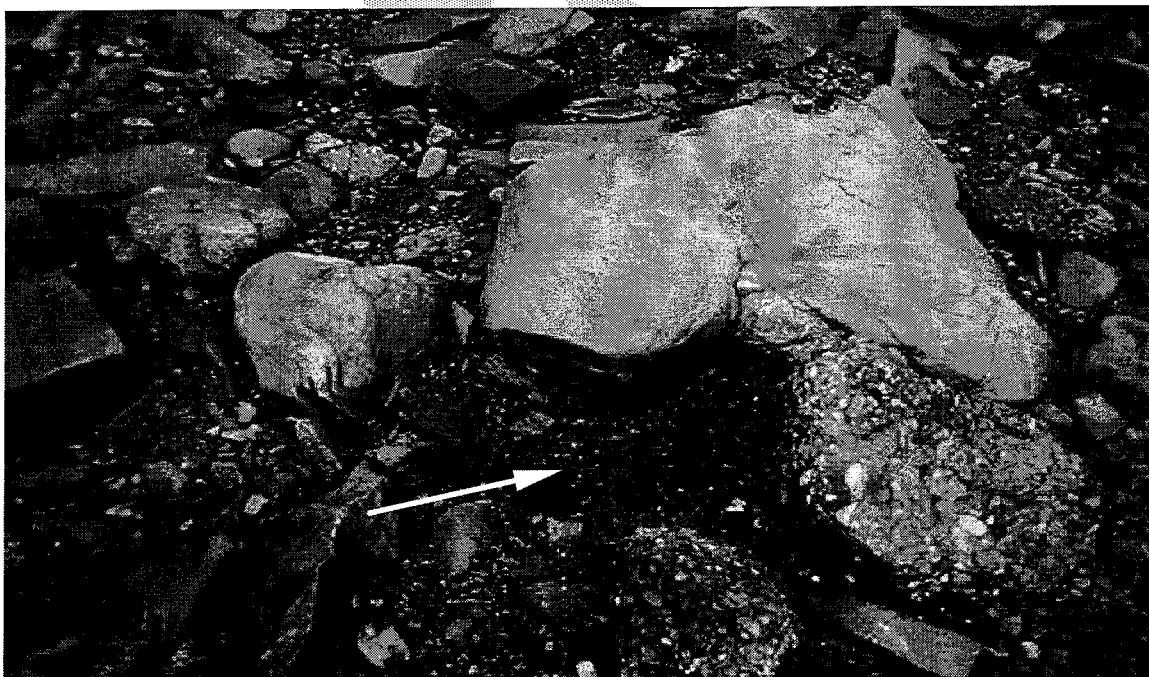
Conditions after treatment at photo reference point 4, EV 039A. Gravels are loose and unconsolidated. Photo taken 7/17/97.

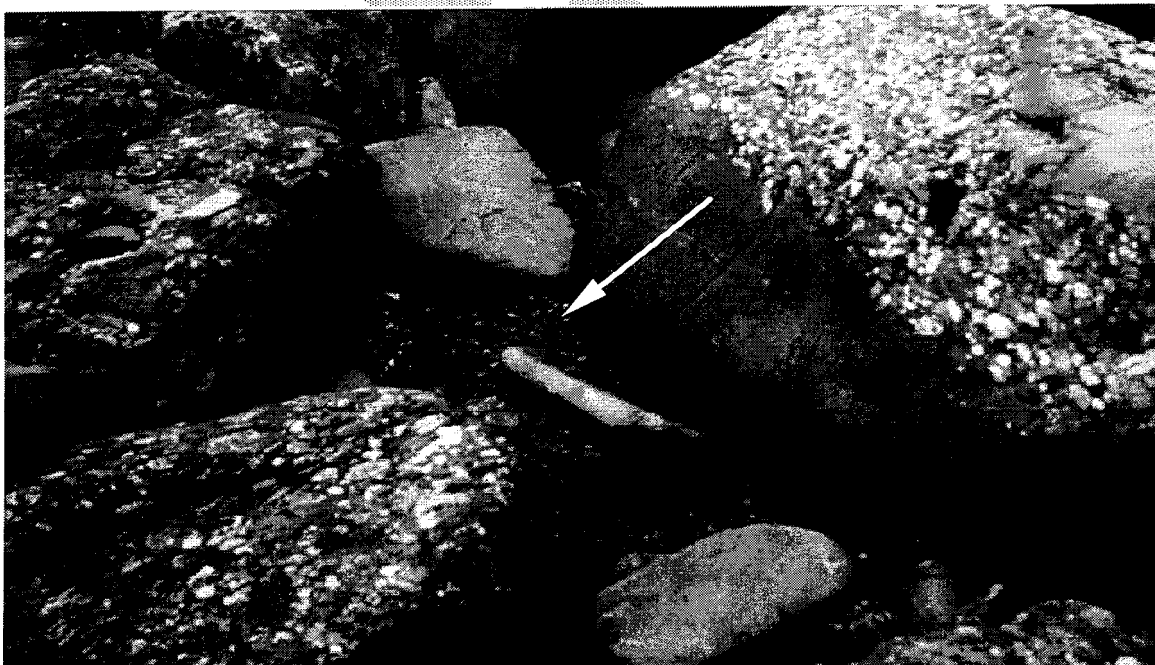
Conditions after treatment, photop reference point 4, EV 037A. Mousse has been removed, gravels are unconsolidated. Photo taken 7/22/97.
