***Exxon Valdez* Oil Spill
Restoration Project Final Report**

**Shoreline Assessment and Oil Removal - ADEC
in Prince William Sound, Alaska**

**Restoration Project 94266b
Final Report**

Field Data for 1994 Manual Treatment and Assessments in Prince William Sound

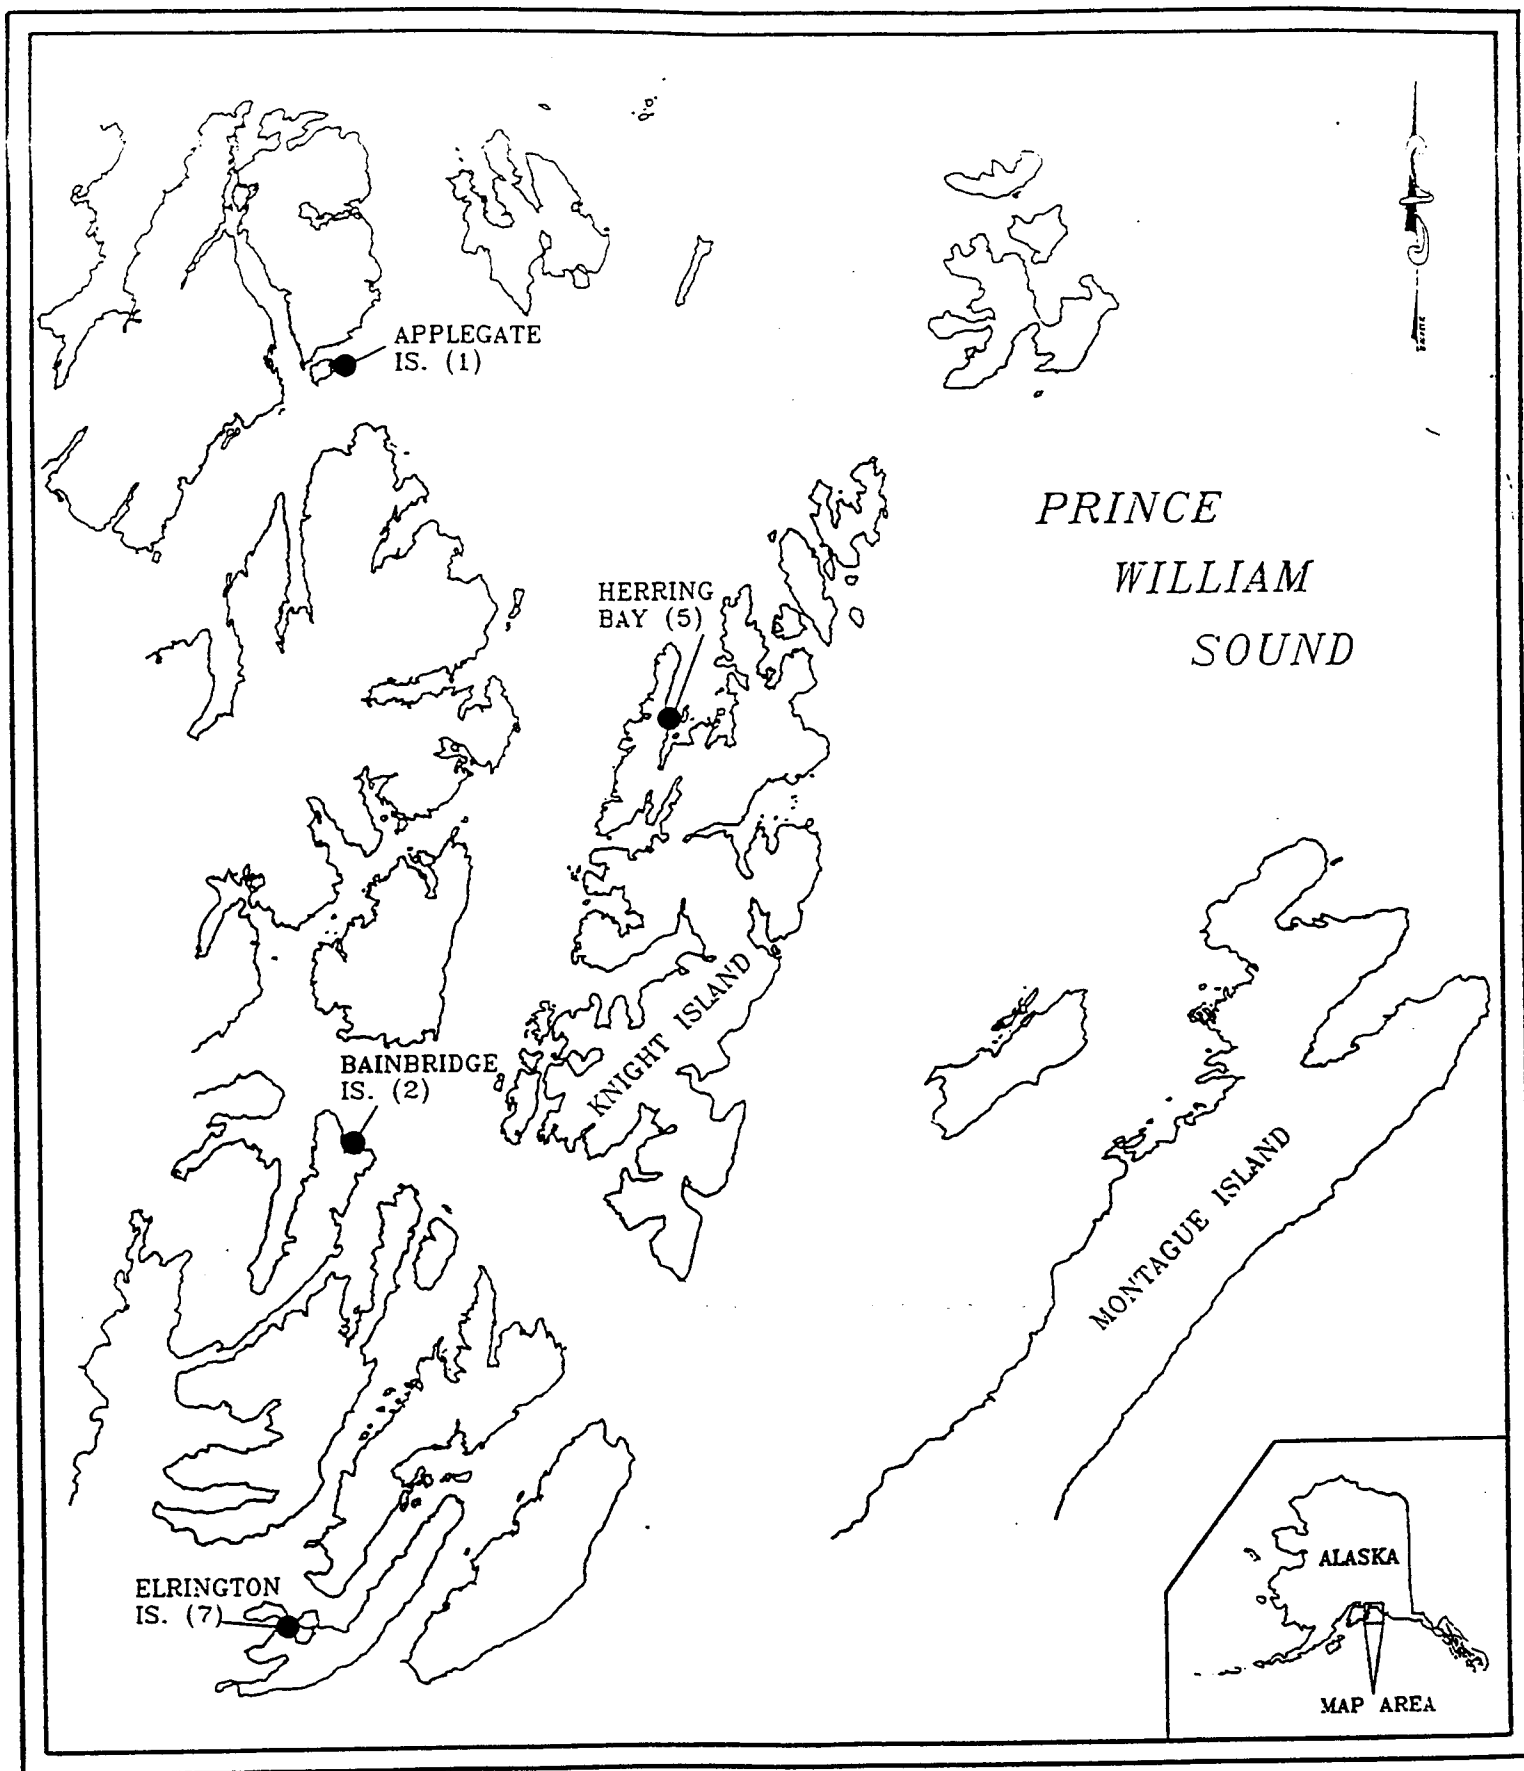
Figure 1. Manual treatment sites where asphalt type oiling was broken and tilled and rebar and debris were removed. Numbers in parentheses indicate the number of locations treated at each subdivision.

ER011A). Areas treated ranged in size from 4 to 600 square meters and ranged in thickness from 2 cm. to 25 cm. The crew worked the low tide windows to ensure complete access of the oil. No sheening occurred as a result of manual treatment.

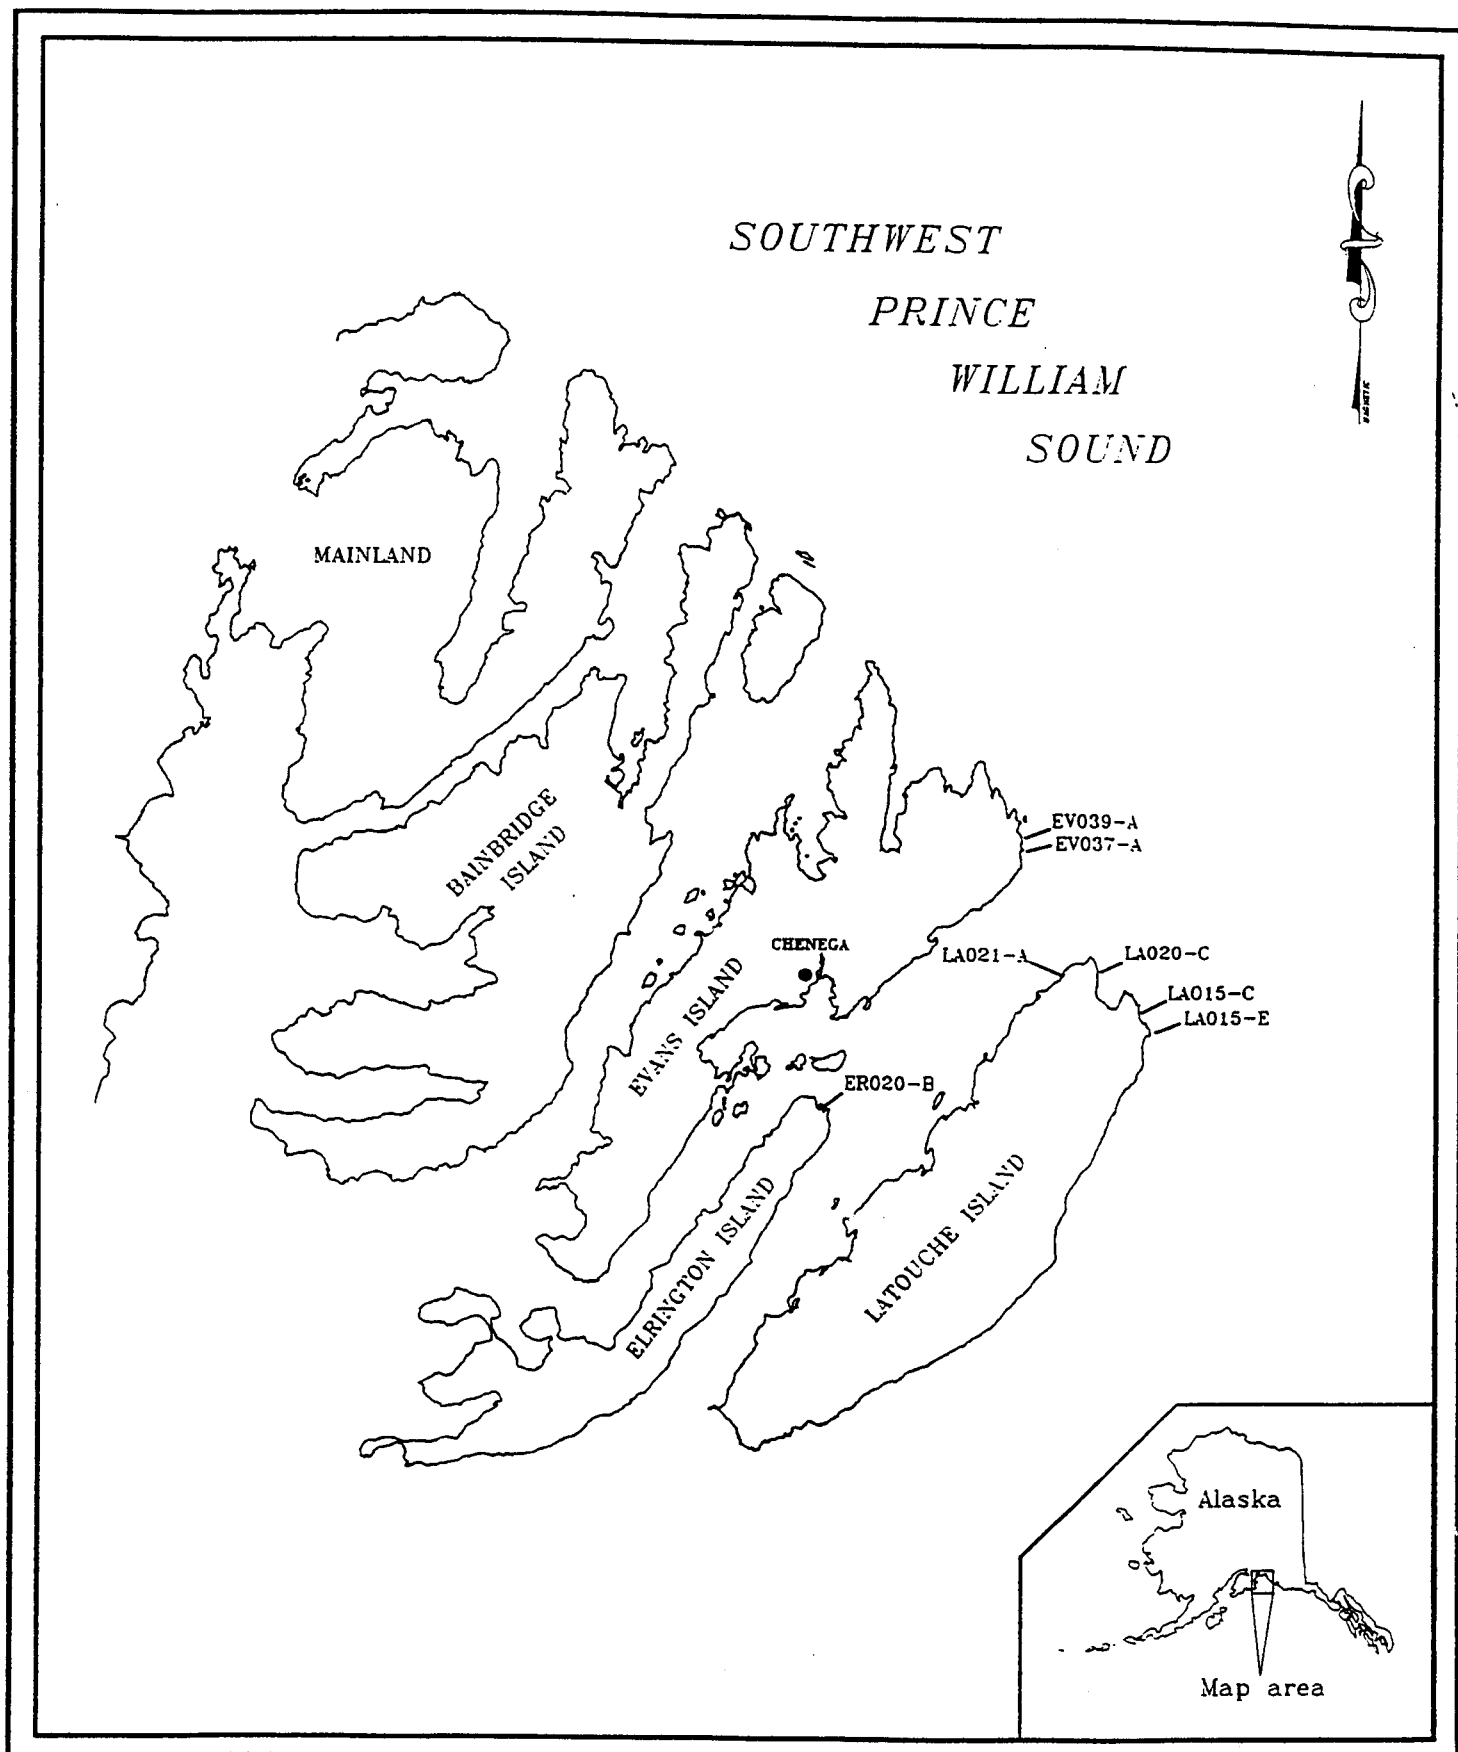
Figure 2. Shoreline subdivisions in southwestern PWS (near Chenega Bay Village) that were surveyed for persistence of residual oiling.

Results of the additional shoreline assessments showed that little to no improvement had occurred at these sites from 1993 to 1994. In general, the six beaches are characterized by a cobble, boulder or cobble/boulder armor covering a gravel sediment. Visually observable residual oil was found in the upper and middle intertidal zones on five of the six subdivisions. This included surface oil residue ranging from heavy to light, mousse and asphaltic pavement. Most often, the residual oil was found on, or adhering to, or below, the boulder and cobble layers, especially in sheltered crevices and the areas that are protected wave energy.

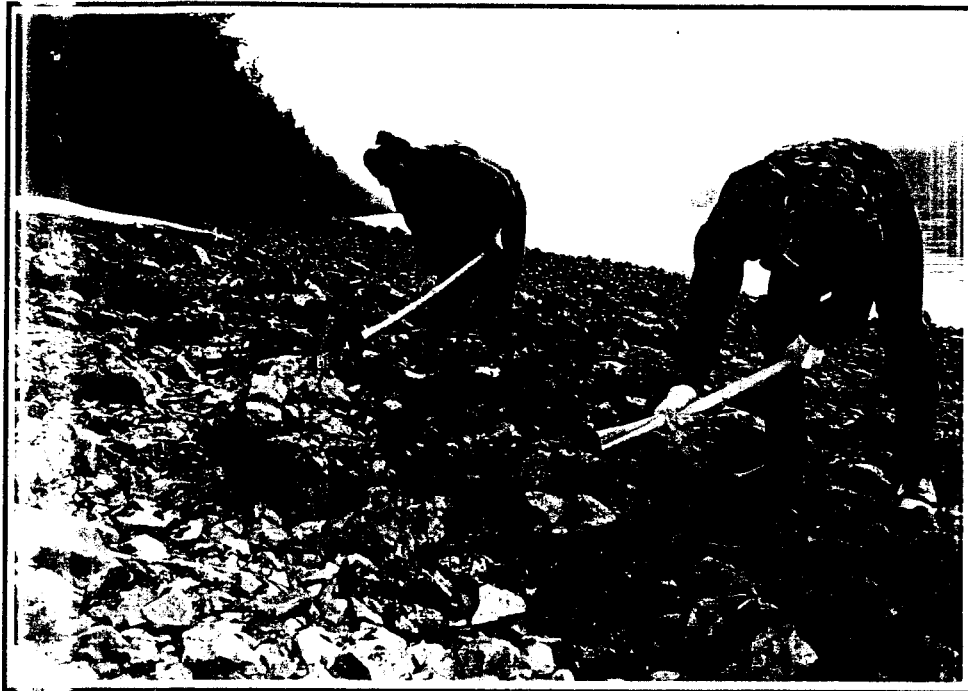
Crew members manually breaking-up asphalt at a site located on the west coast of Harring Bay on Knight Island, (July 13, 1994, Segment # KN0132B)

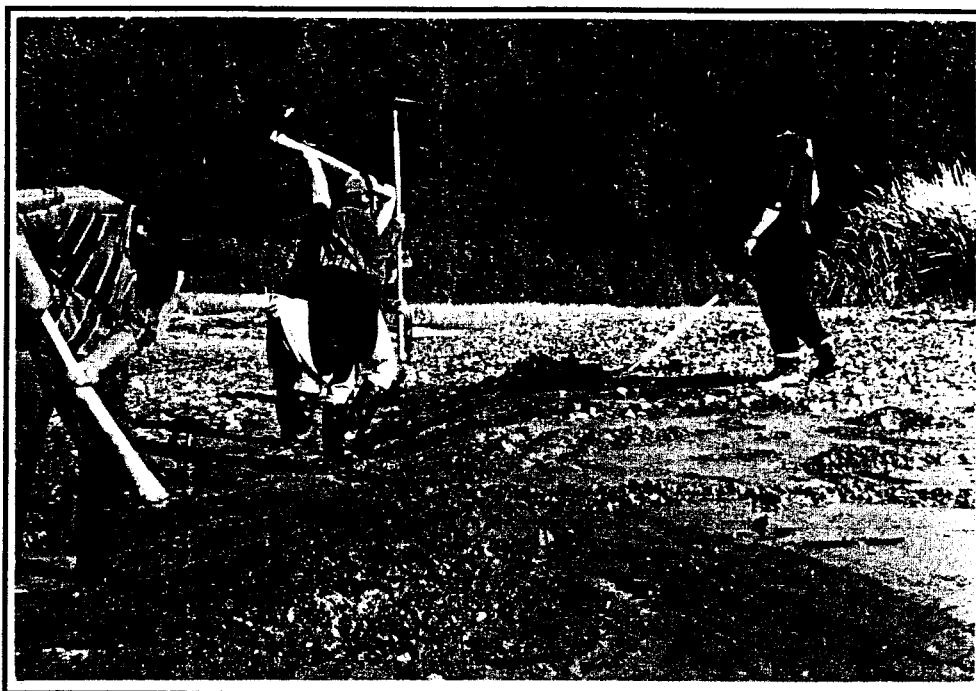
Crew members manually breaking-up asphalt at a site located in Fox Farm Bay on southern Elrington Island. (August 22, 1994, Segment # ER011A)

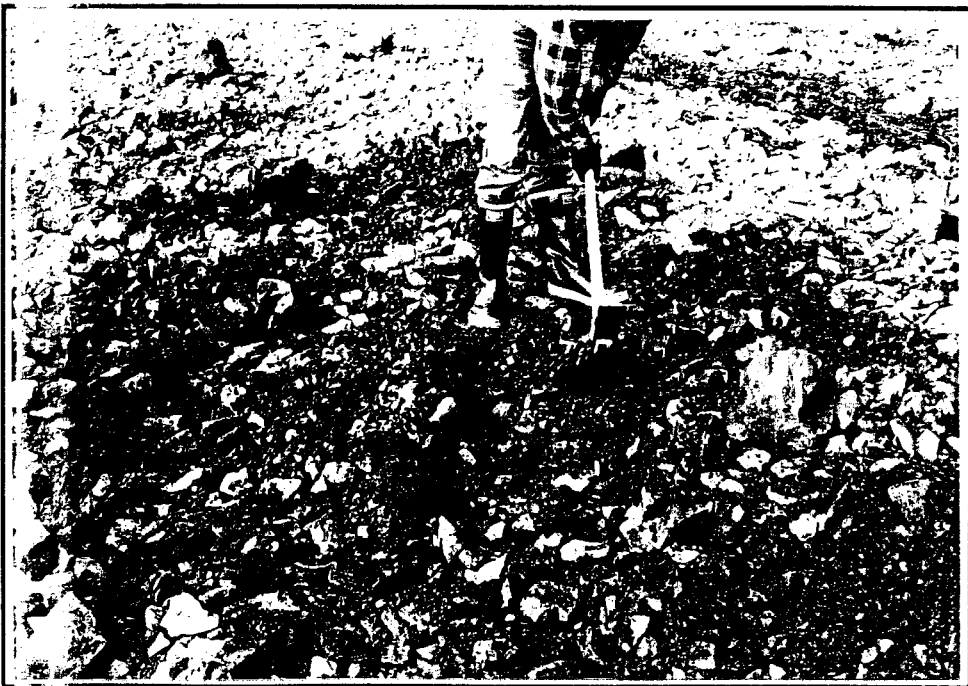
Close-up of above. Asphalt type oiling after being broken and tilled.

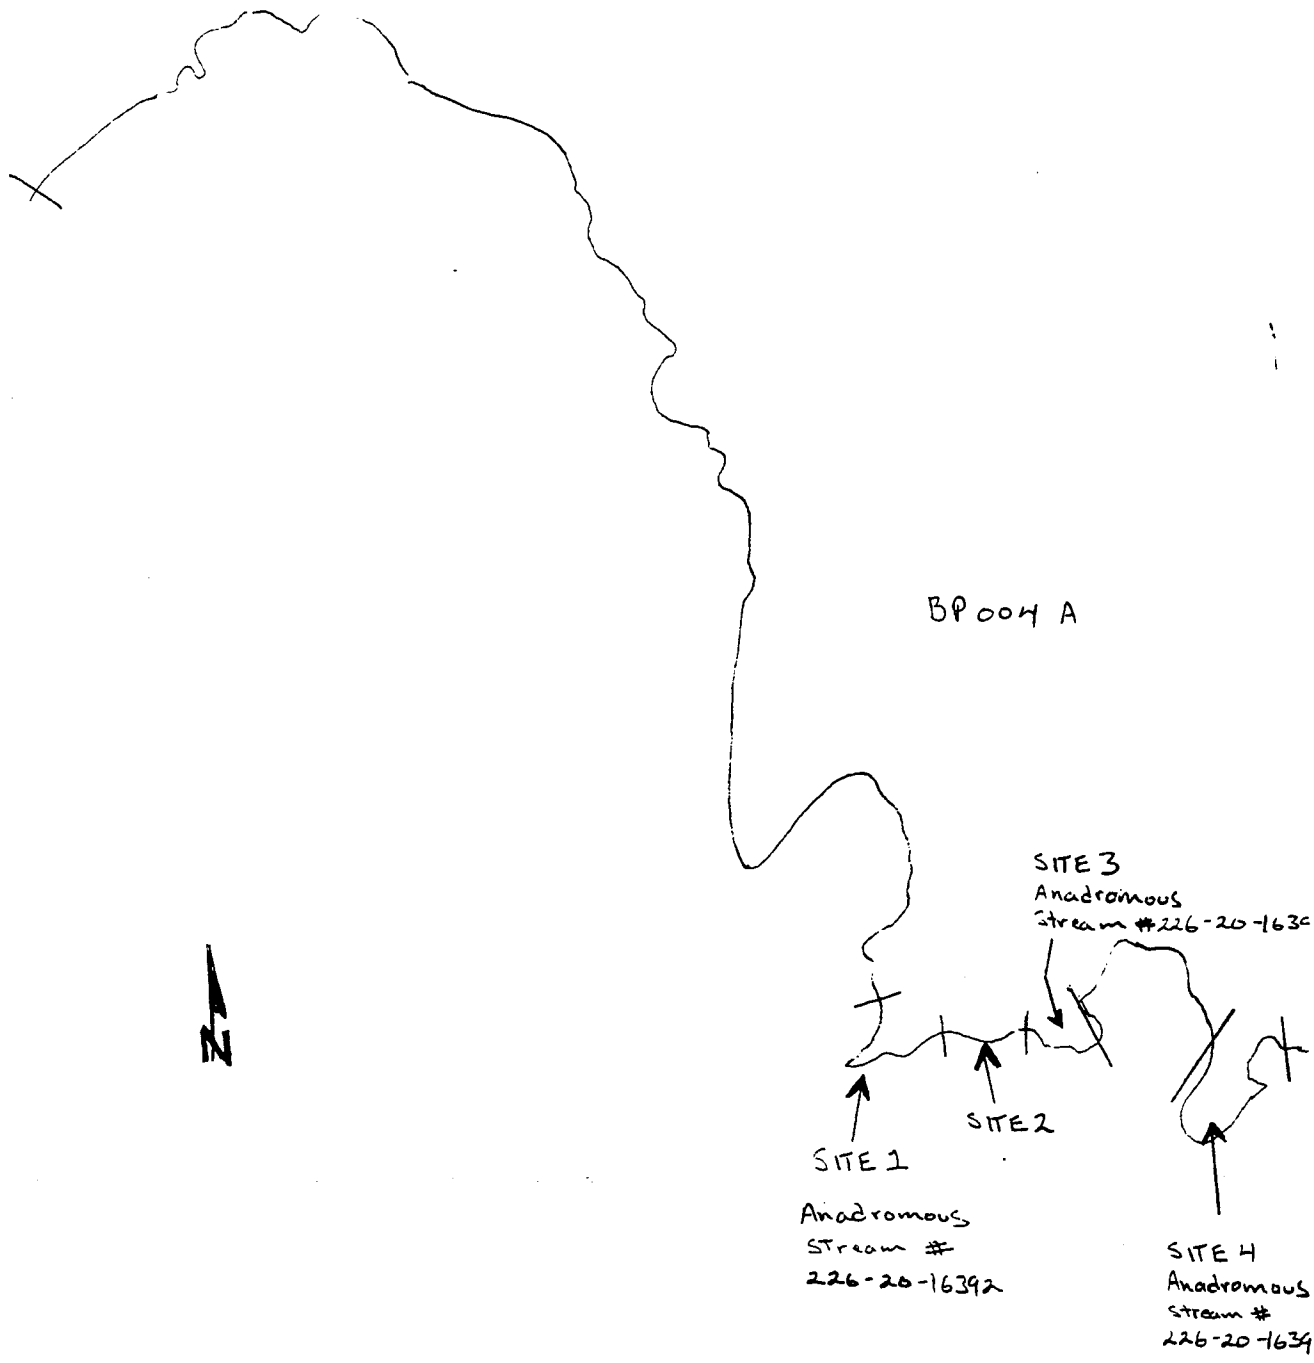
SITE 3

Four areas with substantial subsurface oil remain at beach site # 3. At locations 'B', 'C' and 'D', OP and HOR oiling occur just under surface pebbles. This oil is easily uncovered and extremely heavy. At location 'F', OP and MS was observed amongst and under boulders.

AP/ PATCHY (some broken up)
10x5 meters
Some 10cm thick next to stream

AP / Tarballs HITZ
Sporadic, but
consistently
throughout
100x5 meters
Some broken

CT/ST/SOR
HITZ ON BEDROCK
and large
boulders thru
SPORADIC entire sit

At beach site # 3, two areas, locations 'G' and 'H' had significant amounts of surface AP, SOR and TB. Most of this stable surface oil was broken and tilled by the crew while the survey was being conducted.

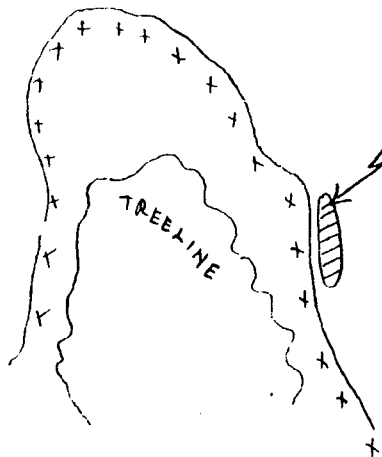
SITE 2

(B)
5x1/2 METER
OP AT BASE
OF BED ROCK
FROM 5-10cm
UNDER pebble
Veneer.

(D)
HOR/OP
2x4 METERS
5cm below
pebble surface.
VERY E2 TO
UNCOVER OIL

(C)
HOR/OP
2x4 METERS
AMONGST BOULDERS
UNDER pebble surface

(E)
CT/ST/SOR
SPORADIC
ALL ALONG IN THIS
SITE, AT HITZ
IN ROCK CRACKS
AND BEDROCK

(F)
OP 2x1 METER
AMONGST BOULDERS
JUST UNDER SURFACE

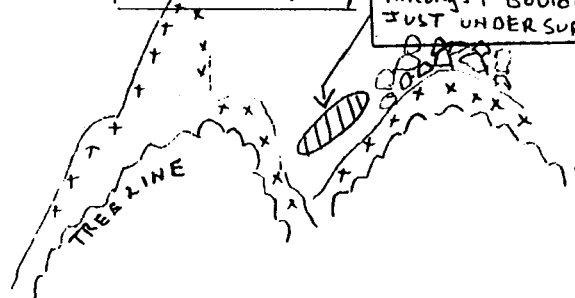
SEGMENT: ER 011 A

AP was the only oil type present at this site. All visible areas of AP were manually broken up and tilled at locations 'A', 'B', 'C', 'D', 'E', 'F' and 'G'.

Subsurface oil observed in 1993 survey consisted of small amounts of buried AP in the upper intertidal zone. The work objective for this site was strictly manual break up and an extensive subsurface oiling survey was not conducted. This segment has a history of oil becoming buried one year and reappearing the next and hence some buried asphalt probably remains.

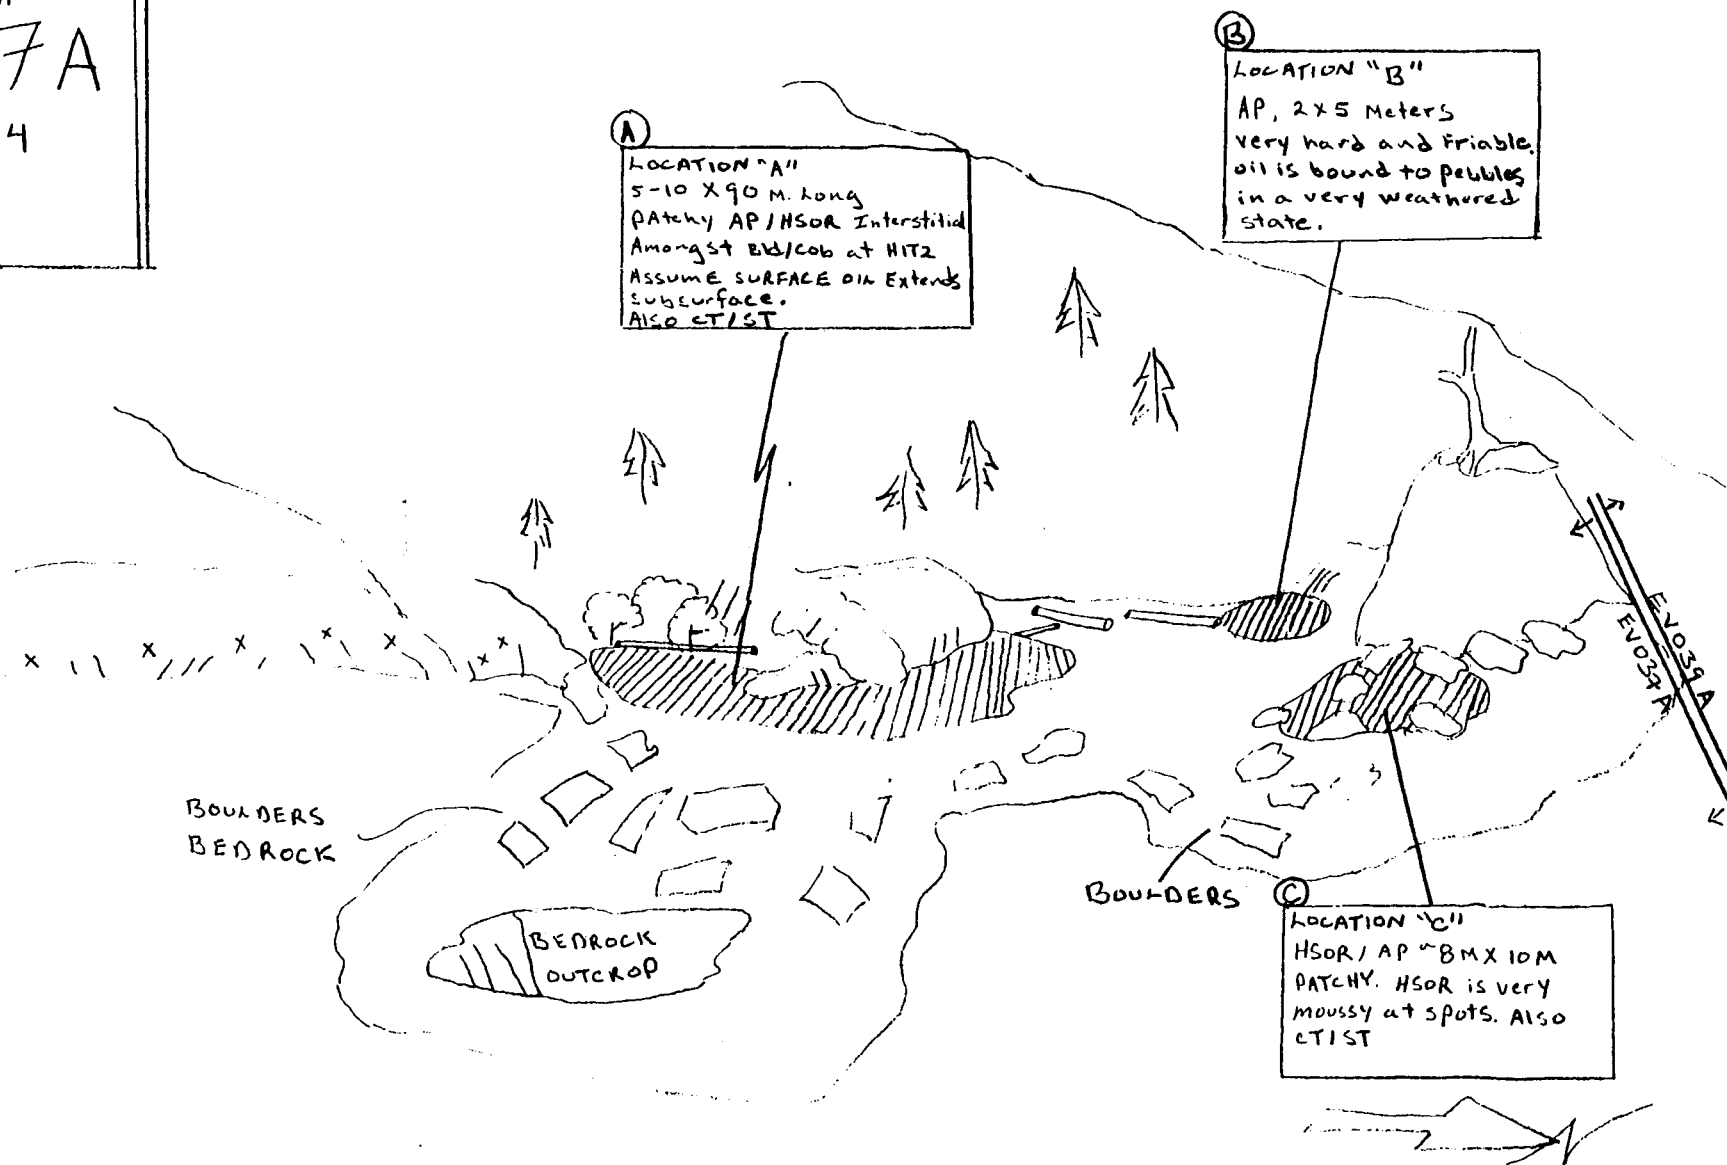
SKETCH "A"
EV=37A
8-19-94
0930 - 1200
3.0' - 9.0'
MUNSON

Sediments are poorly sorted, subangular to rounded pebbles to boulders with much bedrock outcrop. Freshwater flows across the central part of the beach and is noted as a stream in the 1993 field sketch. The northern part of this site consists of rounded large pebble gravel and high-tide berms in the upper intertidal which grades to cobbles and small boulders in the lower intertidal. The area south of the stream, which is designated in the field sketch, consists of boulders and much bedrock outcrop.

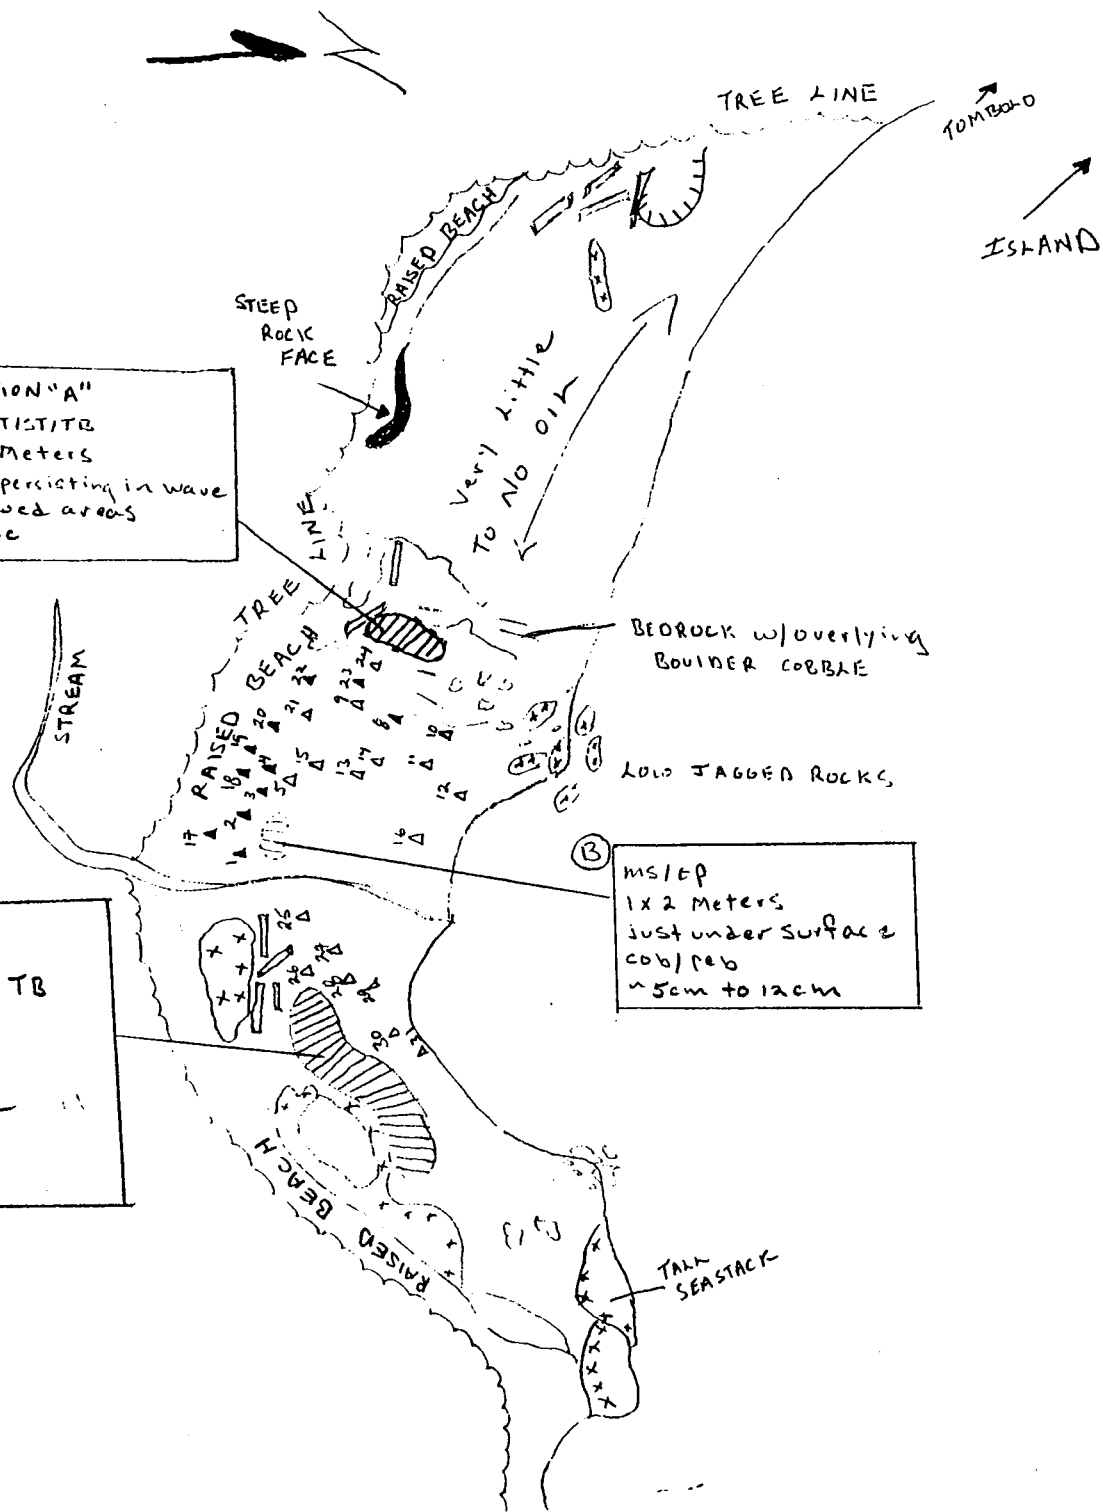
①
LOCATION "A"
SORICTIST/TB
5 X 10 METERS
oil is persisting in wave
shadowed areas
sporadic

②
MS/EP
1 X 2 METERS
just under surface
cob/peb
~5cm to 12cm

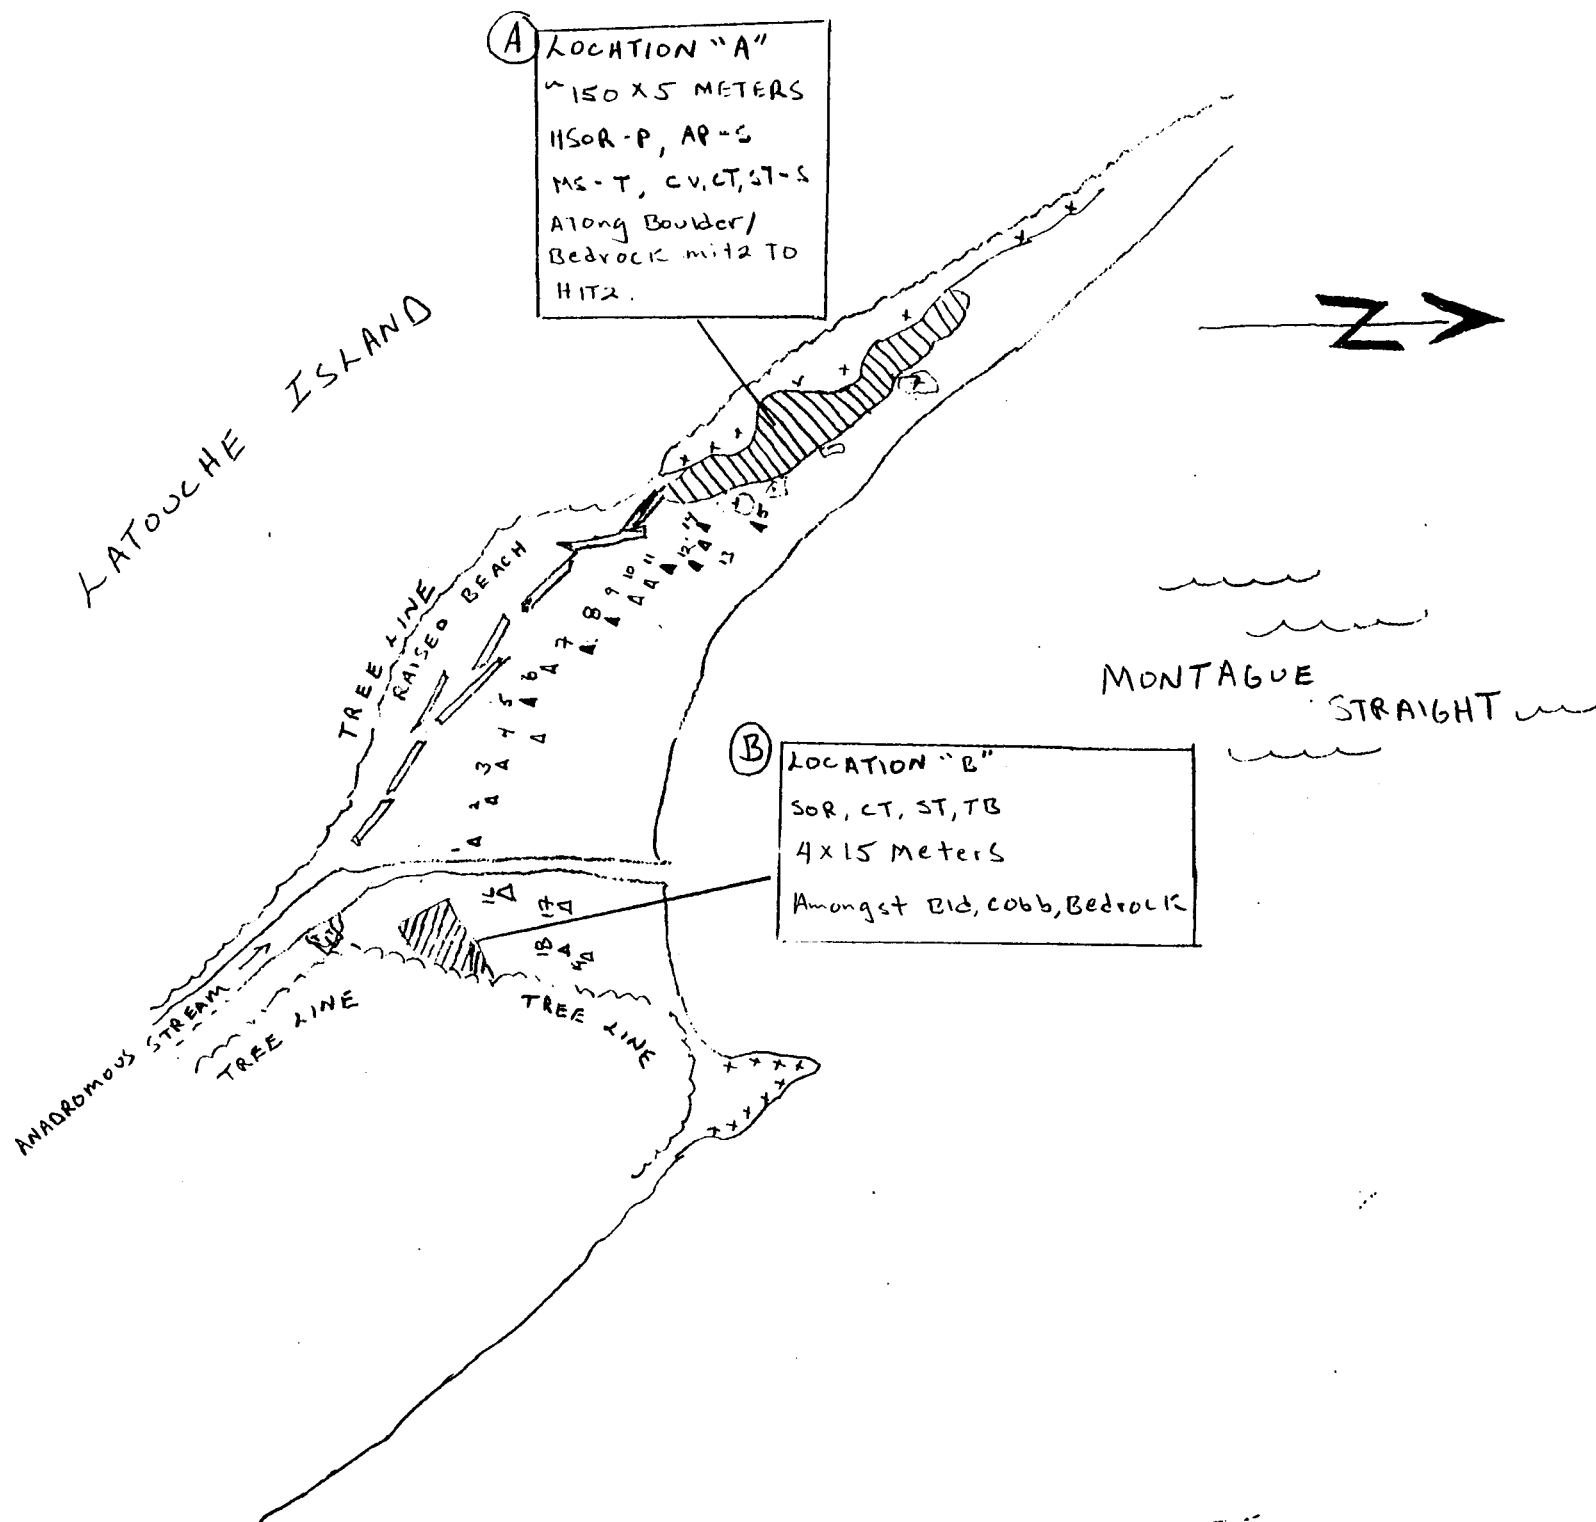
SEGMENT: LA 015 E

Three moderate sized areas, locations 'E', 'J' and 'G' have relatively unweathered areas of AP and SOR persisting. These three locations are in areas where large boulders or outcrops provide protection from waves. In many cases MS was observed oozing out from beneath the boulders. There are several other locations within this site with substantial areas of weathered surface oil.

Subsurface oil was observed discontinuously through the main beach area. In some cases the unweathered surface oil above extends to subsurface OP. An oiled mussel bed of approximately 30 by 40 meters exists at location 'D'.

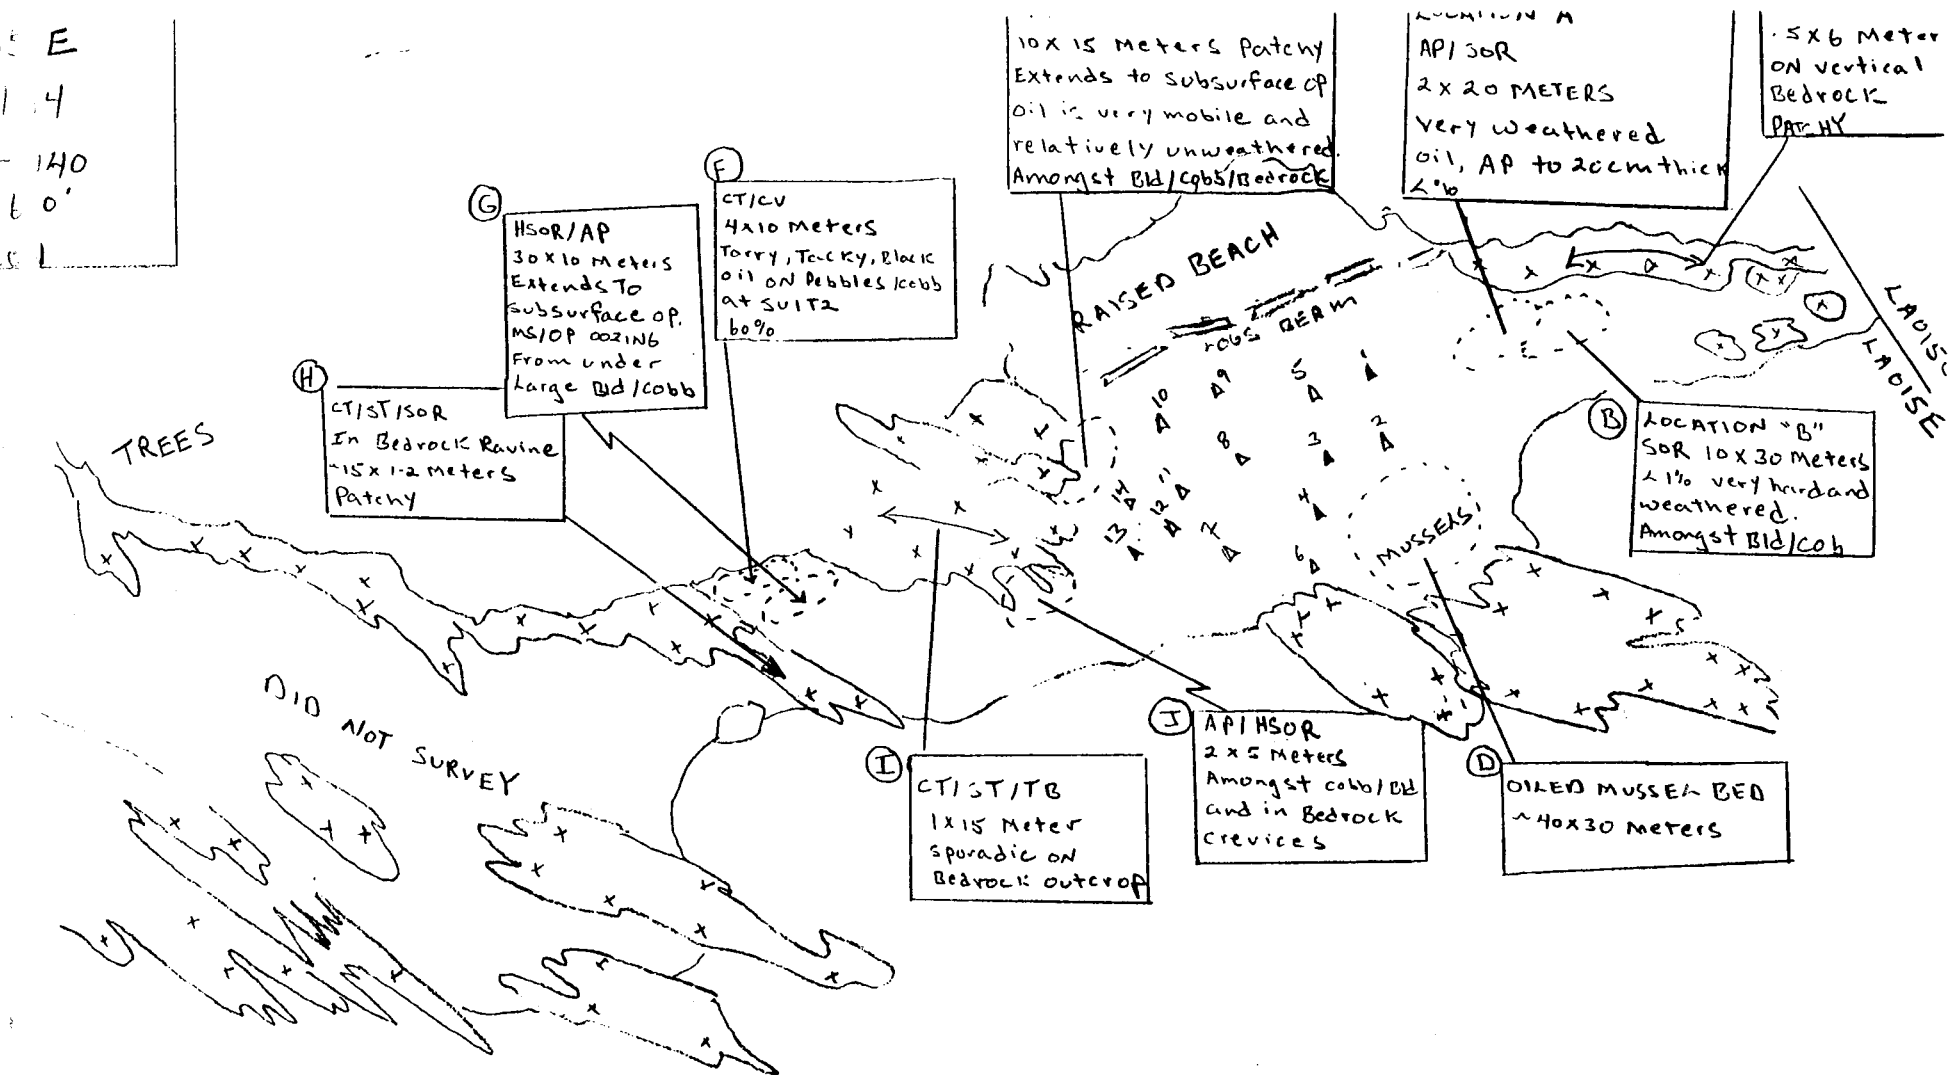
1SEGMENT: LA 020 C

Three significant areas of subsurface oil remains at this site. Location 'ZA' is amongst the very large boulders of surface location 'A'. Location 'ZB' is coincident with surface location 'B', the surface oil at this location often extends subsurface. The largest concentration of subsurface oil observed was within location 'ZD'.

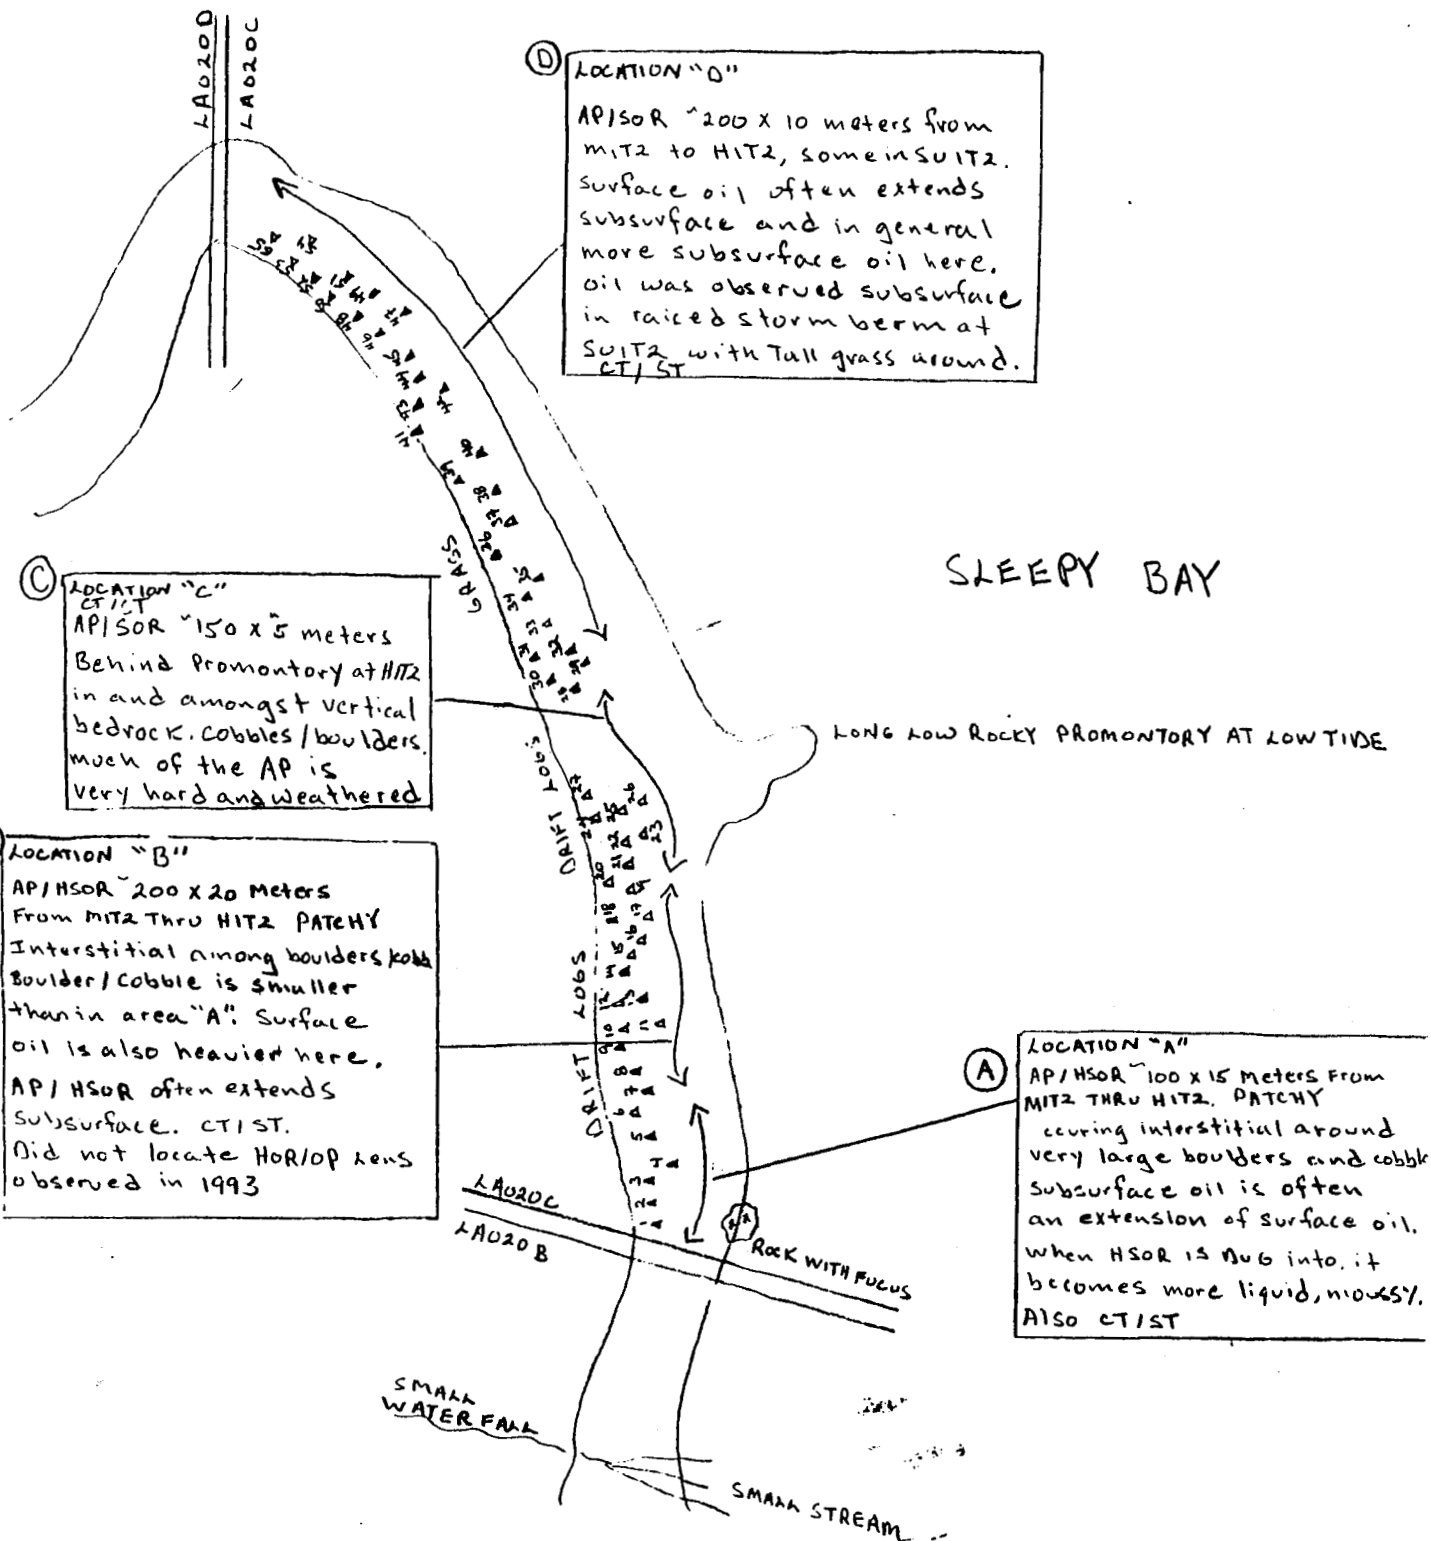
SEGMENT: LA 021 A

Oiling observed was limited to one area of AP and SOR in the upper intertidal zone.
