Exxon Valdez Oil Spill
General Restoration Project Final Report

Kenai Peninsula Streambank Rehabilitation and Protection Project

Exxon Valdez Oil Spill Trustee Council Project 26230602
Final Report

May 2026

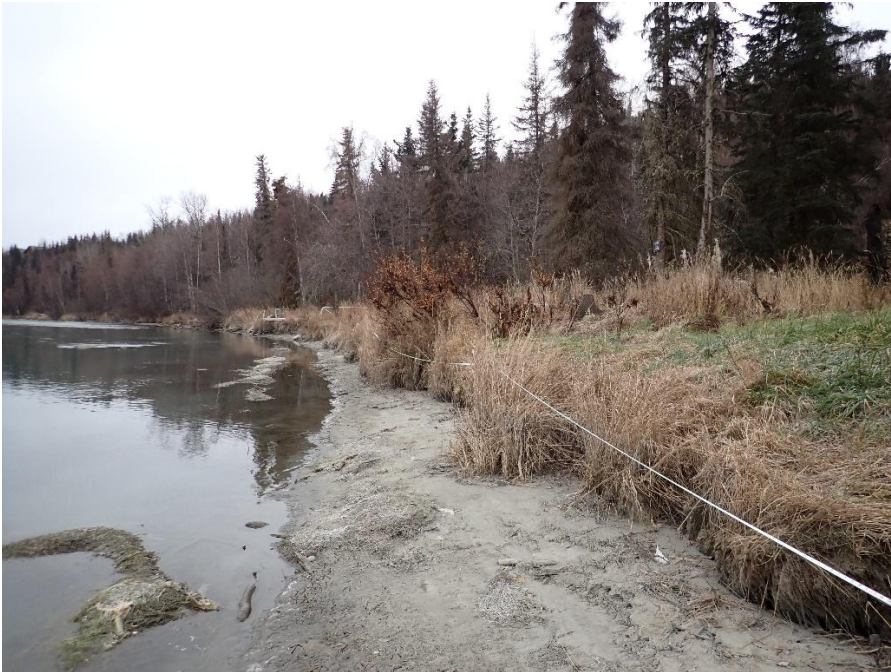
Figure 2. Pre-construction looking downstream at site 202333, October 2022.

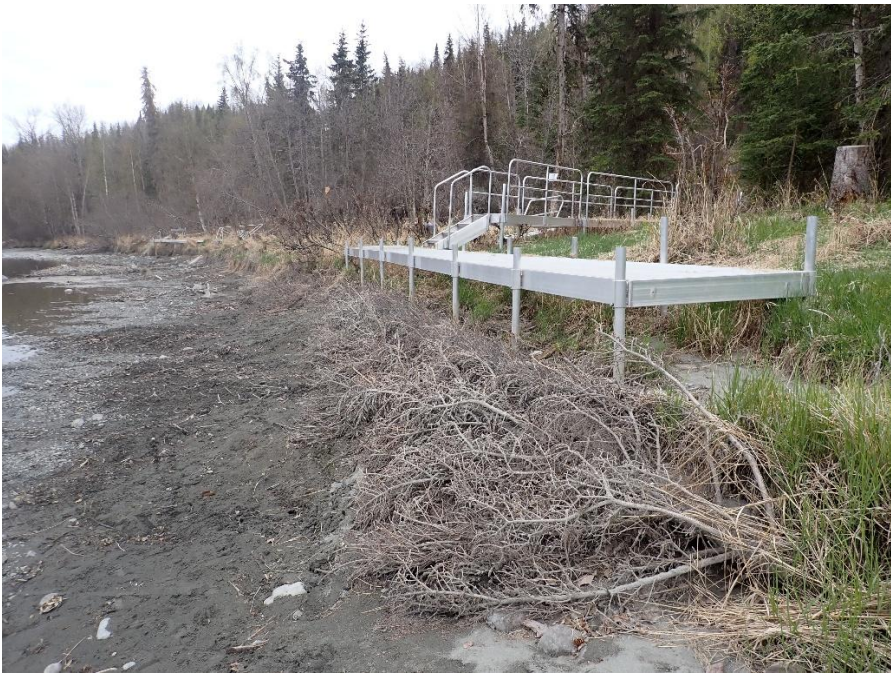
Figure 3. Post-construction looking downstream at site 202333, May 2024.

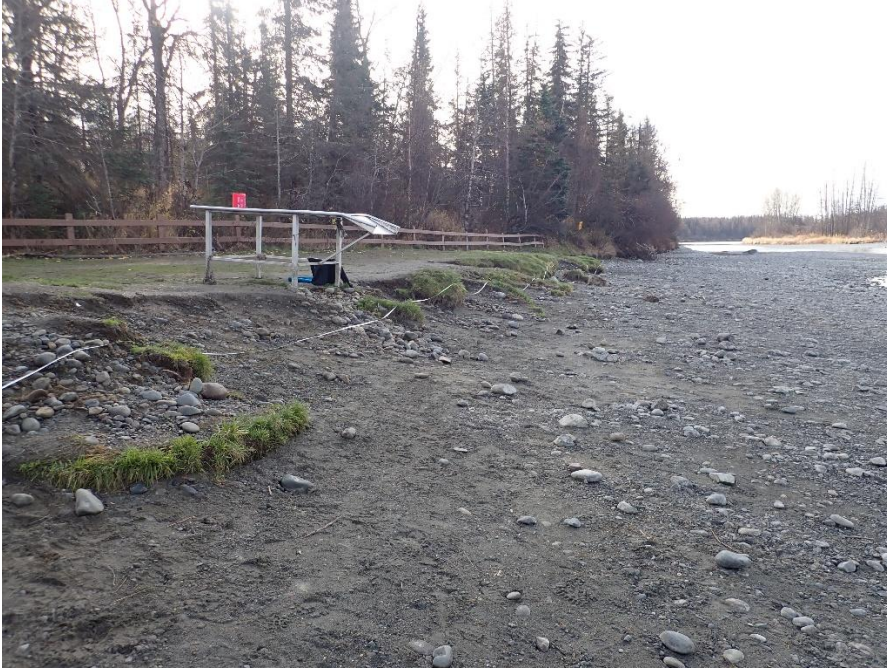
Figure 4. Pre-construction looking downstream at site 202427, October 2023.

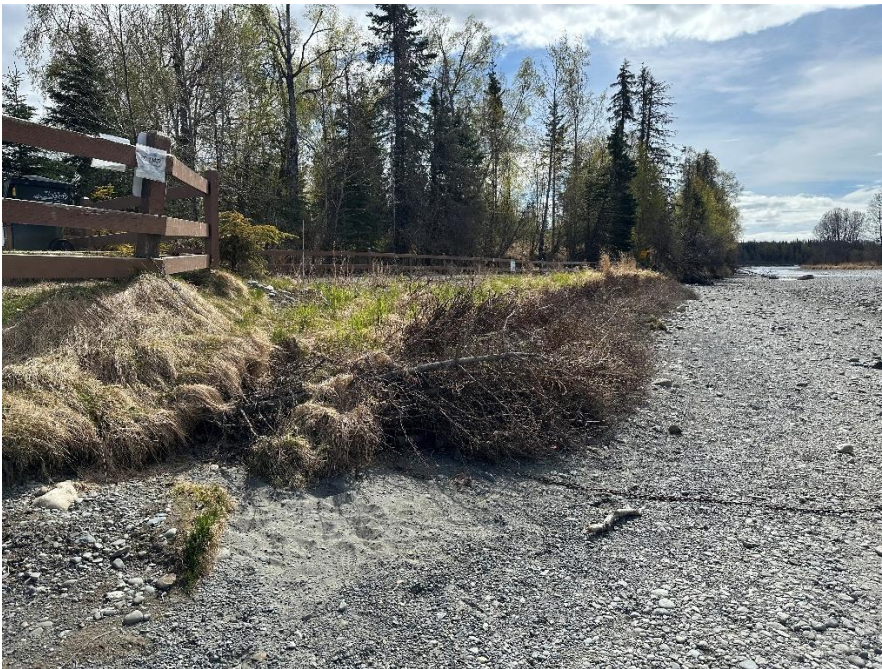
Figure 5. Post-construction looking downstream at site 202427, May 2025.

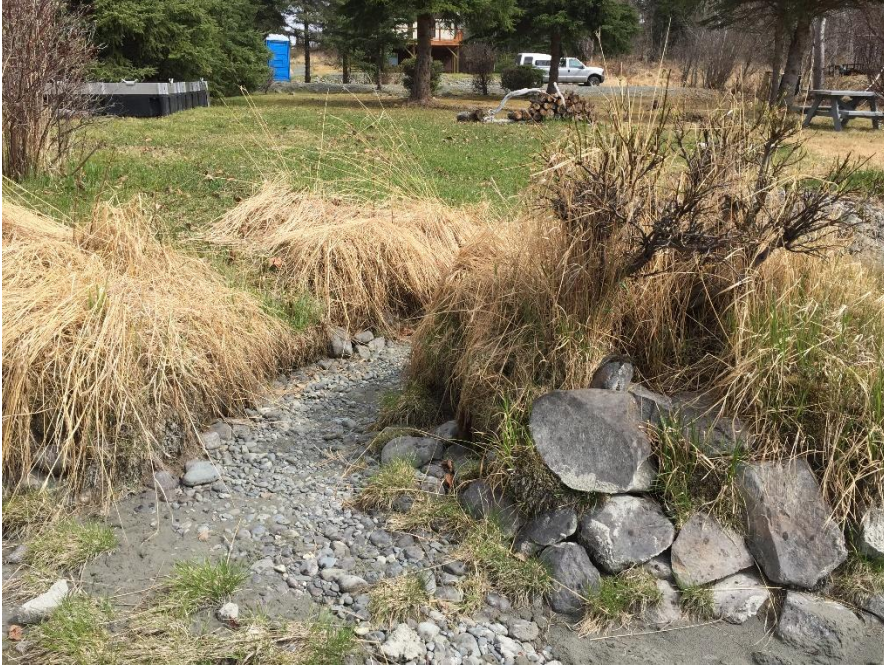
Figure 6. Site 201803, monitoring location, May 2018.

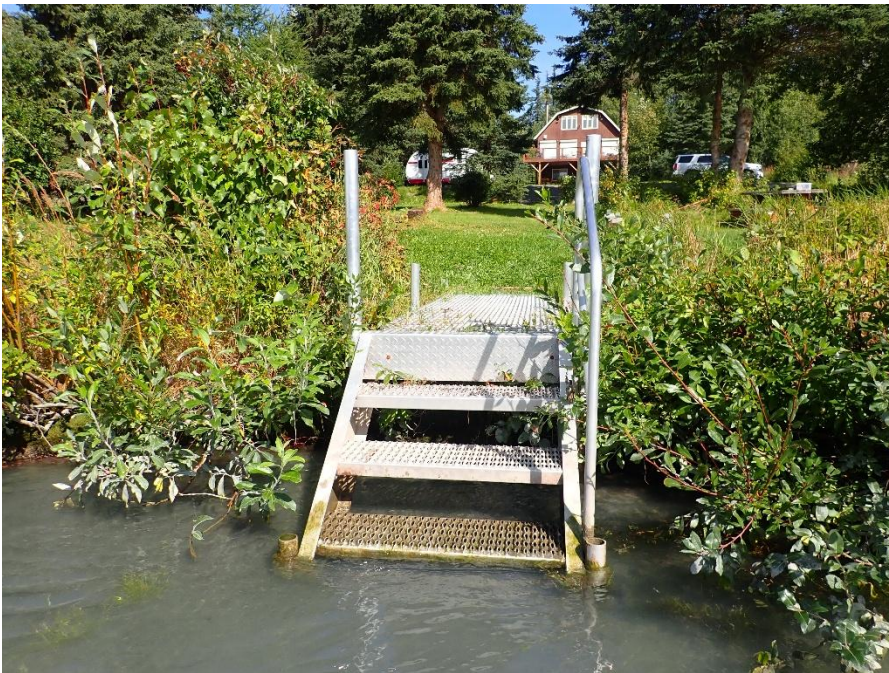
Figure 7. Site 201803, monitoring location, August 2024.

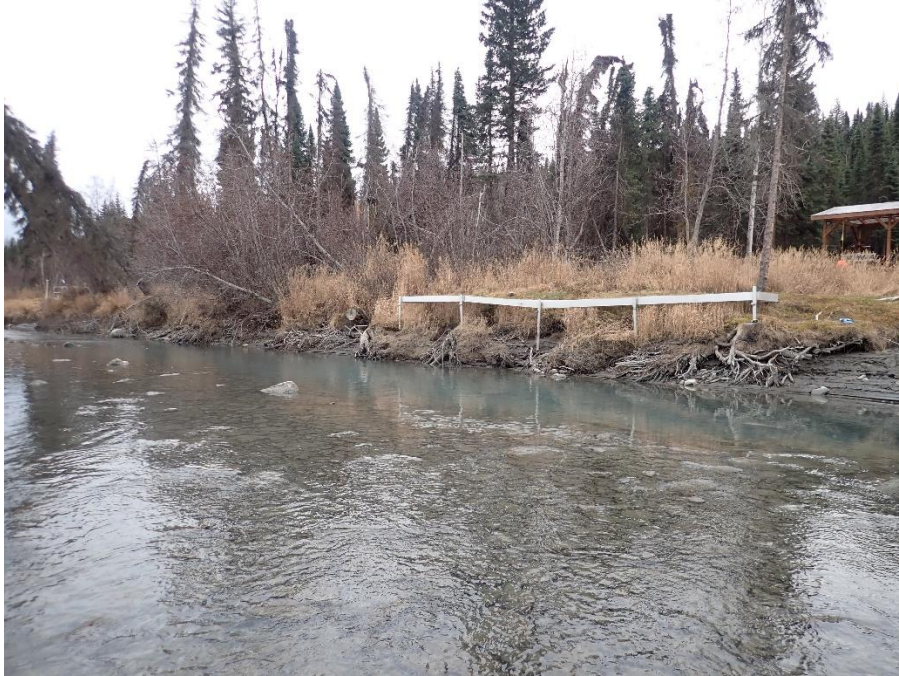
Figure 8. Pre-construction looking at the bank of site 202519, October 2024.

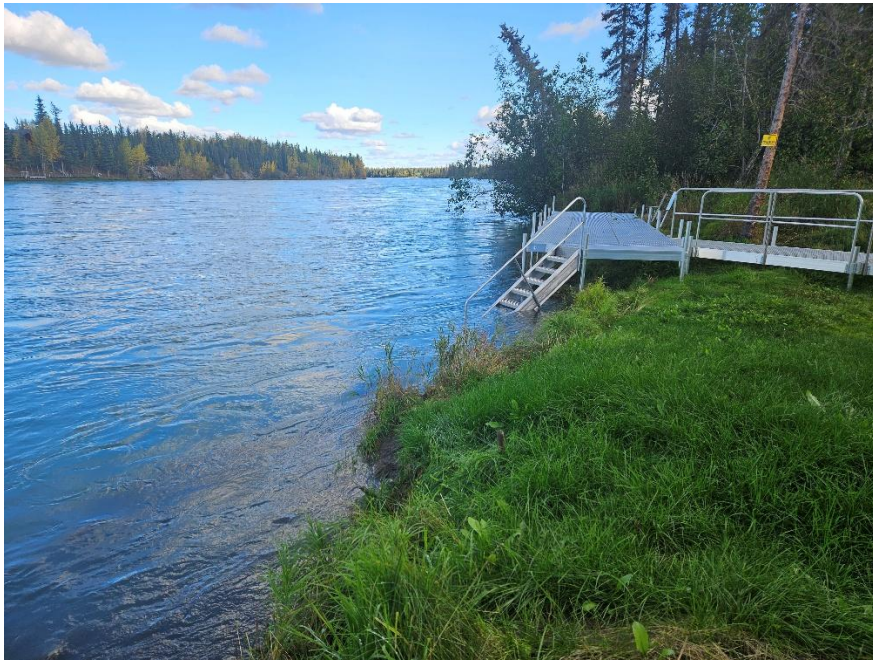
Figure 9. Post-construction looking at the bank of site 202519, September 2025.

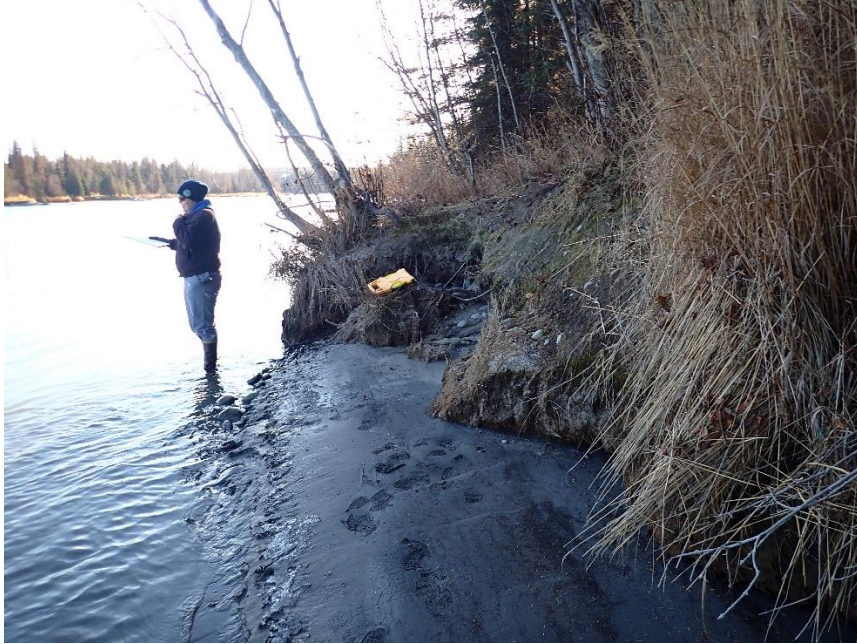
Figure 10. Site 202117, monitoring location, October 2020.

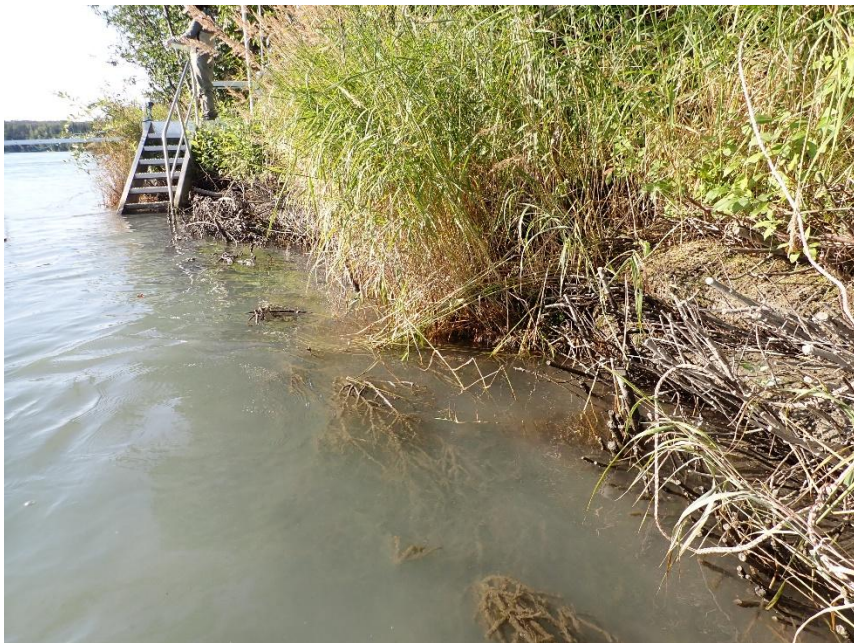
Figure 11. Site 202117, monitoring location, August 2024.

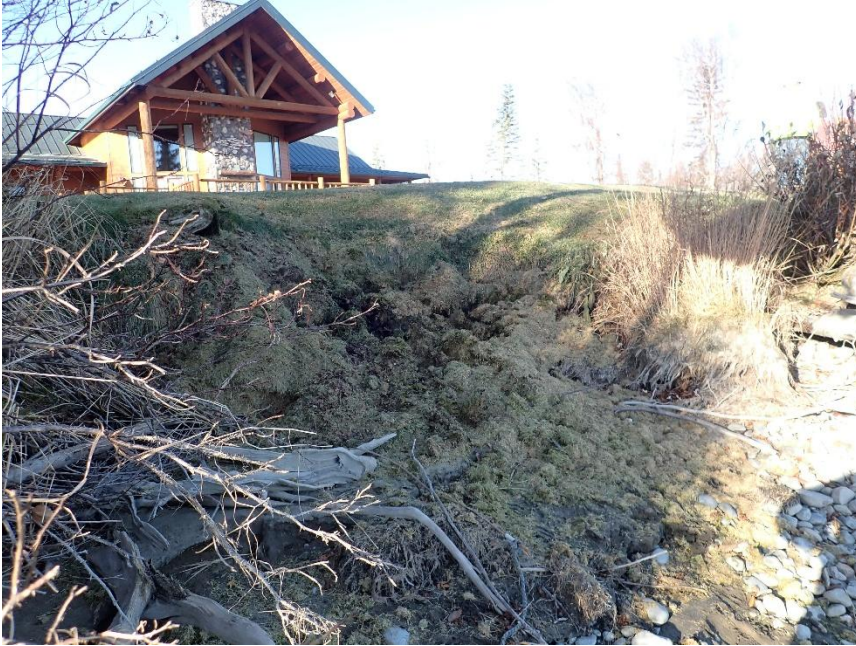
Figure 12. Pre-construction looking downstream at site 202526, October 2024.

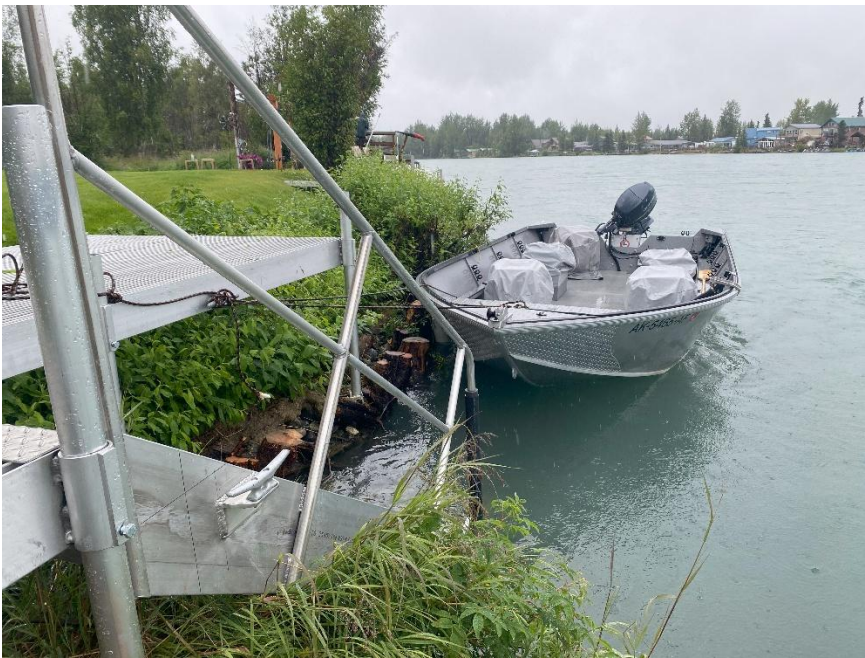
Figure 13. Post-construction looking downstream at site 202526, July 2025.

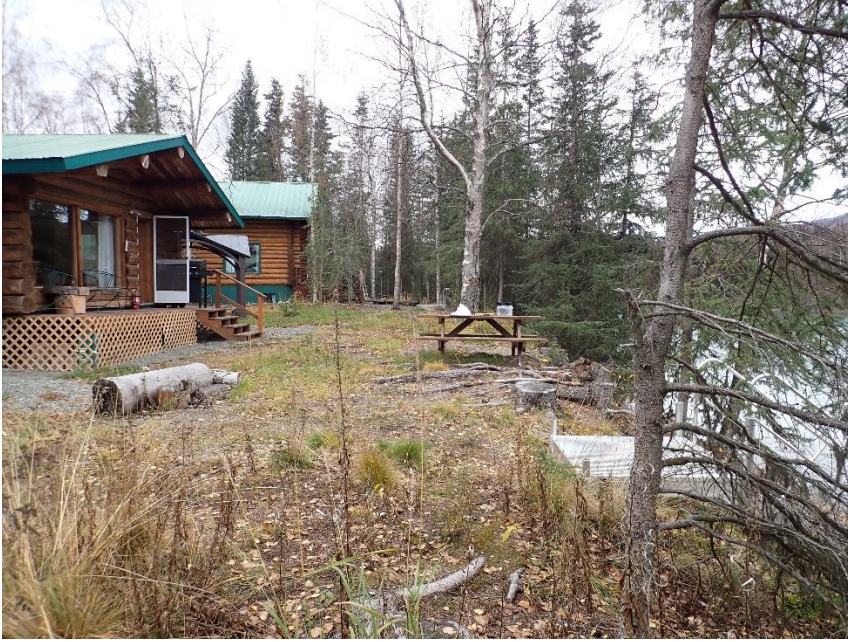
Figure 14. Pre-construction looking at the top of bank riparian at site 202444, October 2023.

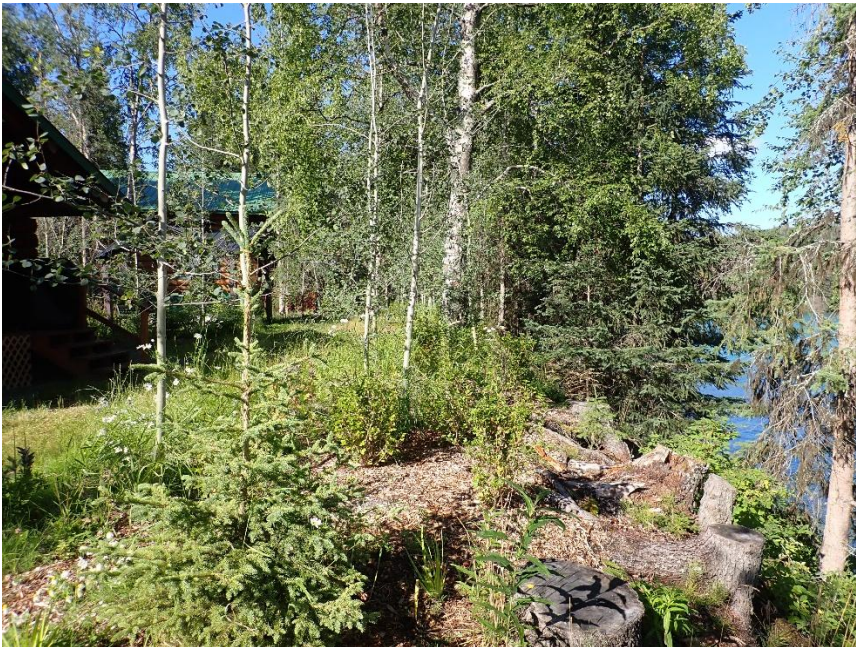
Figure 15. Post-construction looking at the top of bank riparian at site 202444, August 2024.

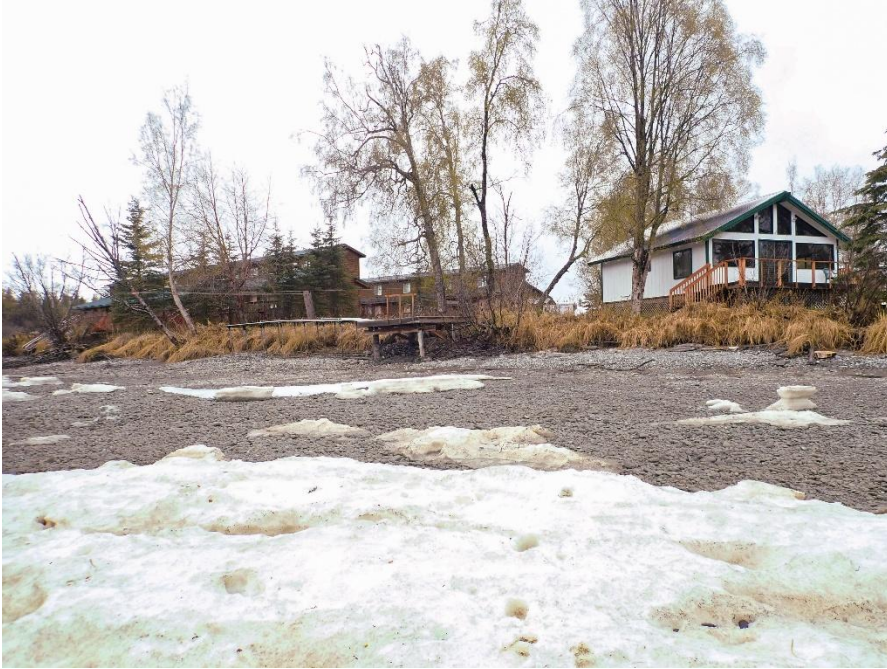
Figure 16. Pre-construction looking at the bank at site 202341, May 2022.

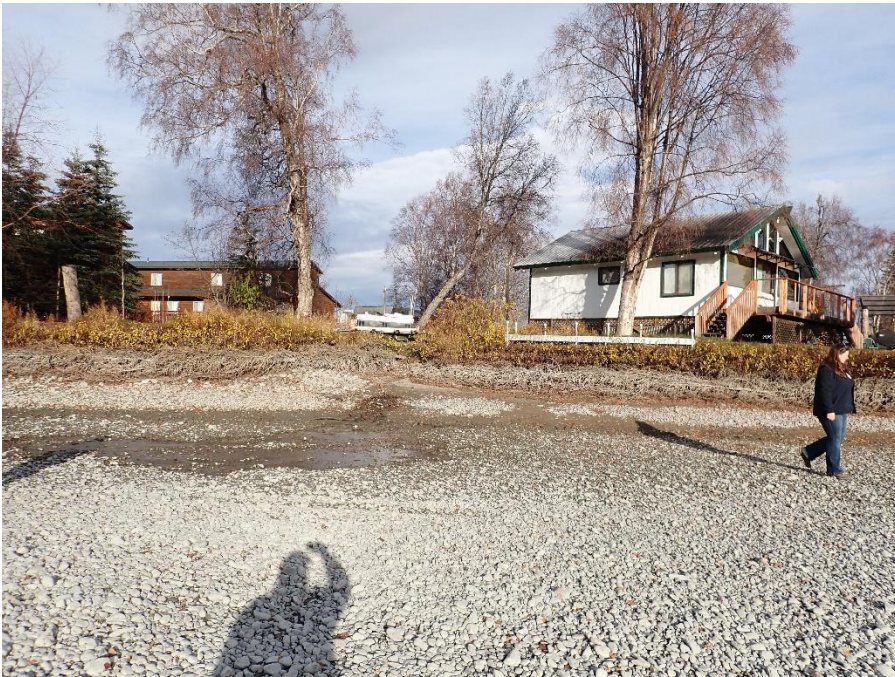
Figure 17. Post-construction looking at the bank at site 202341, May 2023.

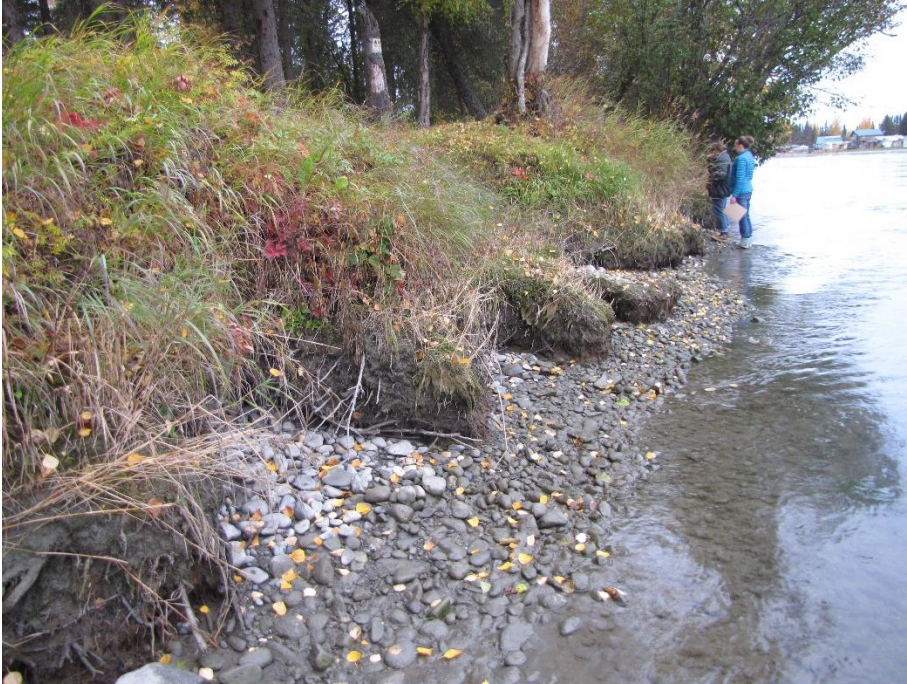
Figure 18. Site 201928, monitoring location, October 2018.

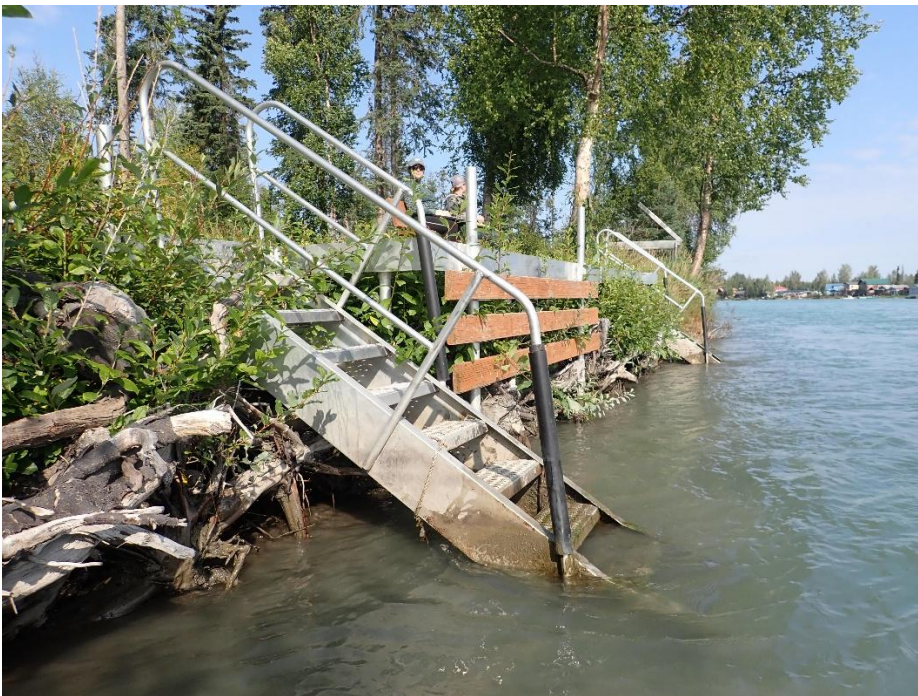
Figure 19. Site 201928, monitoring location, August 2024.
