*Exxon Valdez* Oil Spill  
Restoration Project Annual Report

Archaeological Restoration, Index Site Monitoring, 1998

Restoration Project 98007A  
Annual Report

April, 1999

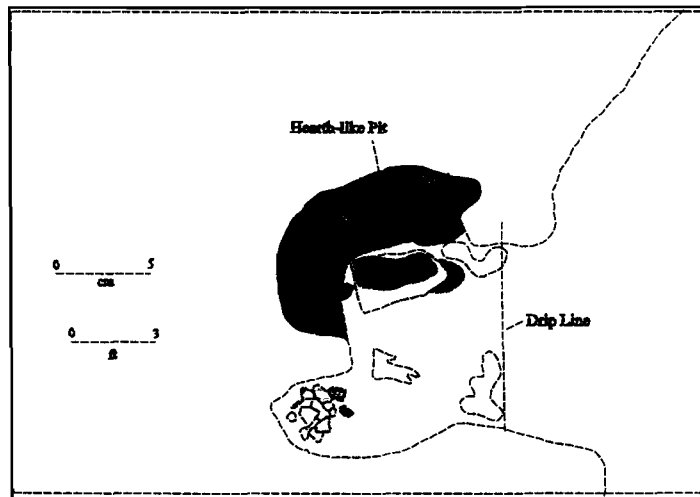
**Figure 8.** Crafton Island Cave map.

The site visit was conducted on July 10, 1998 (Figure 7). Comparisons were made with fieldnotes and a scaled map produced from previous fieldwork (Dekin, et al. 1993). The cave opening is oriented to the southeast and measures 9m wide by 22m high. The interior is 16m wide by 14m deep. The midden covers a 4m x 10m area and is over a meter deep. The prominent rock slab at the entrance is covered by a thin layer of midden, large mammal bones, slate debitage, and otter or fox scat.
