Exxon Valdez Oil Spill
Restoration Project Final Report

Montague Island Riparian Rehabilitation

Restoration Project 97139C1
Final Report

November 1998

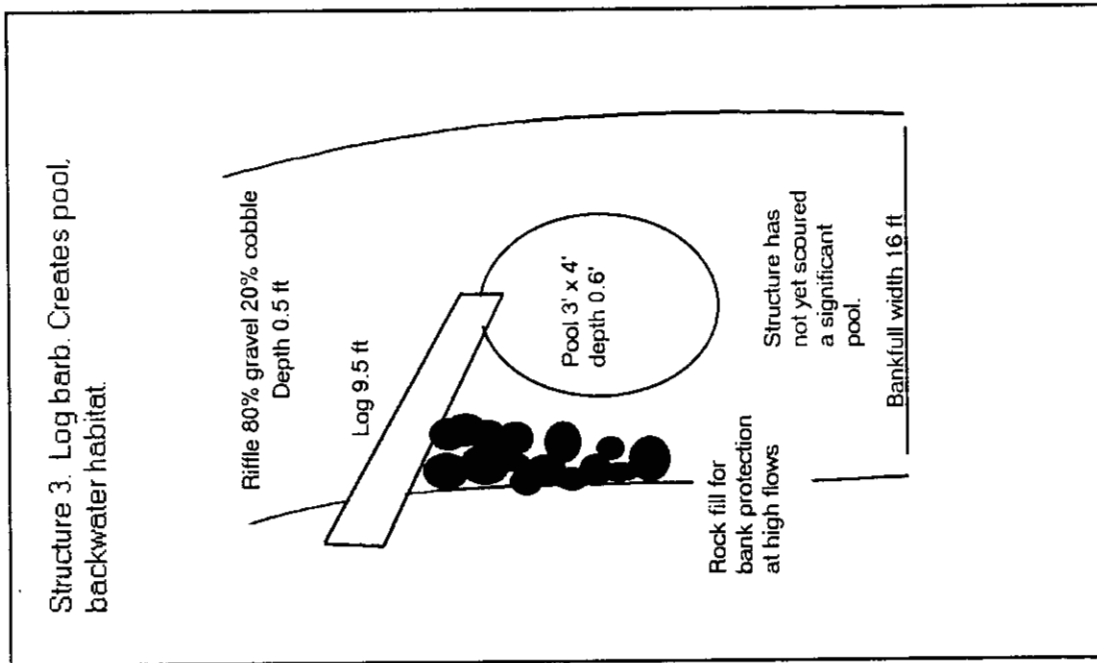
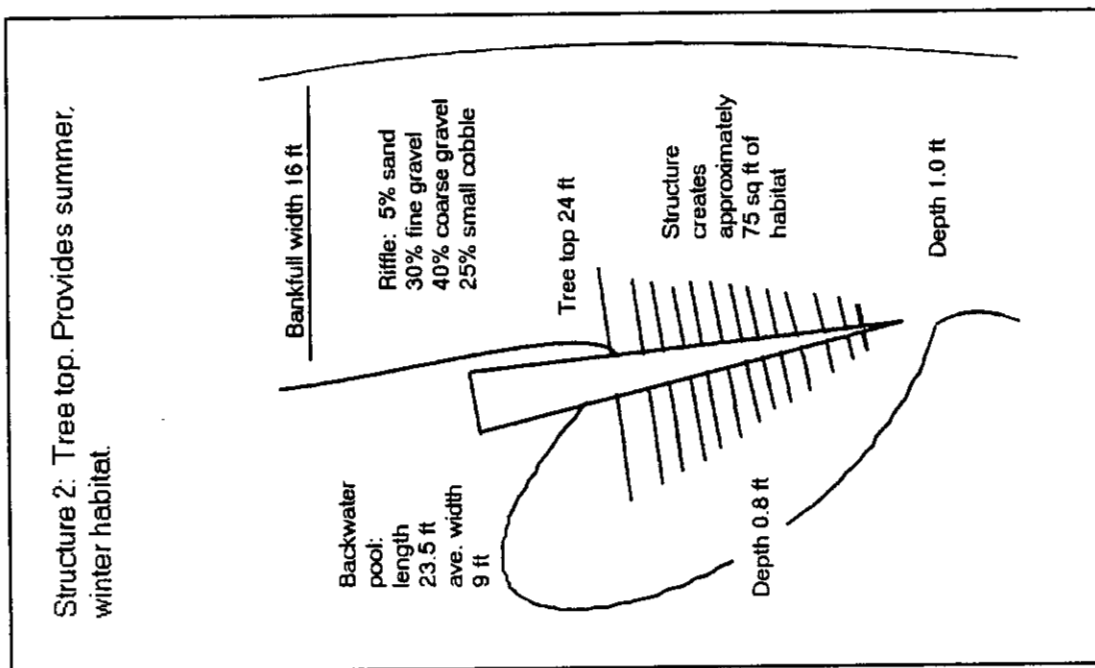
Appendix 2. Diagrams of remaining structures and habitat features. Diagrams of the failed structures are included in the 1994 annual report. Figures not drawn to scale.

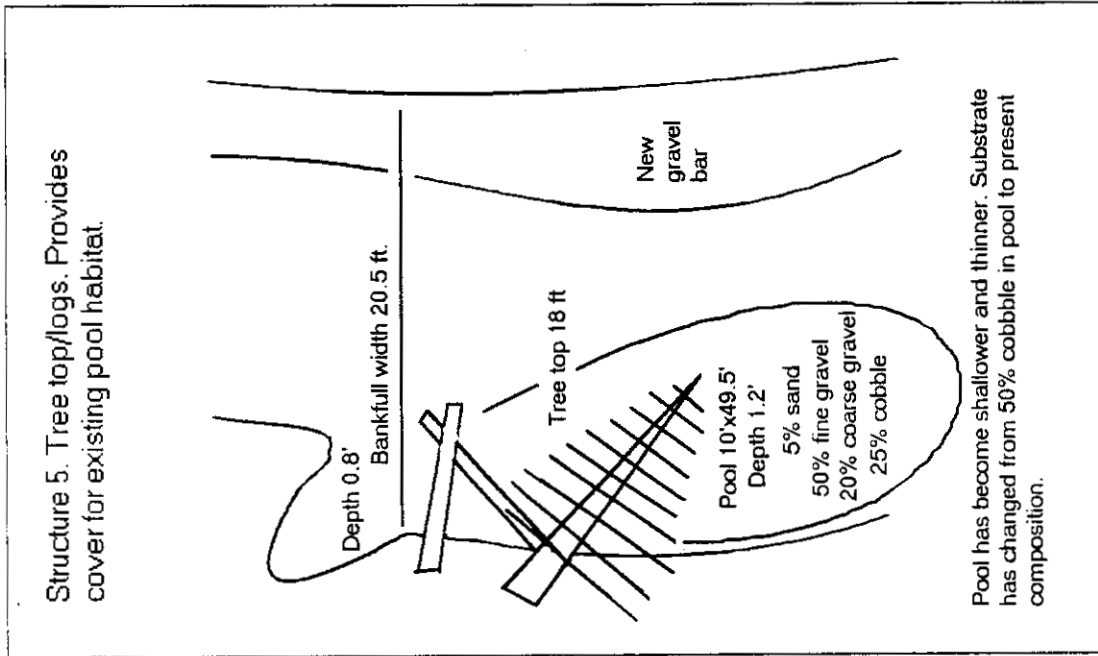
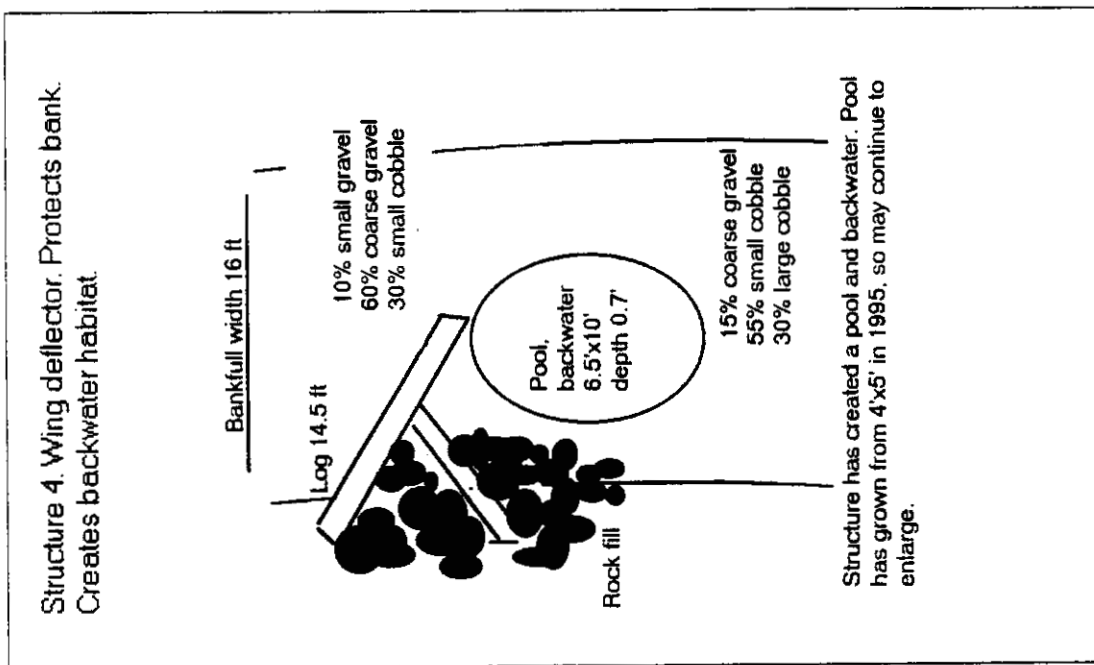
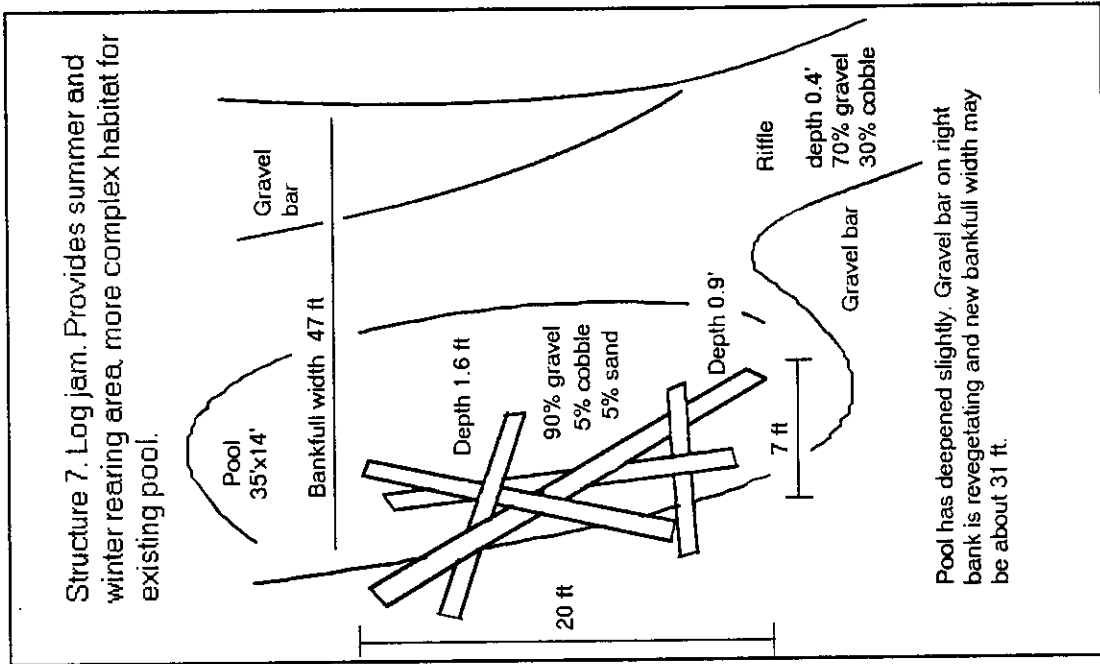
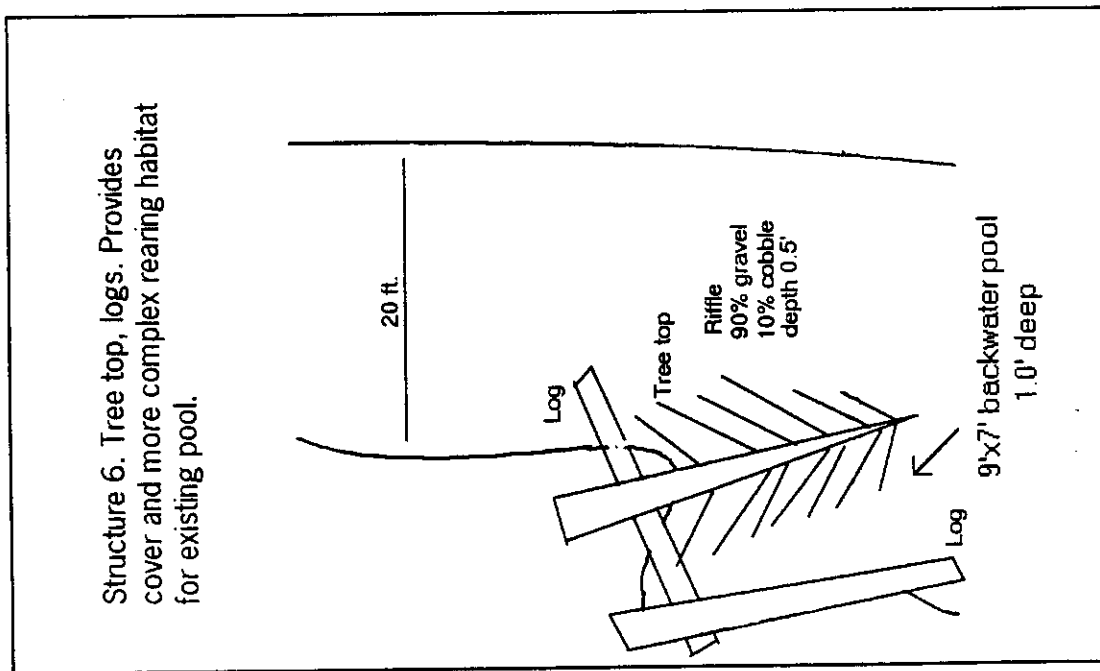
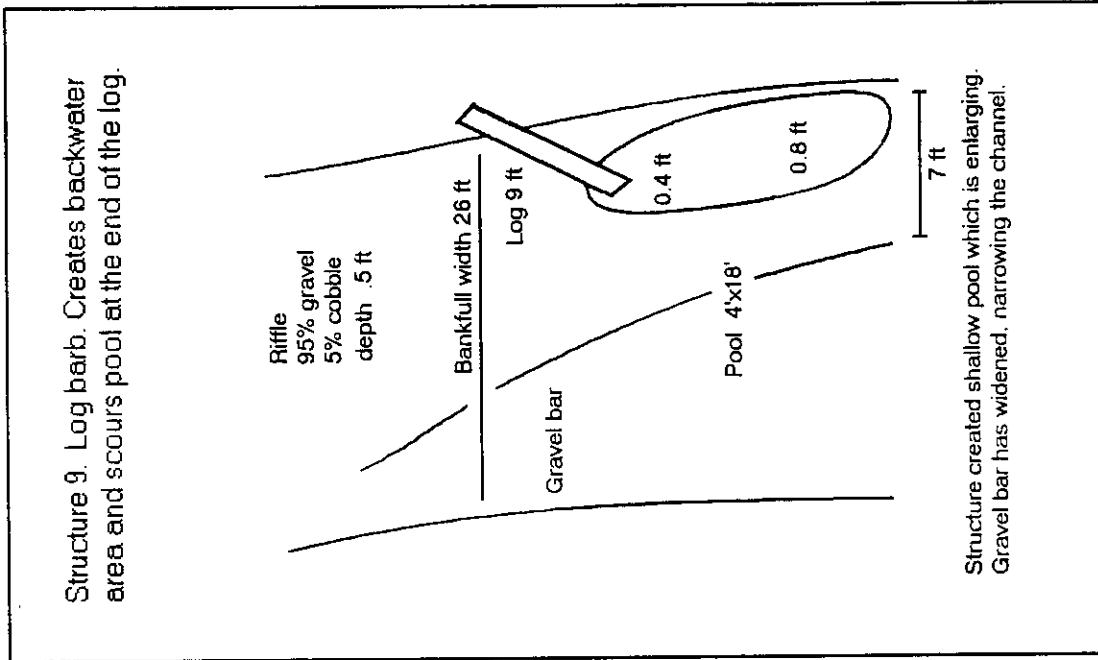
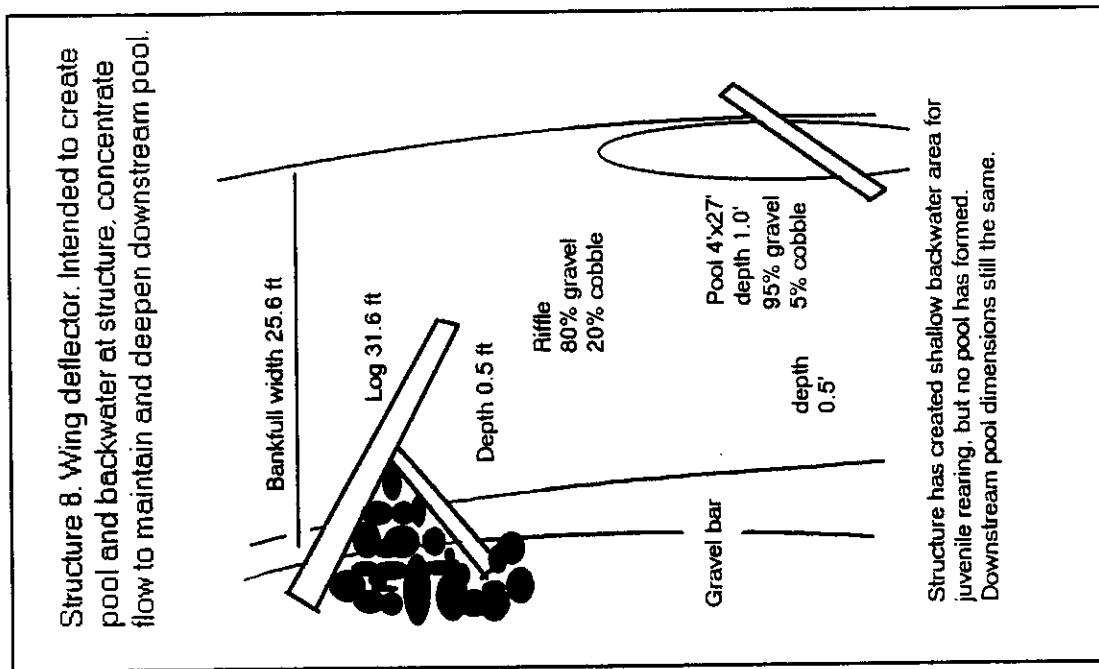
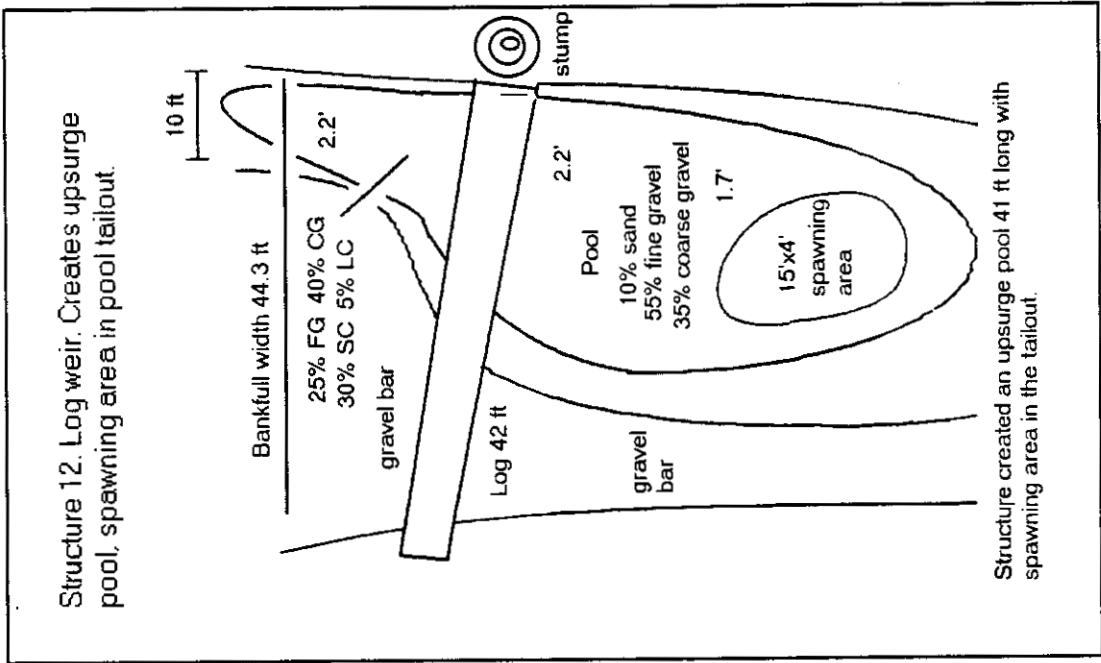
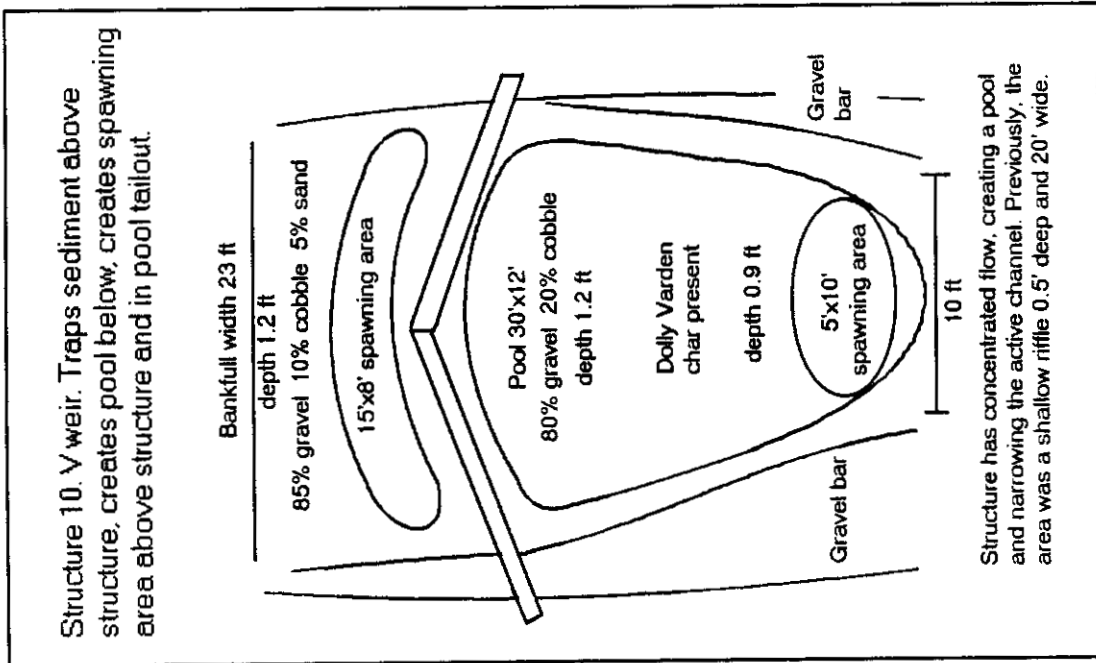
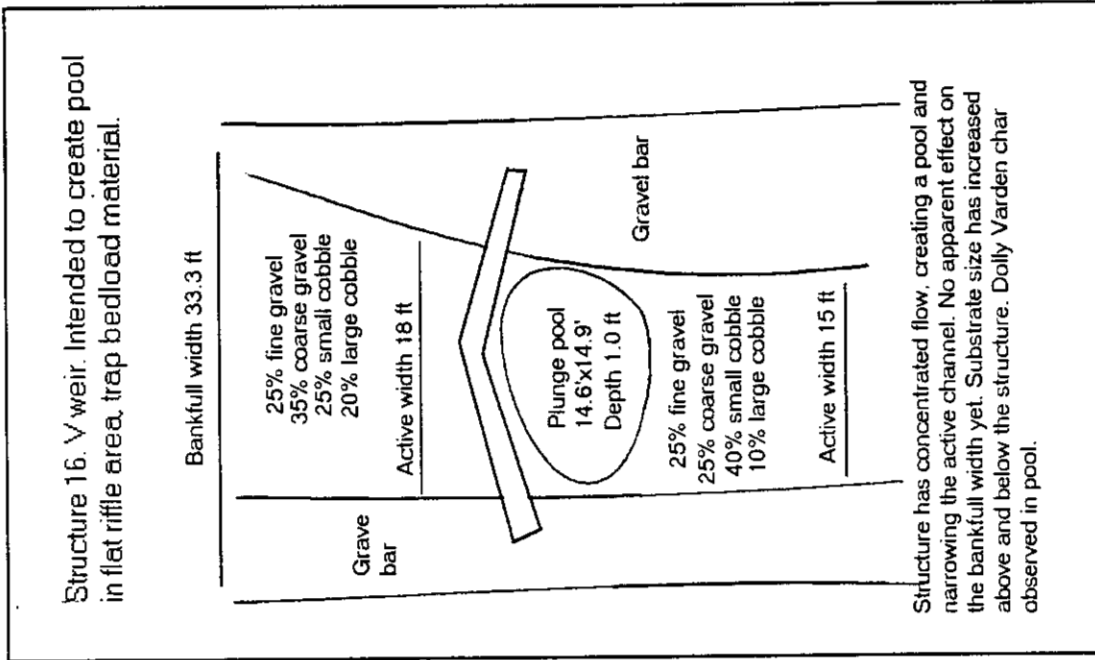
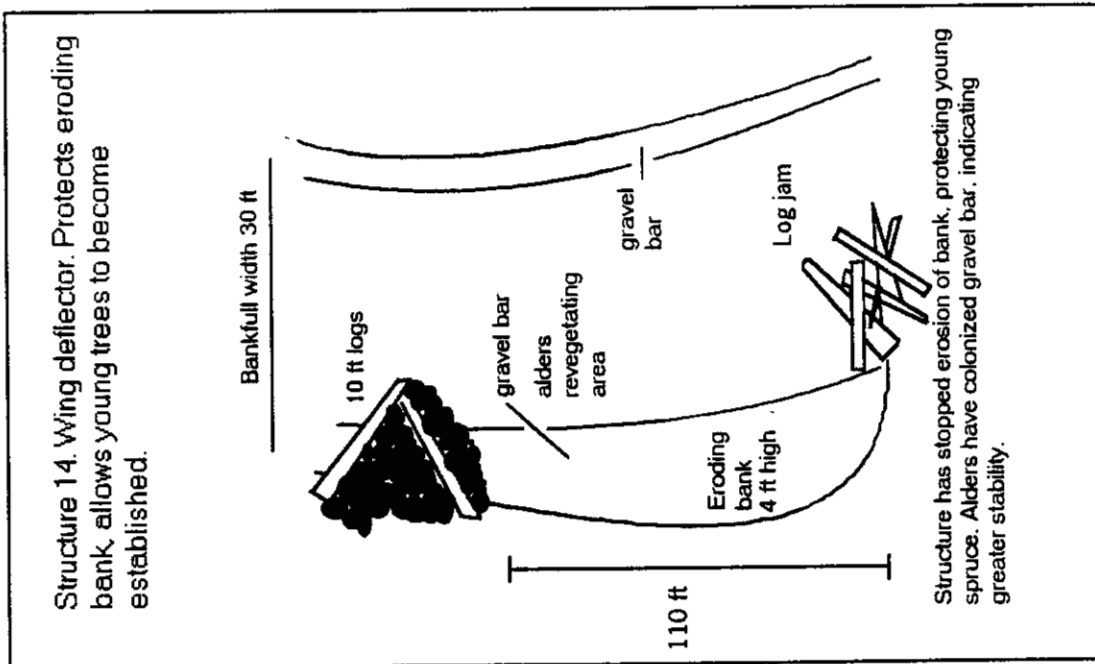
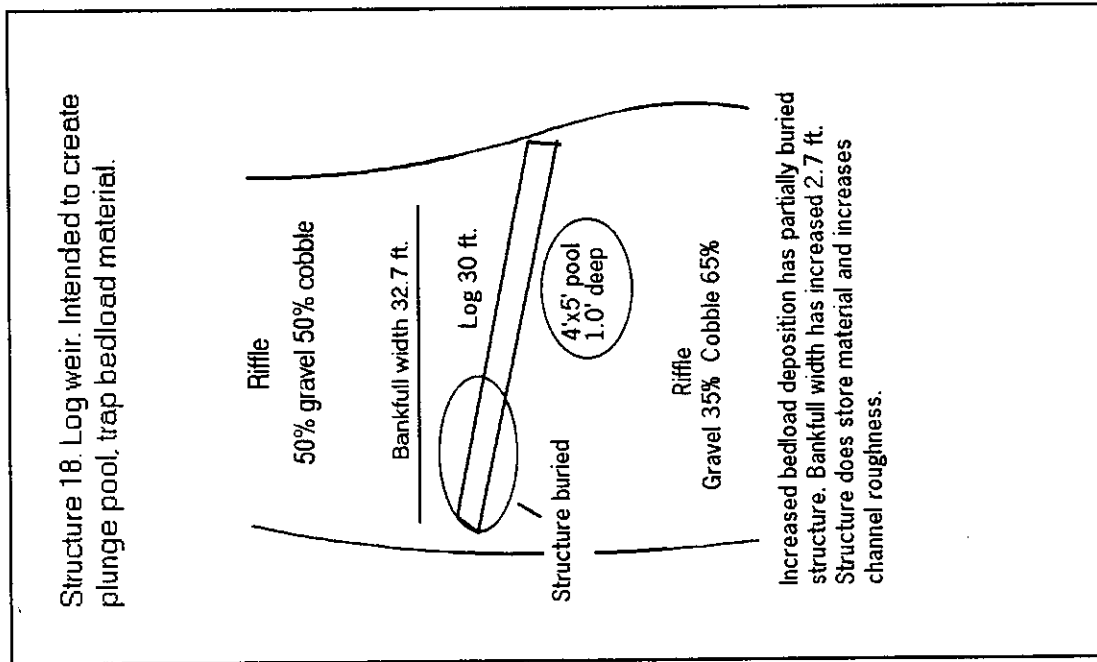
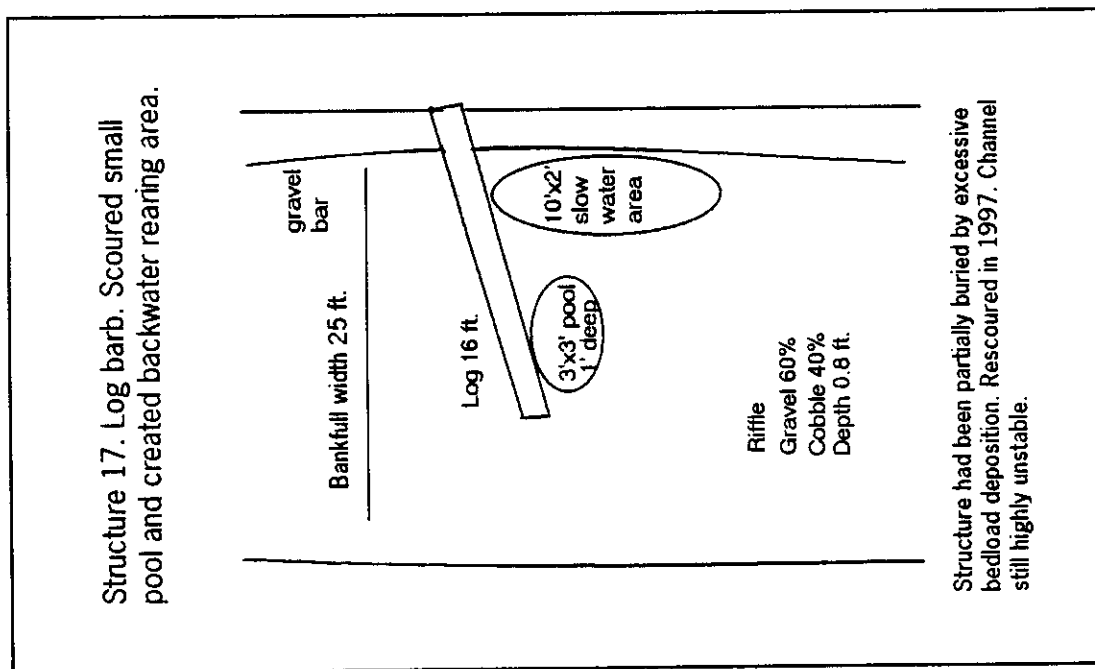
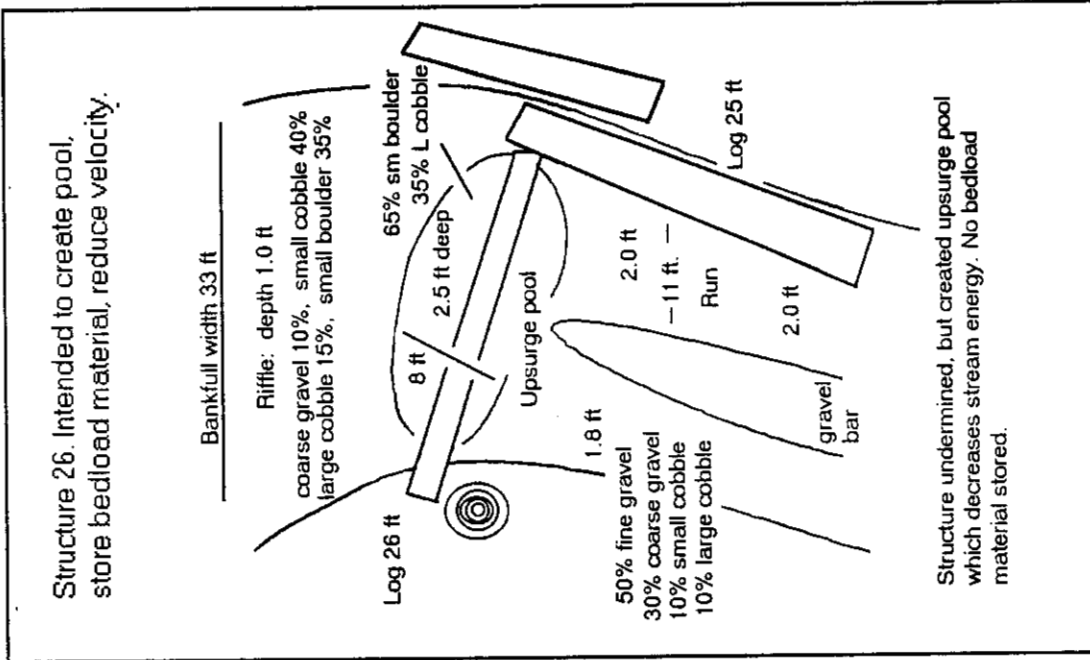
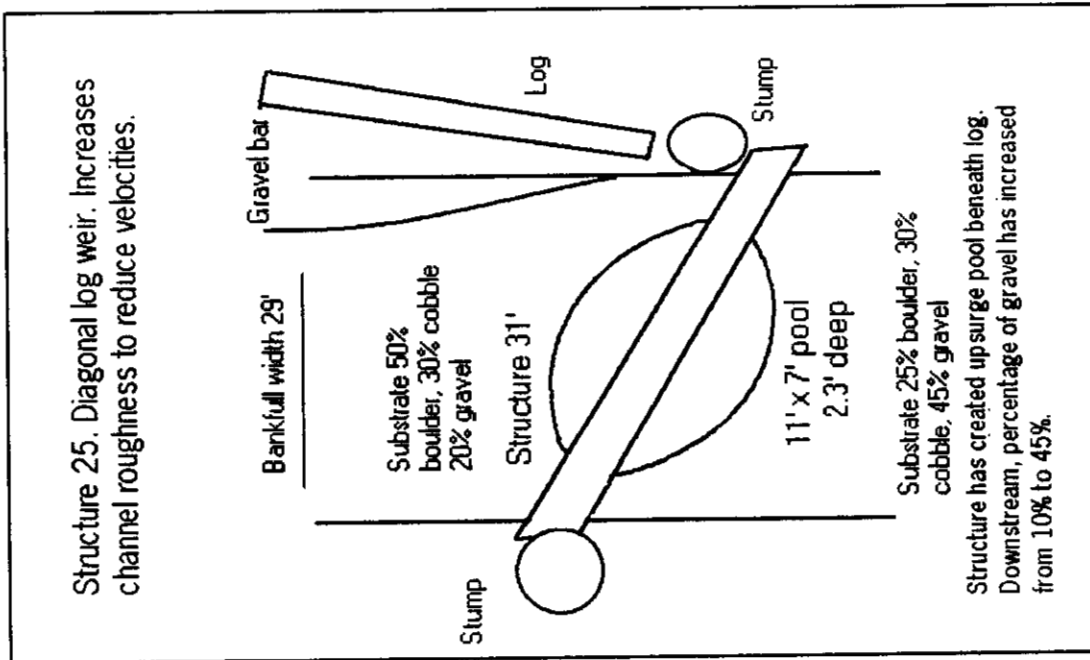
Appendix 2 continued. Diagrams of remaining structures, habitat features. Not drawn to scale.
