*Exxon Valdez* Oil Spill  
Restoration Project Annual Report

Montague Island Chum Salmon Restoration  
Restoration Project 94139C1  
Annual Report

# Montague Island Chum Salmon Restoration

## Restoration Project 94139C1 Annual Report

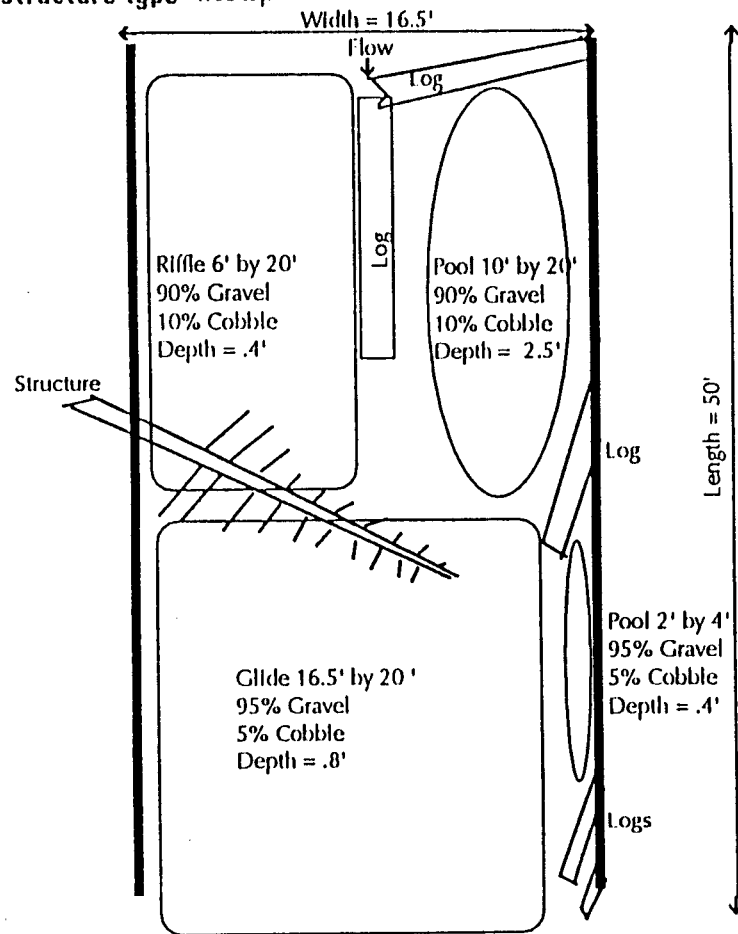
**Structure Number 1** Location Left trib, 264' from mouth.  
 Hanning Creek, Hanning Bay, Montague Island, AK.  
 Structure type Tree top

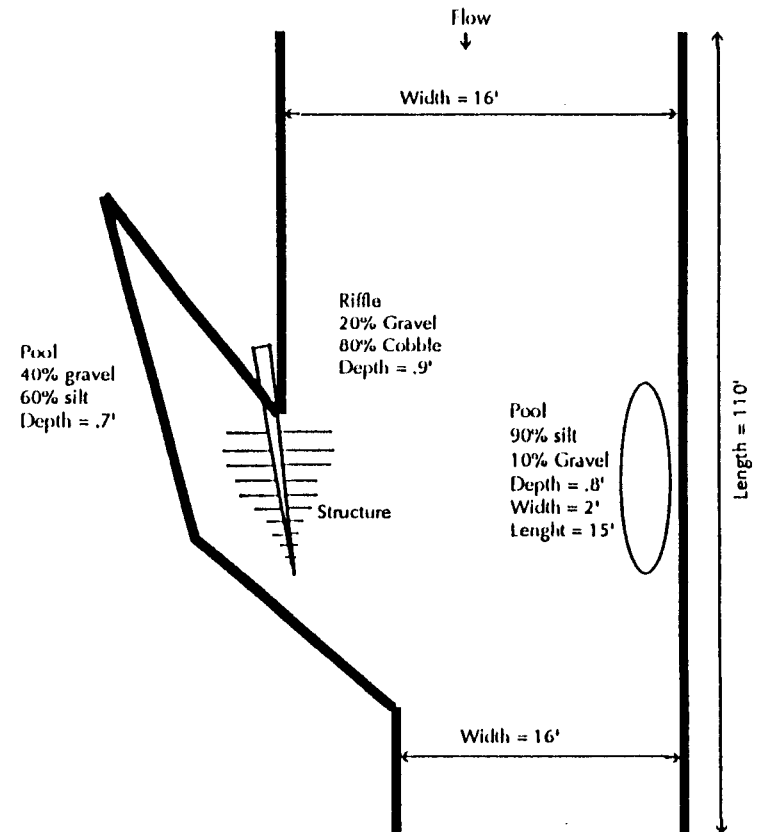
**Structure Number 2** Location Left trib, 1000' from mouth.  
 Hanning Creek, Hanning Bay, Montague Island, AK.  
 Structure type Tree top

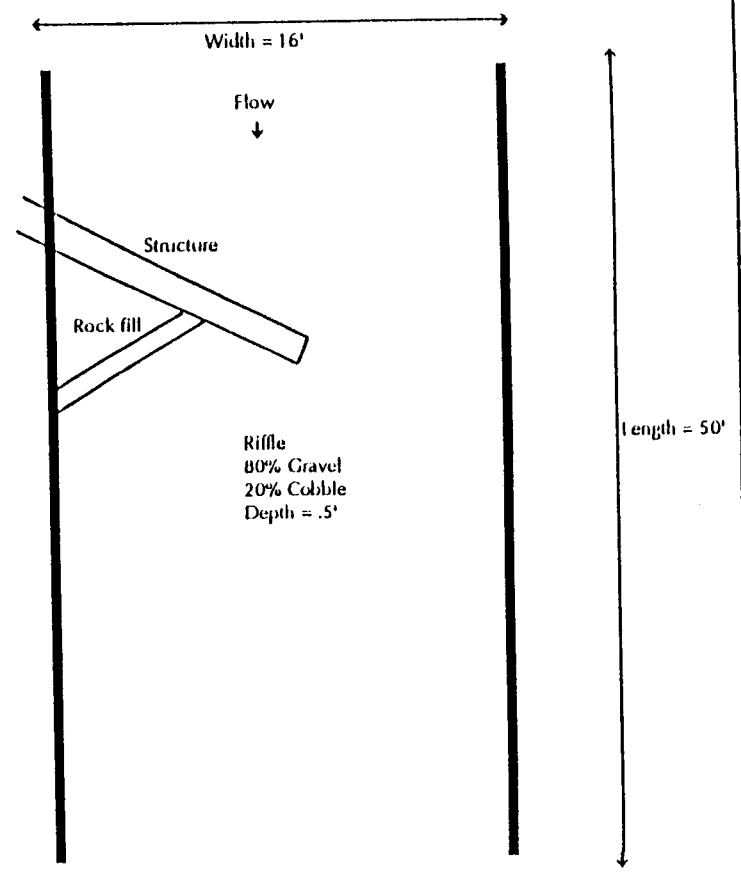
**Structure Number 4** Location Left trib. 1650' from mouth.

Hanning Creek, Hanning Bay, Montague Island, AK.

Structure type Wing deflector  
Width = 16'

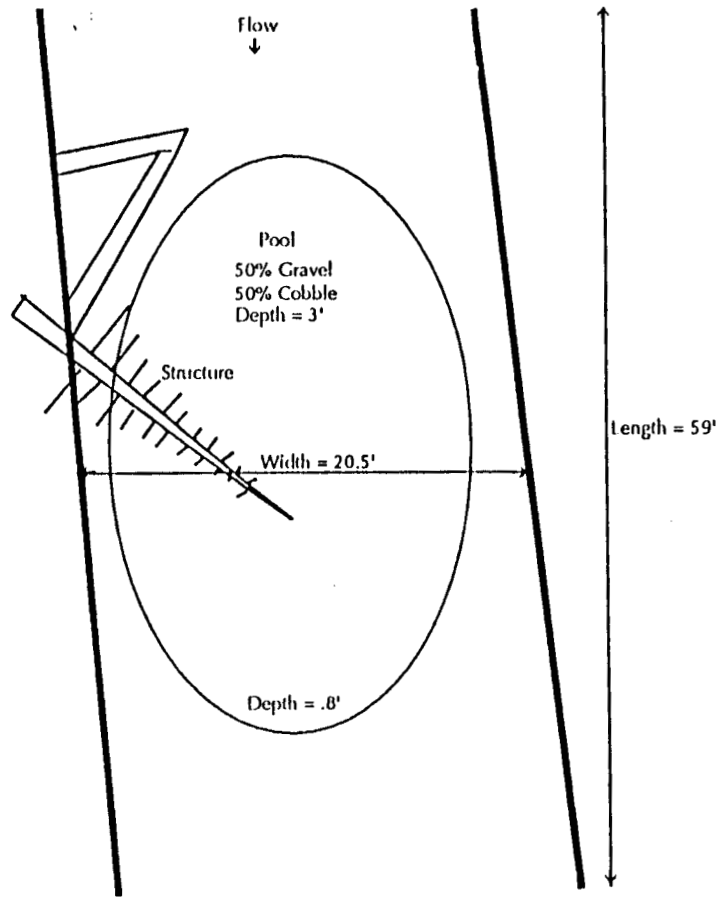
**Structure Number 5**    **Location** 100' up from structure 4 on the left trib.

**Hanning Creek, Hanning Bay, Montague Island, AK.**

**Structure Type** Tree top

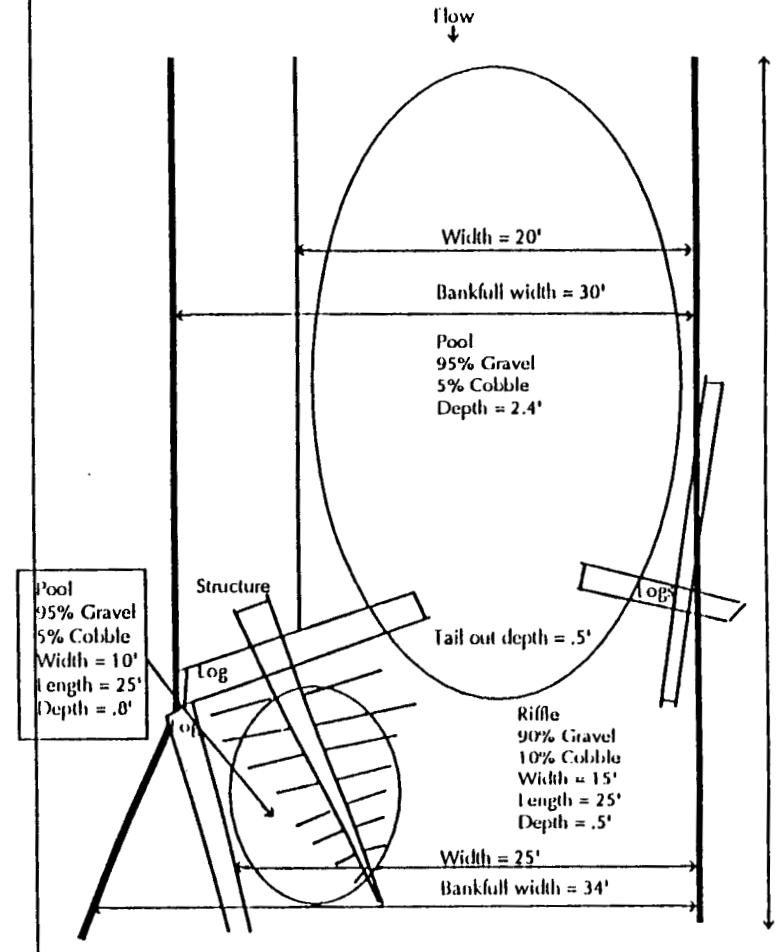
**Structure Number 6**    **Location** 1500' from mouth of left trib.

**Hanning Creek, Hanning Bay, Montague Island, AK.**

**Structure Type** Tree top

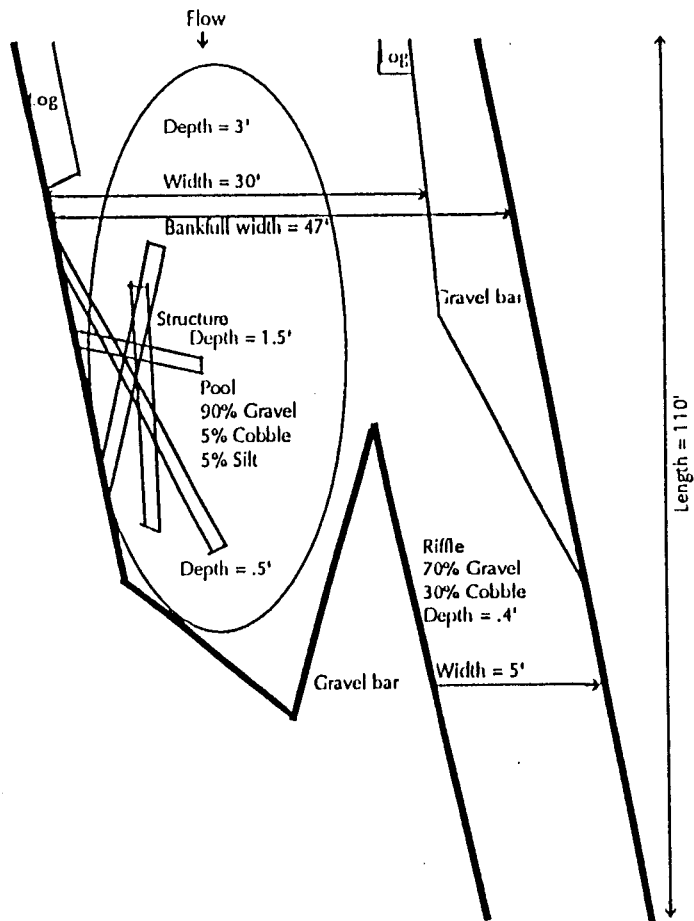
**Structure Number 7**      **Location** 1600' from mouth of left trib.

**Hanning Creek, Hanning Bay, Monague Island, AK.**

**Structure type** Log Jam

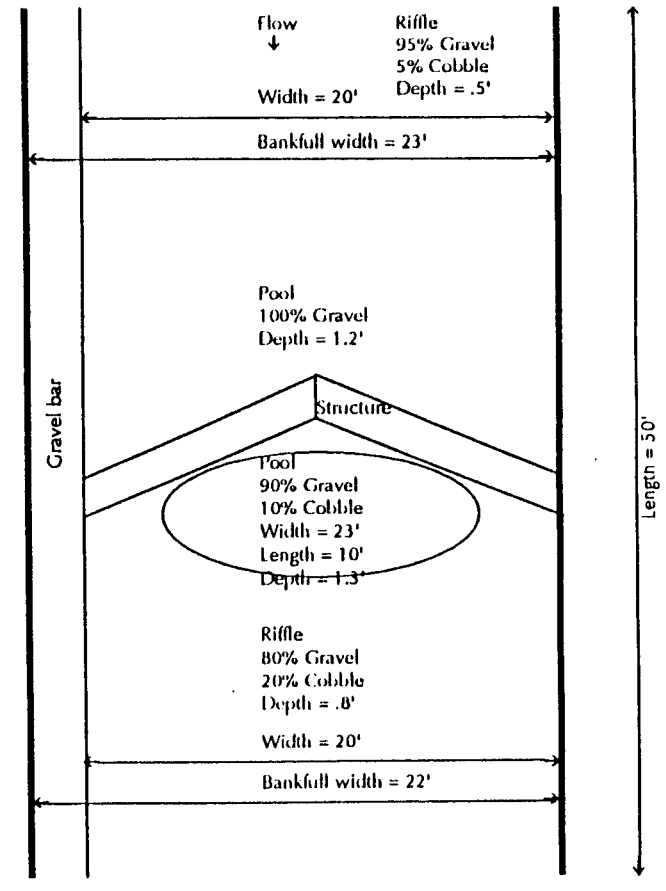
**Structure Number** 10 **Location** 1800' from mouth of left trib.

**Hanning Creek, Hanning Bay, Montague Island, AK.**

**Structure Type** Upstream V

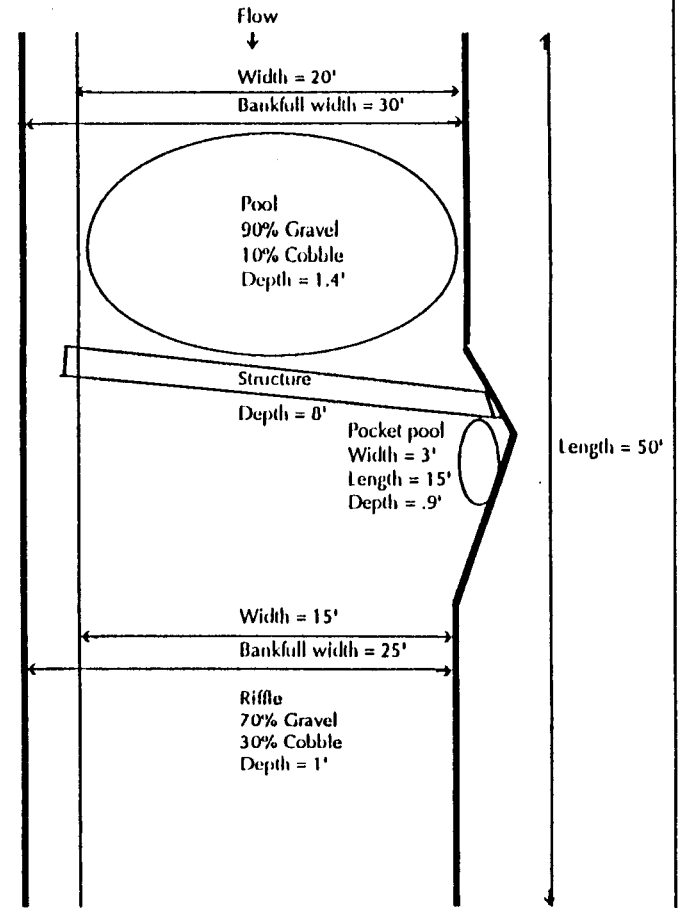
**Structure Number 18**    **Location** 615' from mouth of second trib.

**Hanning Creek, Hanning Bay, Montague Island, AK.**

**Structure Type** Diagonal weir

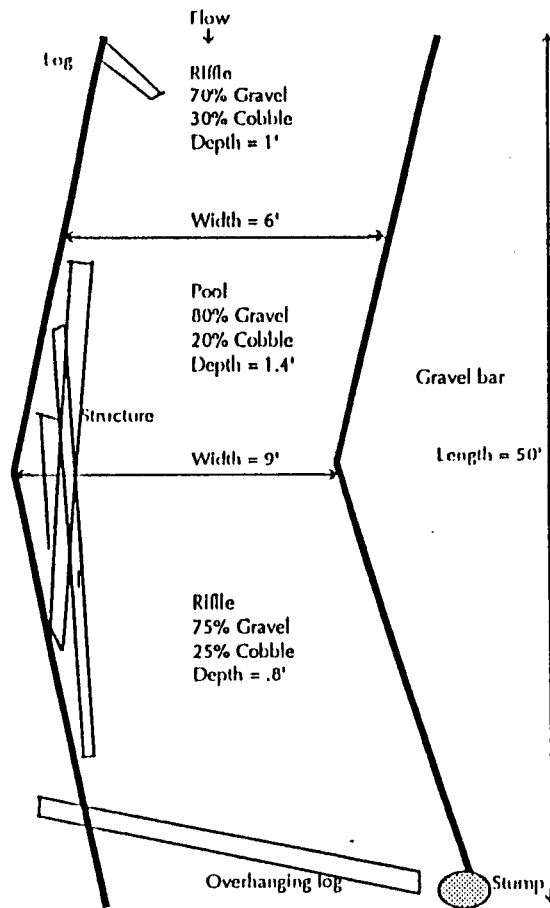
**Structure Number 21** Location 660' feet down from junction of second trib. on main branch.

Hanning Creek, Hanning Bay, Montague Island, AK.

Structure Type Log pile to prevent bank erosion.

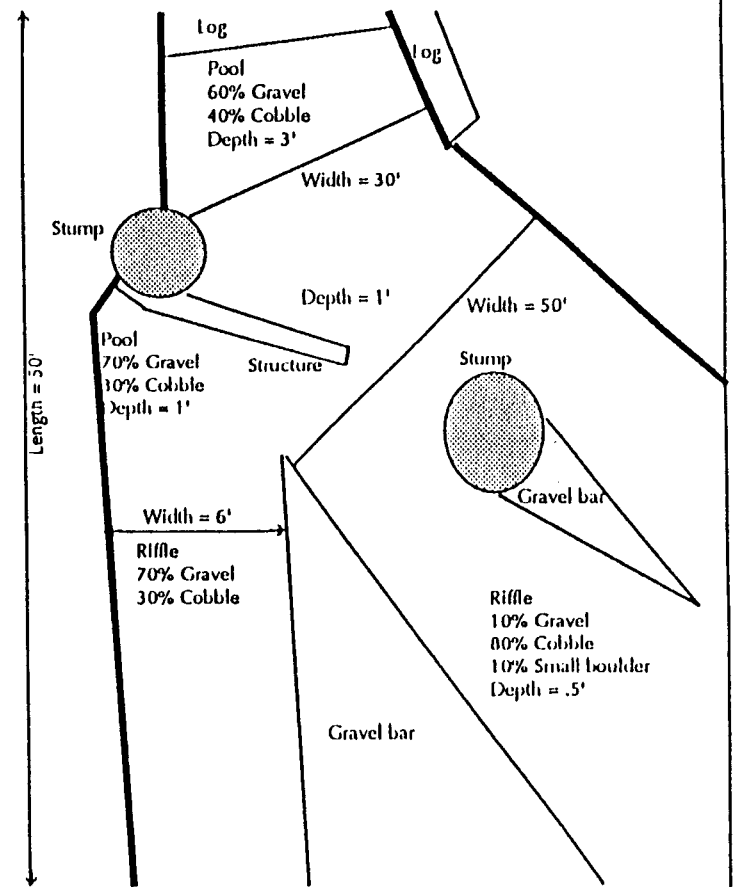
**Structure Number 22** Location 600' below where the second left trib joins the Main branch.

Hanning Creek, Hanning Bay, Montague Island, AK.

Structure Type Log barb

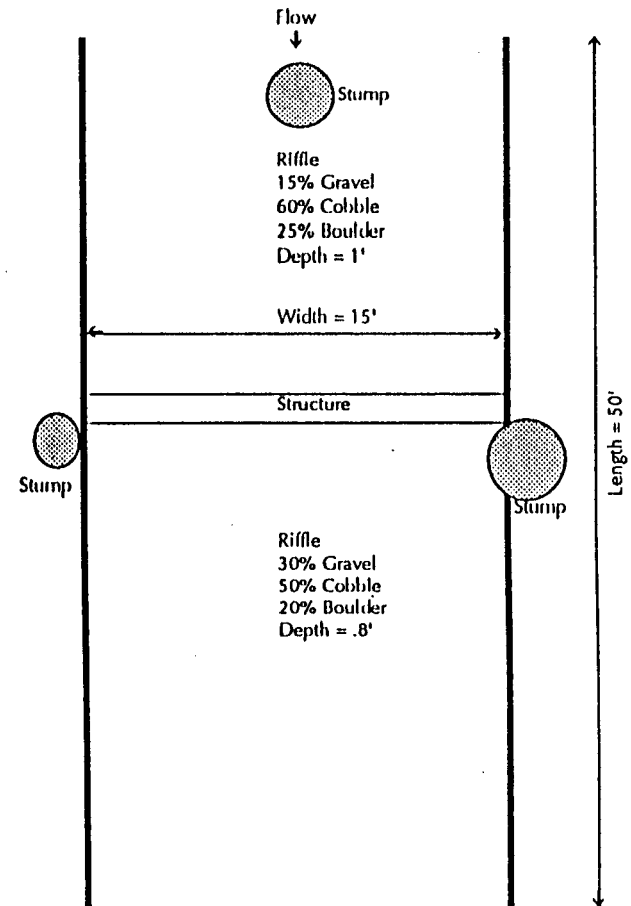
**Structure Number** 28 **Location** 875' above where second trib joins the main branch.

**Hanning Creek, Hanning Bay, Montague Island, AK.**

**Structure Type** Diagonal log weir
