### *Exxon Valdez* Oil Spill Restoration Project Annual Report

# Archaeological Site Restoration, Index Site Monitoring, 1997

### Restoration Project 97007A Annual Field Report

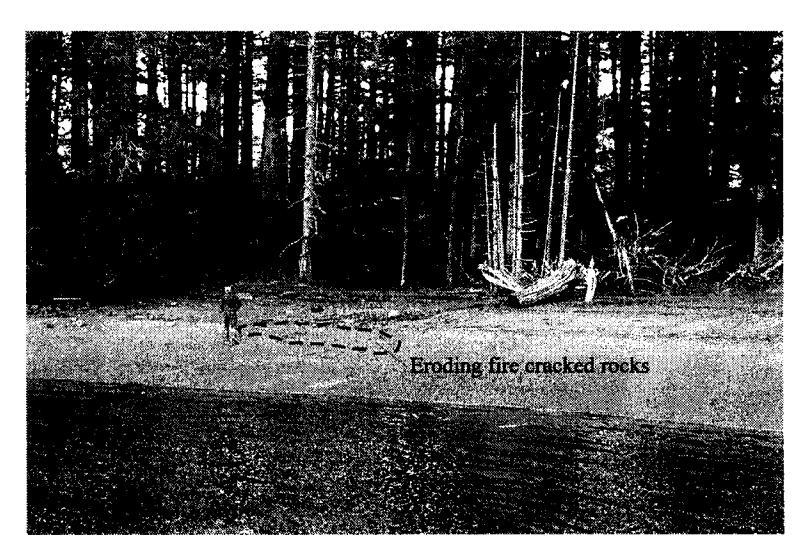
No serious degradation of the beach cultural remains appear to occurred since 1996. Erosion has continued but no more than expected. Two newly exposed artifacts were noted among the fire cracked

**Figure 1**. View of AFG-098 to the east at near high tide. Eroding fire cracked rocks and artifacts are outlined. (OHA Photo, 8/13/97)

rock fragments in the upper intertidal zone. Both are hammerstones. One hammerstone is oval in shape and cross-section and measures 15.0 cm in length. The other hammerstone is square in cross-section and sub-triangular in side view. It measures 20.0 cm in length. Both hammerstones were left in place on the beach near the center of the fire cracked rock exposure.

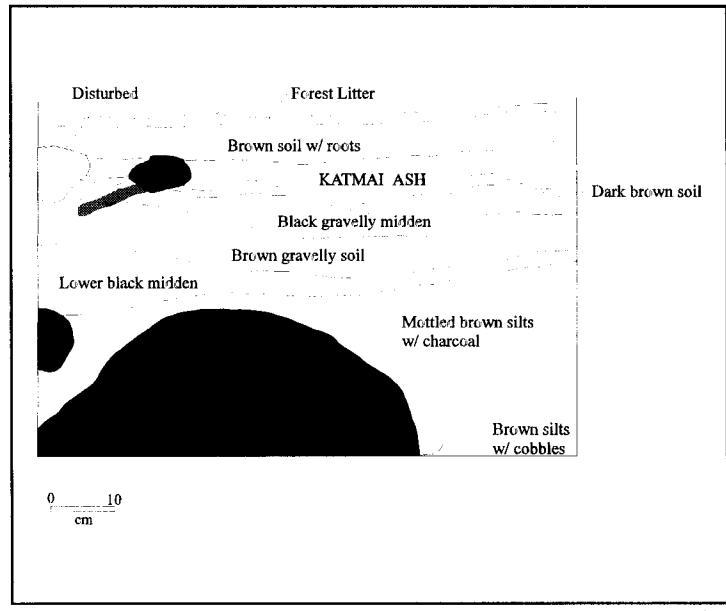
hearth and obtain charcoal for radiocarbon dating. Stratigraphy in the test reflects a profile (Figure 2) similar to that seen in the 1996 test on house pit #2. A thin dark brown soil immediately underlies the forest litter and duff. At a depth of about 5cm below the ground surface, the 1912 Katmai Ash was encountered. The Katmai Ash varies between 4cm and 8cm thick but is continuous over the feature. A disturbed area was found near the center of the test, probably an earlier shovel test. It was filled with soil replaced with the lower

**Figure 2**. Stratigraphic profile, north wall, House pit 9 test.

soils on top of the displaced Katmai Ash. The inverted stratigraphy and mixed appearance of the sediments allowed limits of the pit to be easily distinguished.

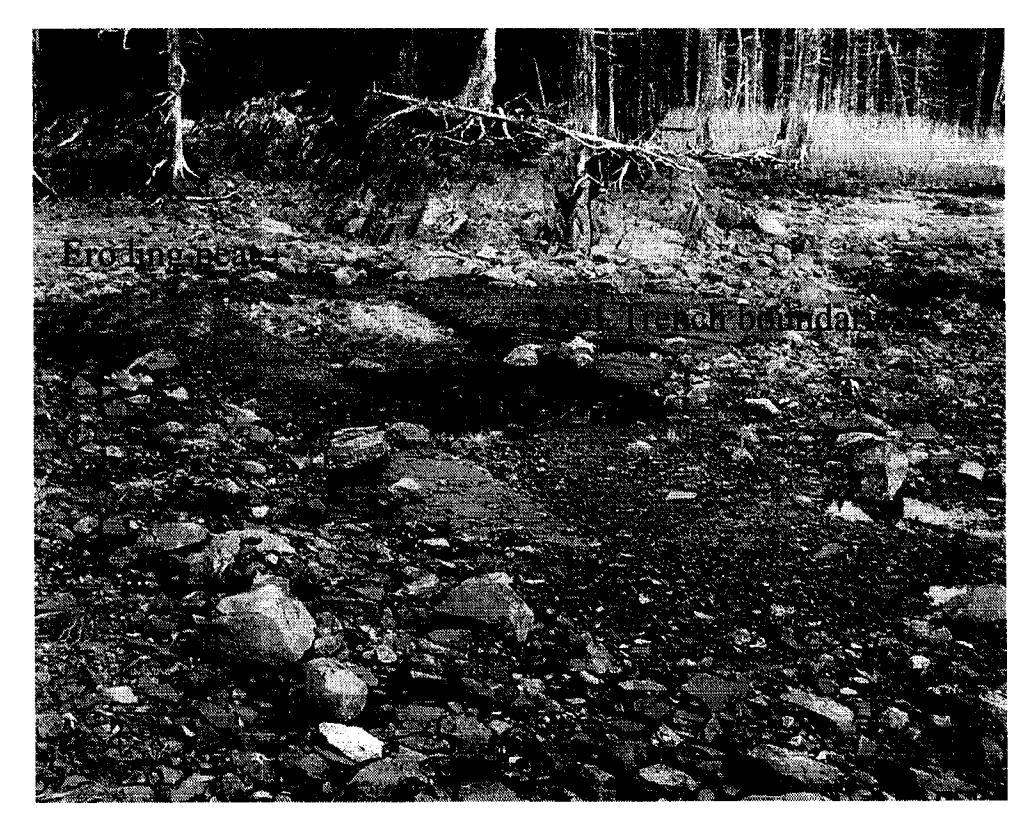
The Berger Bay site was briefly visited in September 1997. Outline of the test trench excavated into the intertidal peat during 1991 was obvious because much of the gravel fill has eroded (Figure 3). Beach grass is growing on gravel fill at the north end of the trench. The peat continues to resist erosion however some peat from the deposit surface has been striped by tidal erosion. A new area of cultural debris, primarily wood chips, is

Figure 3. View of SEL-215 showing 1991 trench and area of eroding cultural material. (OHA Photo, 9/97)

exposed immediately adjacent to the trench. The area of chips and fire cracked rocks measures  $1.5m \ge 1.5m$ . Located near the middle of the trench, layer is mostly gone.

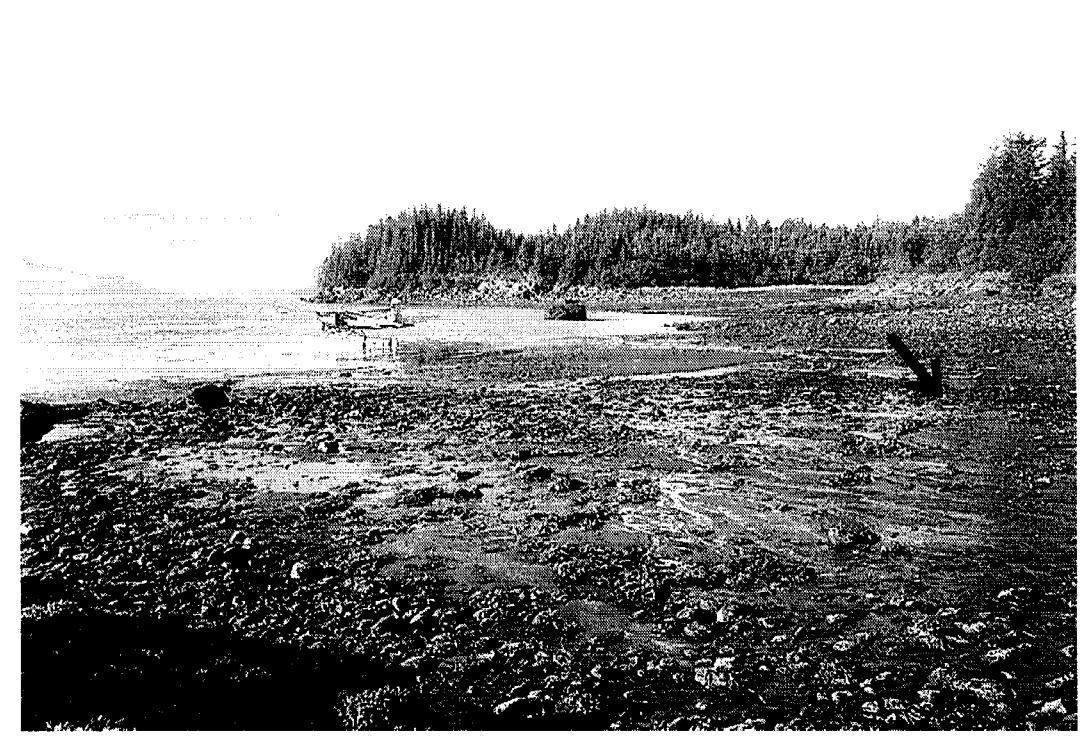
Douglas Reger and State Historian Jo Antonson visited the Kake Cove Site in September 1997. The tide level was low but was not a minus tide. The appearance of the intertidal peat deposit has changed a great deal since the Office of History and Archaeology mapped the deposit in 1991. Considerable erosion of the artifact bearing peat layer has occurred although some cultural remains still exist on the beach. Wave deposited sand obscured part of the existing peat deposit (Figure 5).

A flat stone grinding slab remains near the west end of the site area. It is approximat ely on the west boundary mapped in 1991. A bone. probably a mammal vertebra. was eroding out of the peat. It was very close to the grinding slab. The datum

**Figure 5**. SEW-068 beach looking southwest from the 1990 Exxon datum. Arrow indicates location of eroding peat and grinding slab. (OHA Photo, 9/97)

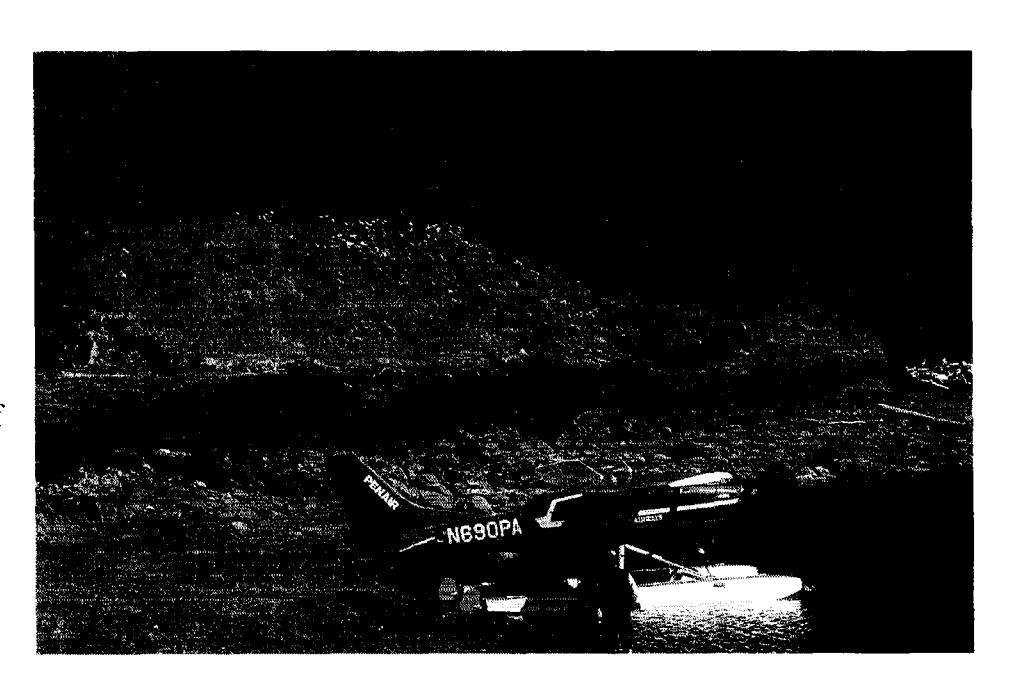
Figure 6. AFG-026 during the 1997 site visit. (U.S.F.W.S. Photo, 6/97)

Service archaeologist Debra Corbett and volunteer Sue Garland visited the site in late June 1997. Again Area B of the site was traversed on foot to orient the team. All previously reported potholes were relocated, and all were overgrown. Large sections of the bluff face were unvegetated but all exposures were weathered and dry, with no evidence of excavation since the last investigation. The stone lined cache noted in 1993 was still visible in the exposure. The beach was inspected and while bone, fire cracked rock and pieces of slate were observed no artifacts were found. The beach fronting Area A was examined next and again we saw bone and fire cracked rock but no artifacts. There does not appear to have been any illegal excavation at this site since 1989 when the Exxon archaeologists reported fresh potholes.

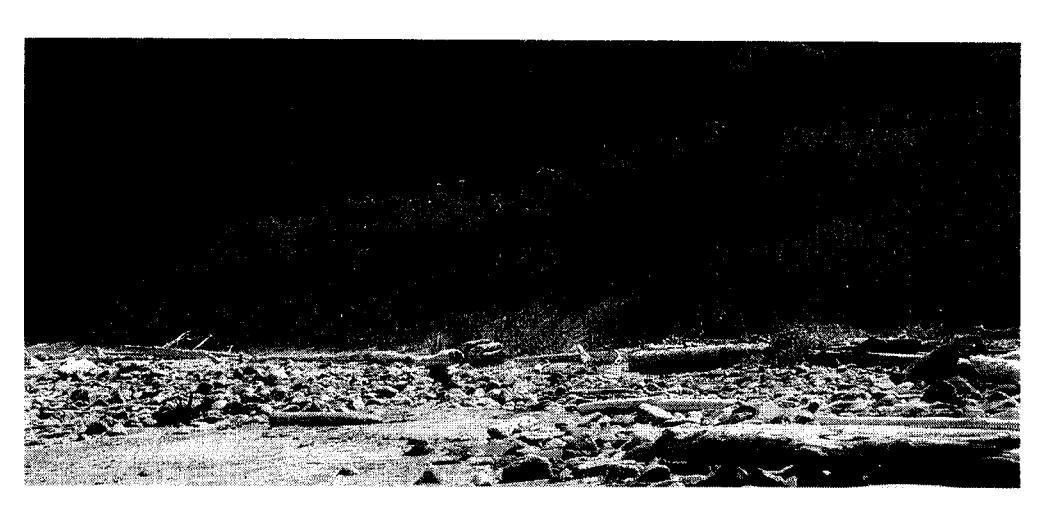
**Figure 7**. AFG-028 viewed during the 1997 site visit. (U.S.F.W.S. Photo, 6/97)

Service archaeologist Debra Corbett and volunteer Sue Garland revisited the site in late June 1997 (Figure 7). The actual site location is slightly different than that reported in previous years. We relocated four of the six previously reported potholes in the housepit and on the bluff face. All were densely overgrown with rank vegetation. The bluff face is almost completely overgrown and there is no sign of active erosion or recent vandalism. The beach was inspected but no artifacts were found.

There is no sign of recent damage to the site and all previously reported damage has recovered naturally. There is also no active erosion affecting the bluff face edge of the site.

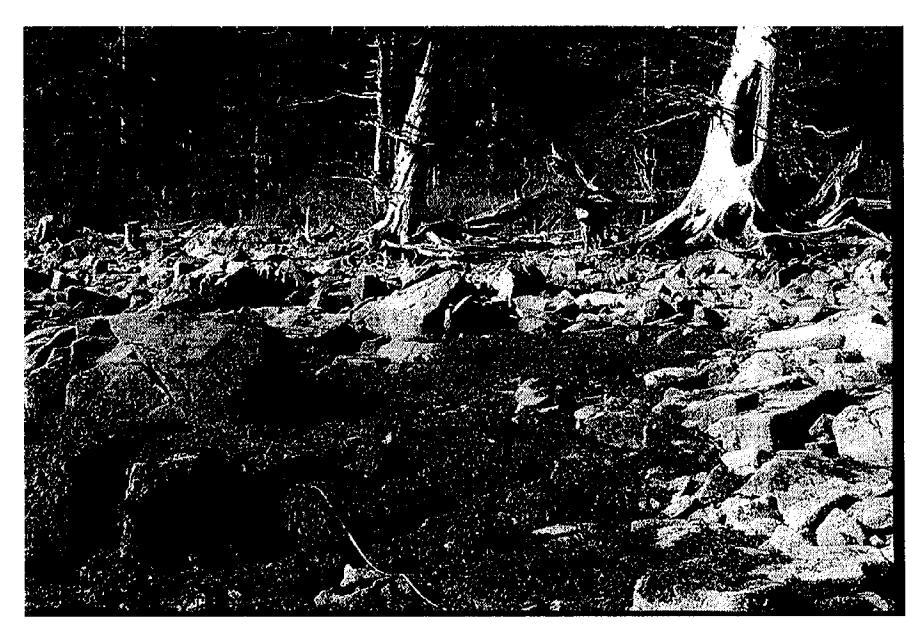
The McArthur Pass Site, SEL-188 was monitored as proposed for 1997 (Figure 8). Mark Luttrell was accompanied by Steve Baird, wildlife biologist from Homer. The site was oiled during the Oil Spill and exposed artifacts on the beach are subject to collection by vandals.

Figure 8. Intertidal area at McArthur Pass Site. (NPS Photo, 9/3/97)

Rocks on the beach in the samples locations have shifted somewhat, probably due to wave action. No evidence was seen that indicates human disturbance. An attempt was made using the 1993 map by Klingler to relocate the adze he found. The attempt only succeeded in duplicating Schaaf in 1994 by relocating a green hammerstone that was near the original location of the adze. The absence of the adze inconclusively suggests tat theft has occurred between 1993 and 1994. Dekin's Test #1 near the mouth of the stream (Dekin et al. 1993) was relocated and it appeared much as described in 1994 and 1995; well backfilled and covered with moss and granite spalls. The location of the 1989 Zollars test and expanded excavations by Schaaf and Johnson (Schaaf and Johnson 1990:3) were unsuccessful. That is attributed to careful backfilling and replacement of the vegetation mat.

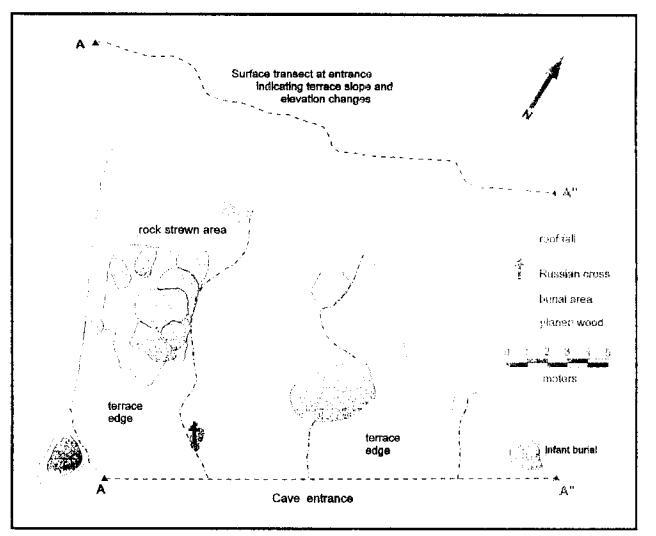
Although the lower cave interior floor localities of SEW-469 had been sketched during previous visits, the lack of a scaled map posed difficulties in interpretation of features noted by different visitors to the site. During the 1997 site monitoring trip, a more formal map (Figure 9)was made of this lower locality, showing archaeological surface features, roof fall areas, and general elevation changes over the main portion of the cave. The cave entrance measures approximately 22m wide, while the distance to the deepest part of the cave is about 17m. Scattered human remains were still present on the surface and appeared undisturbed in the uppermost area of the cave, which was vandalized by an oil spill cleanup worker in 1990. Other portions of the cave with human and cultural remains also appeared undisturbed since the previous monitoring visit. Documentary photographs were taken from the eastern edge of the roof fall pile which is northwest of the Russian cross, and on each individual terrace.

**Figure 9**. Surface feature distributions, SEW-469. Based on field measurements by L. Yarborough and S. Barthold, 1997.

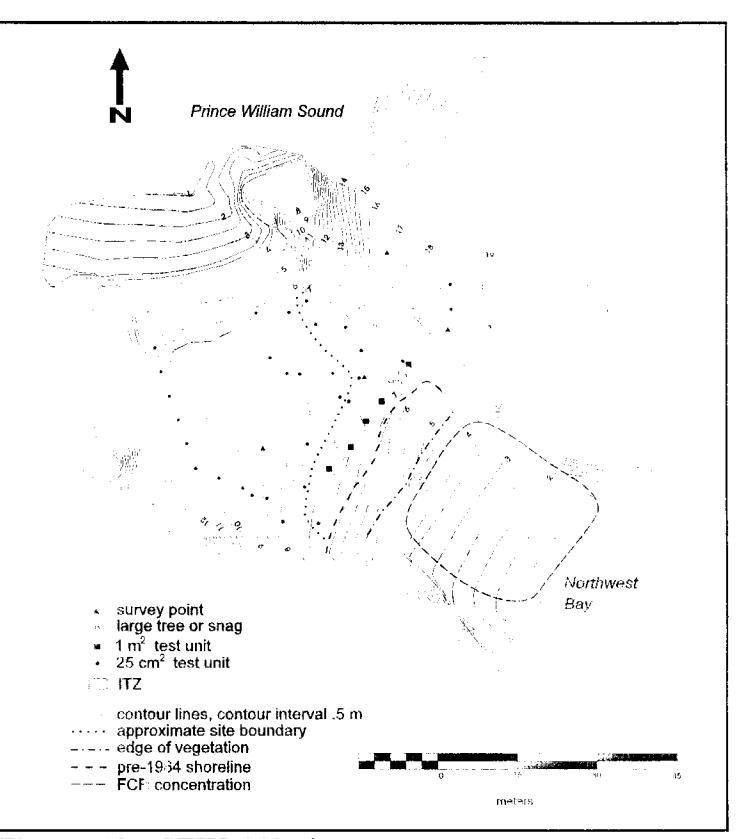
Figure 10. SEW-440 site map.

During the monitoring visit to SEW-440 (Figure 10), the site was photographed from the shore,

and from the headland northeast of the site. The narrow deer trail leading from the intertidal zone up on to the site, which was noted as eroding in 1994, 1995 and 1996, appeared to have received less use during 1996-1997 and was revegetating. The backfilled Archaeological Site Restoration project tests made in 1994 have revegetated and blend in with the natural surroundings. Although substrate samples taken from the intertidal zone in front of this site in 1994 and 1995 tested positive for the presence of oil, the 1997 sample, analyzed using the HNU-Hanby field test kit tested negative. It appeared that no natural erosion or humanly associated damage occurred to the site during the time between monitoring visits in 1996 and 1997.
